Job Number: 21-12082

Subject: On-Site Wastewater Treatment System
Observations, Kerr Residence, Lot 11, Sidney
Peak Ranch Subdivision, Routt County,
Colorado.

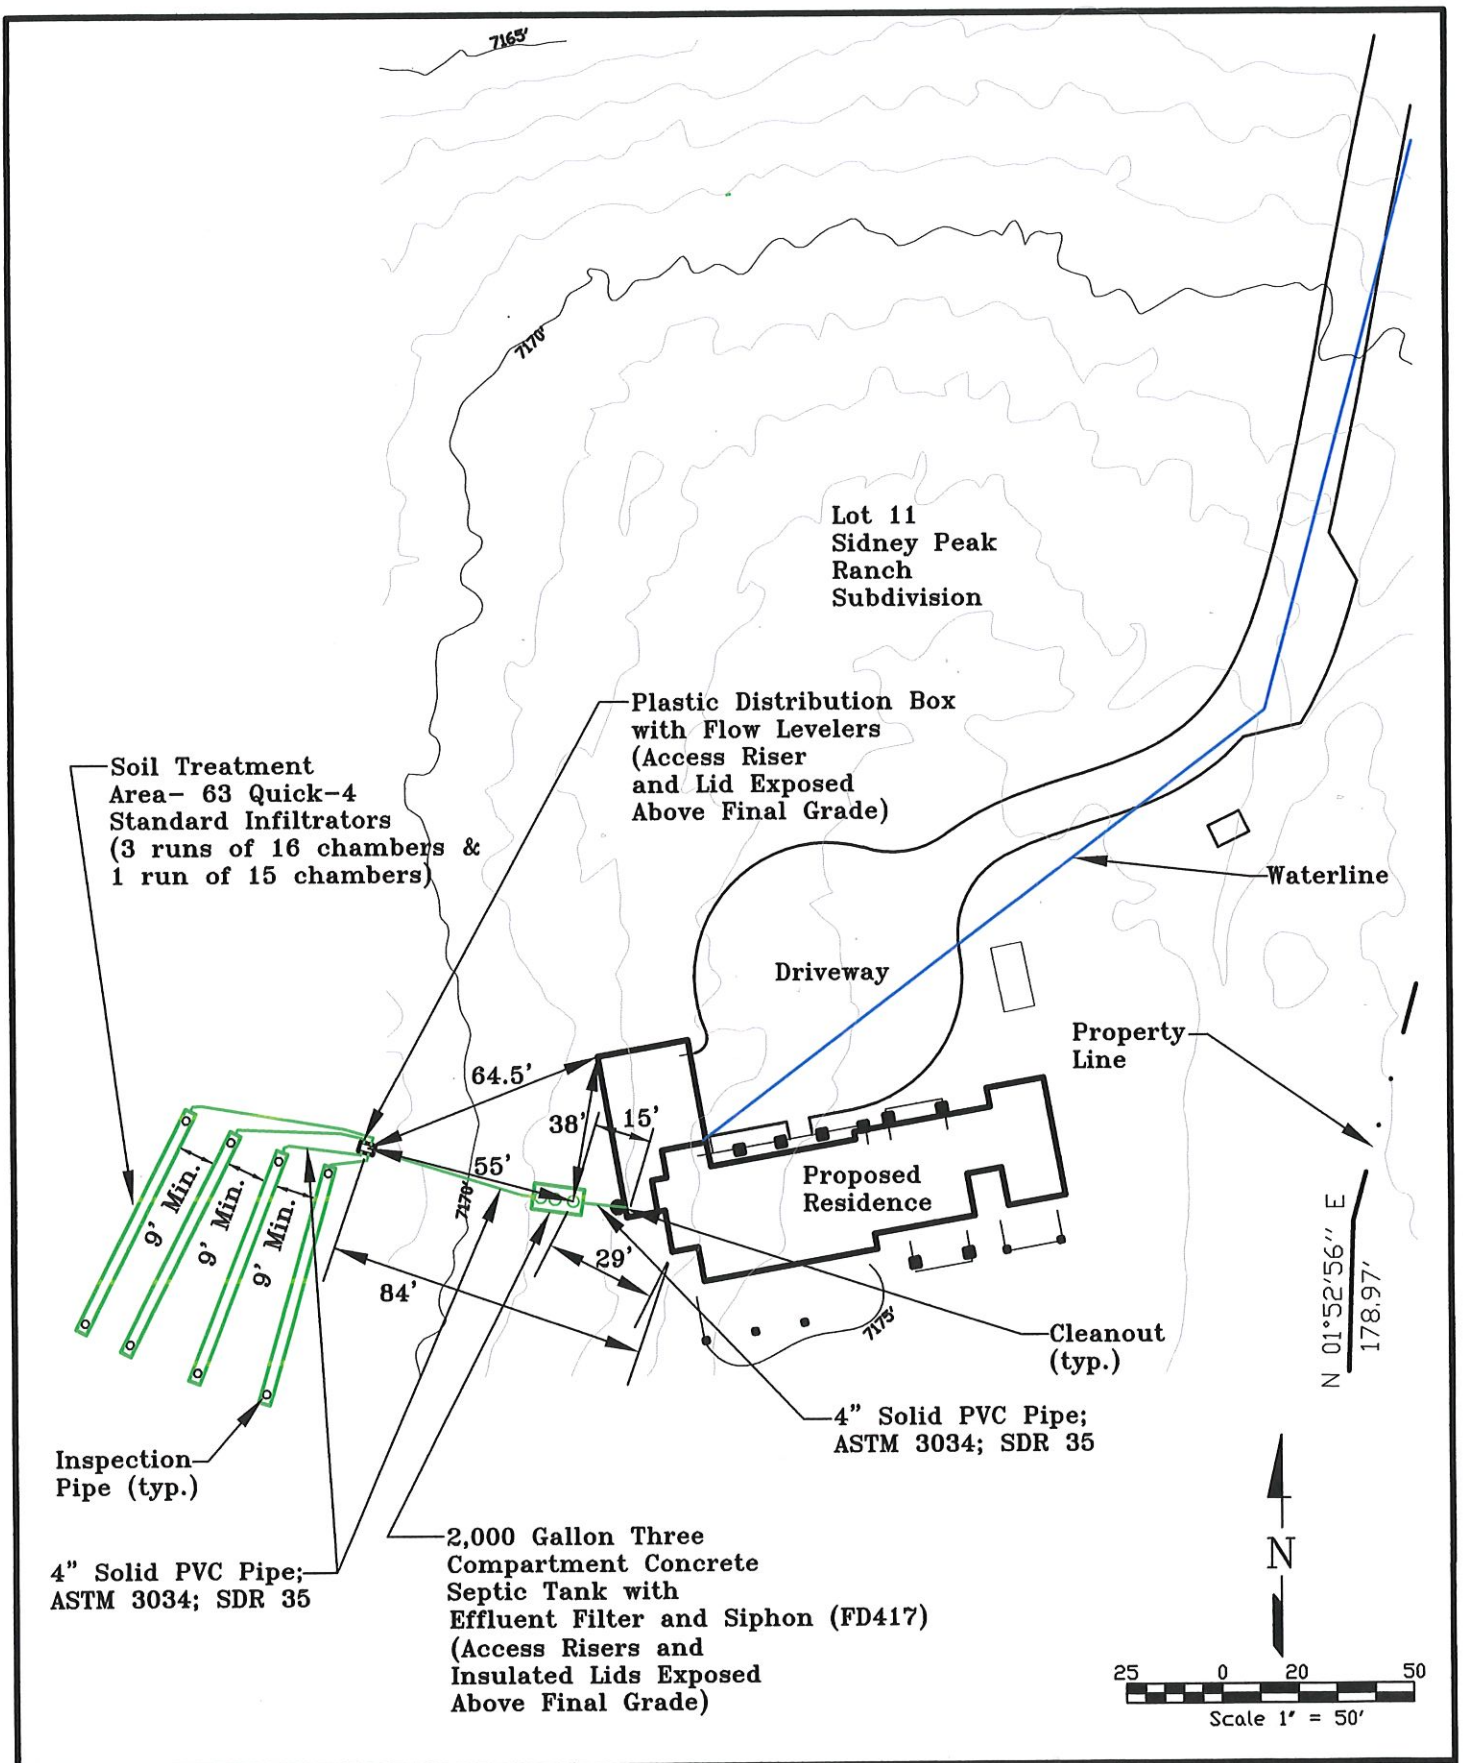
Title: OWTS - AS BUILT SITE PLAN	Date: 11/21/2023

At the time of our site visit on November 17, 2023, the installer had completed backfilling the OWTS. Risers had been installed on the septic tank access and the lids were accessible above the finished ground surface. It appeared that sufficient cover had been placed over the piping, septic tank and chambers. An as-built drawing taken from field measurements of the system is presented in Figure #1.
