ASBESTOS INSPECTION REPORT

CLIENT:	Beall, Benjamin
ADDRESS:	38600 Main St.
	Milner, CO, 80487
EMAIL:	ben@aquaworksdbo.com
PHONE:	1-970-846-1513
ECOS JOB NUMBER:	S-23-0029-AT
PROJECT LOCATION:	Same Location
DATE OF INSPECTION:	12-12-2023
DATE OF REPORT:	01-05-2023

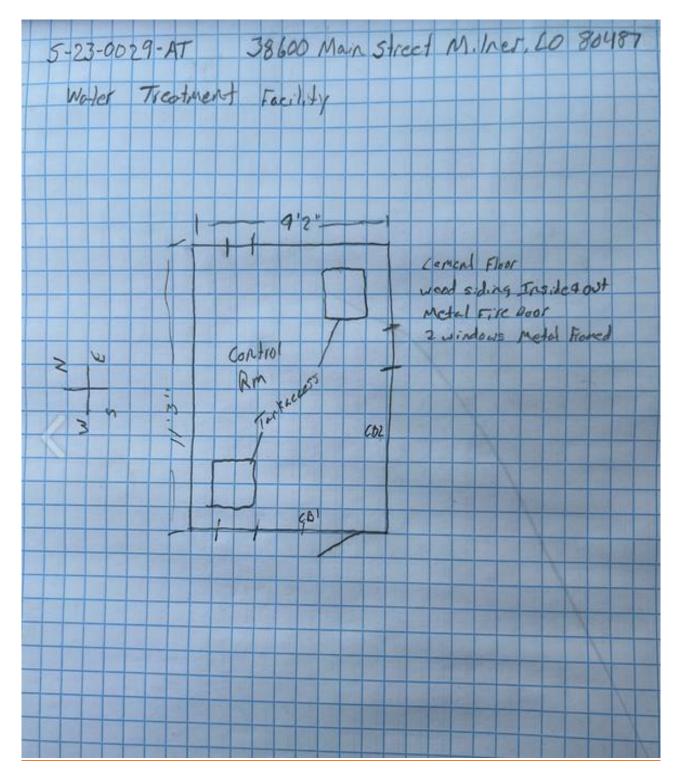
SKETCH

SAMPLE	HOMOGENOUS AREA	LOCATION/FUNCTIONAL SPACE	DESCRIPTION
CB	Area 1	CONTROL ROOM	COVE BASE AND MASTIC
