AHERA Asbestos Survey Report (Revised)

Strawberry Park Elementary School
39620 Amethyst Drive
Steamboat Springs, CO 80487

Weecycle Job No.: 18-14588

Performed On: 4/27/18 & 3/9/20

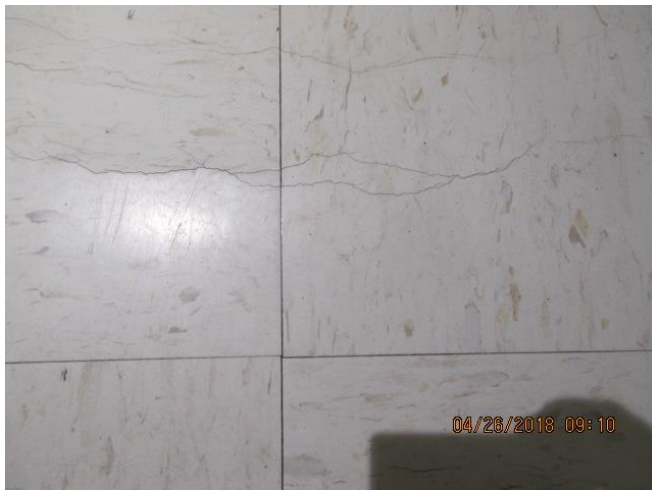
HOMO #	Homogeneous Material	Location of Material	Percentage of Asbestos	Total Square Feet
FT4	12x12 Tan Floor Tile & Mastic	Kitchen	Tile - 3% Chrysotile Mastic - ND	≈300

12x12 Floor Tile

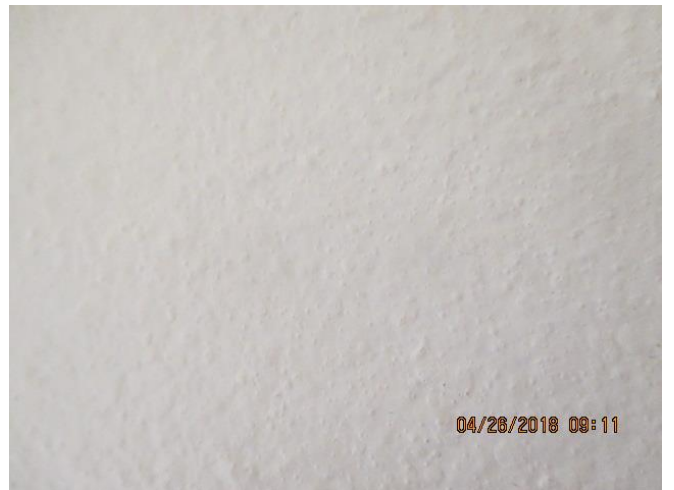
Typical Texture Appearance

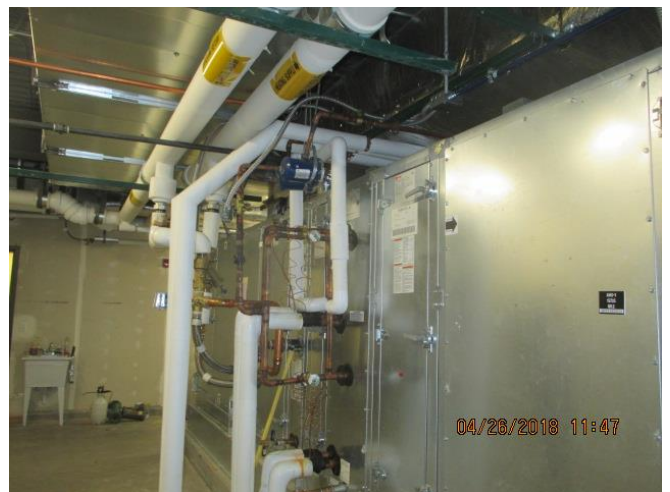
Mechanical Room Fiberglass & PVC Insulation

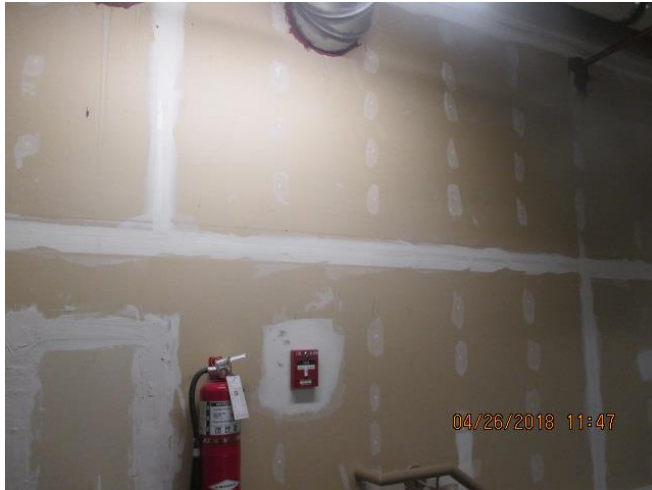
Drywall Unfinished – Only Joint Compound

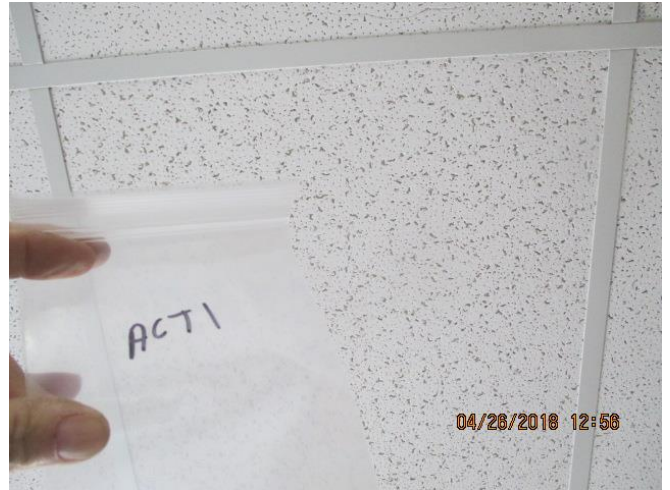
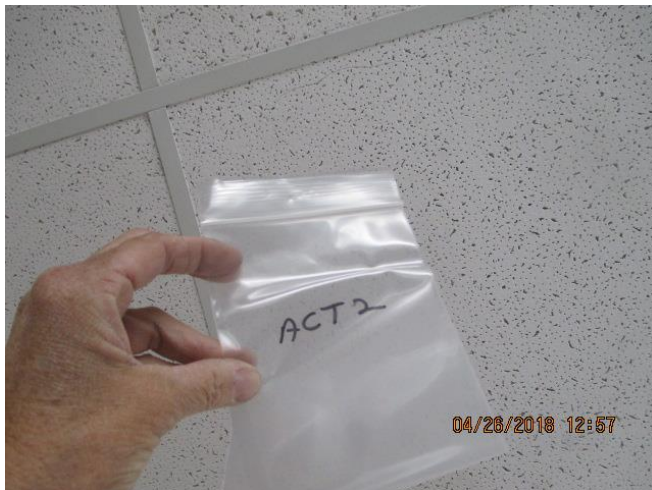
Ceiling Tile Throughout School

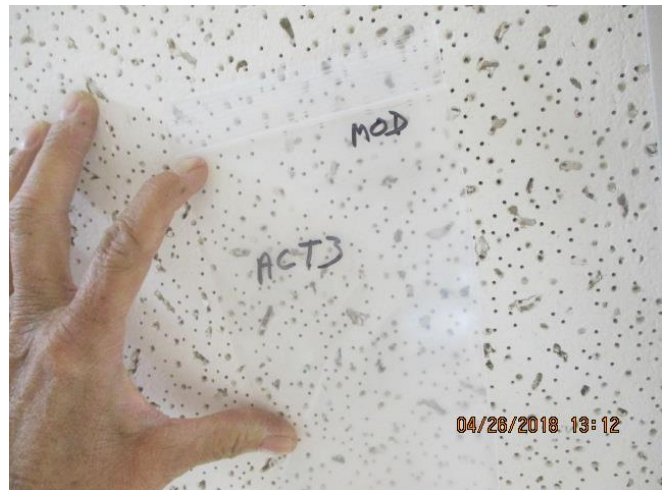
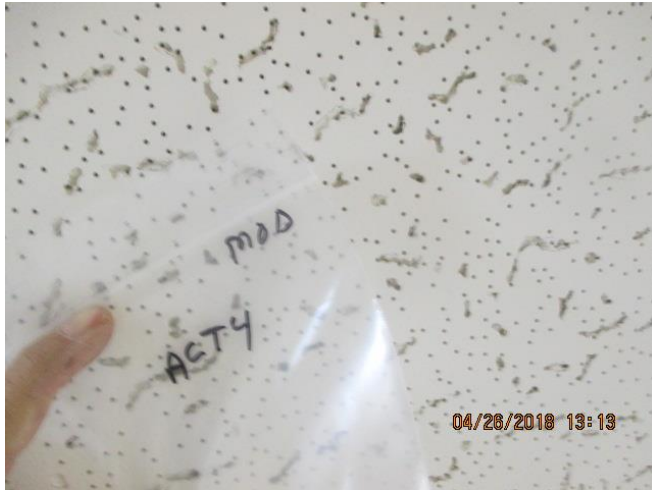
Ceiling Tile- Mobile

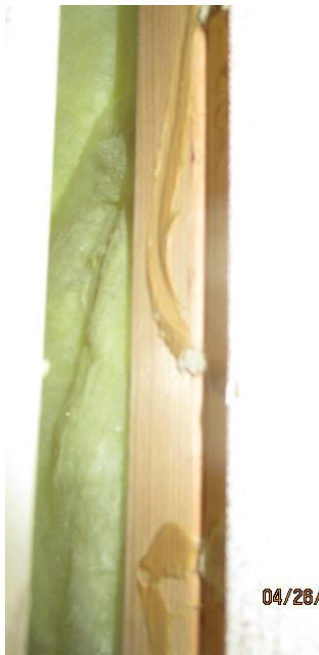
Wall Board Adhesive Mobile

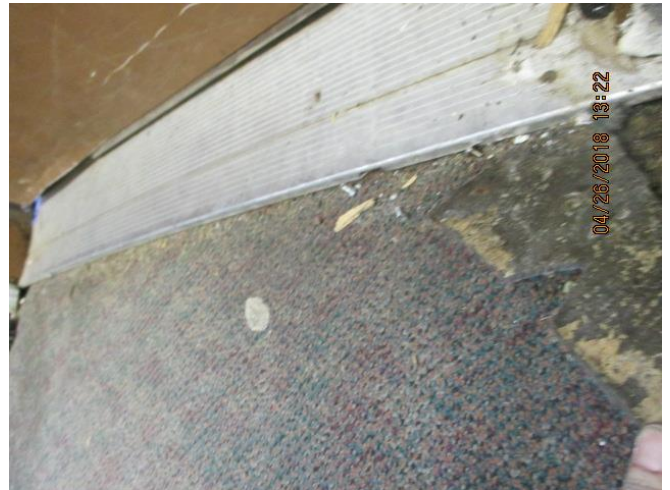
Carpet Adhesive Mobile

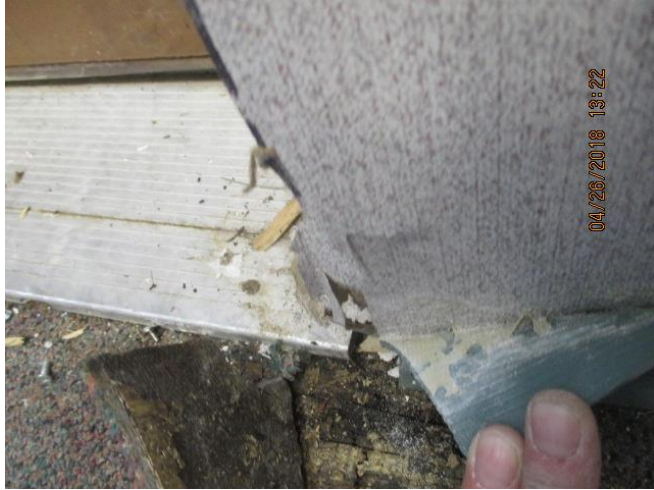
Cove Base Adhesive
