February 23, 2022

Job Number: 20-11636

Subject: On-Site Wastewater Treatment System
Observations, Donham-Burgess Residence, 27875
US Highway 40, Routt County, Colorado.

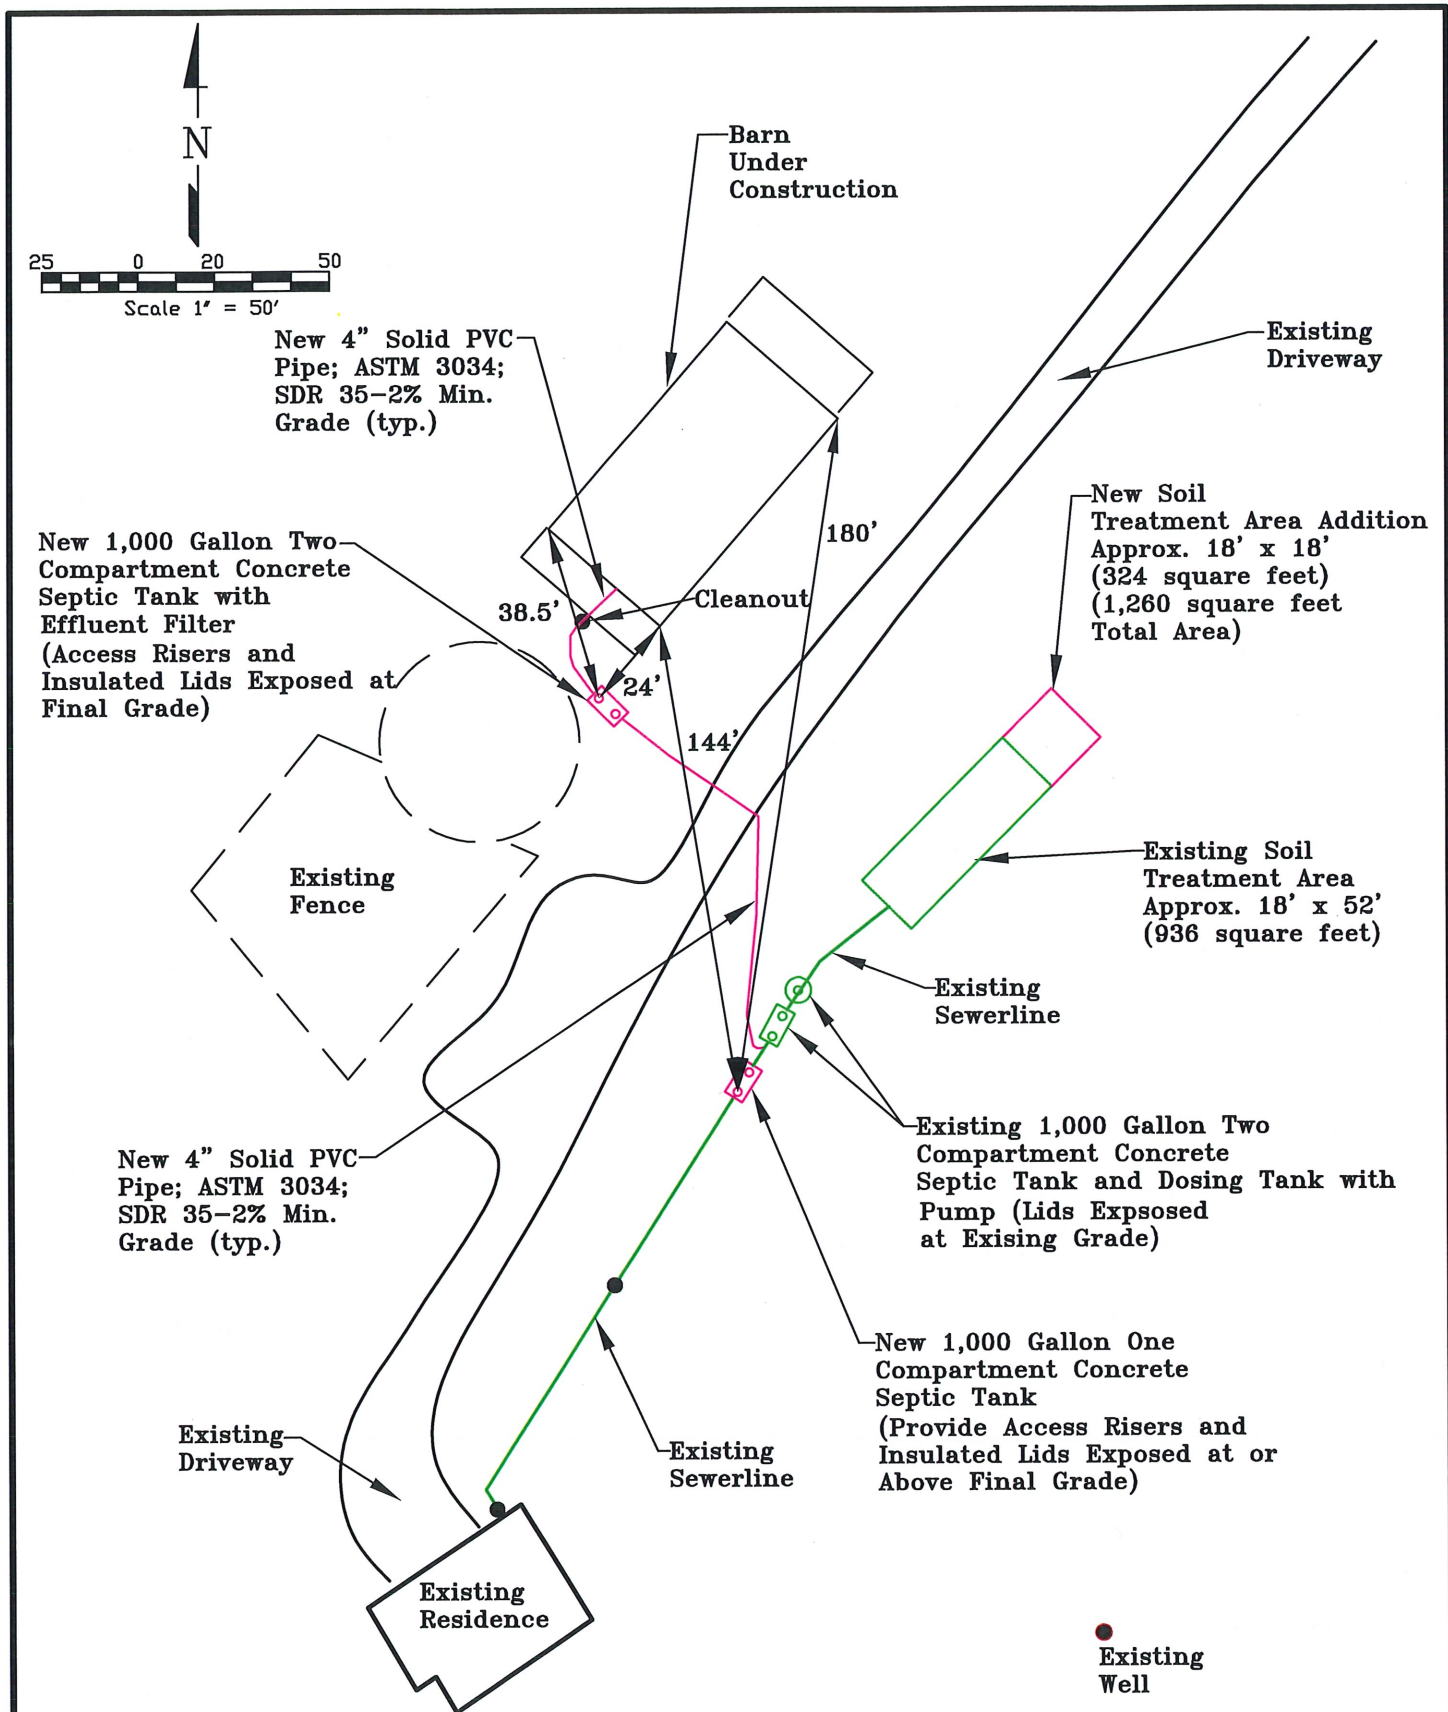
Figure **#1**

At the time of our site visit on November 10, 2020, the OWTS had been backfilled. It appeared that sufficient cover had been placed over the piping, tanks and soil treatment area. The lids for the septic and dosing tanks were accessible at the finished ground surface. An as-built drawing taken from field measurements of the system is presented in Figure #1.
