Re: **Compliance Advisory for the Milner Landfill:**  
20650 County Road 205  
Steamboat Springs, CO 80487

A Copy of the inspection report is enclosed with this Compliance Advisory.

# Attachment 1 - Photo Log

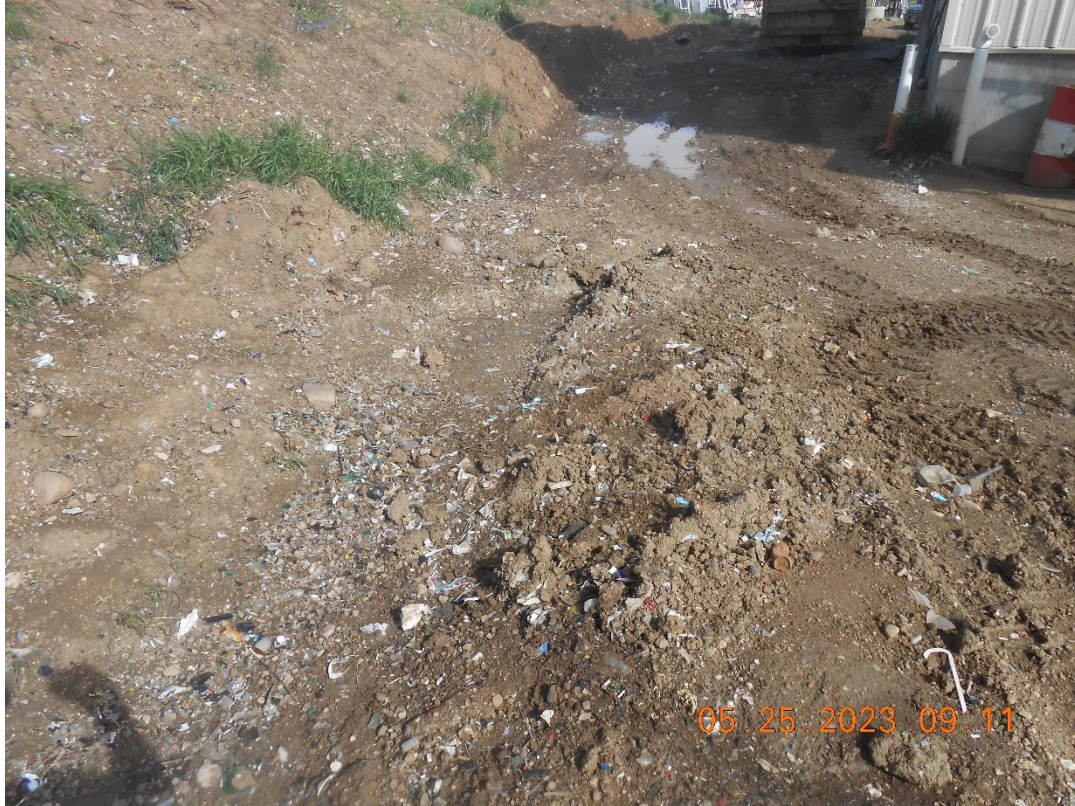
**Deficiency 1:** There was a substantial amount of litter present on the ground surface to the west and south sides of the material recovery facility (MRF), in apparent violation of Section 4.7.1 "Litter Control" of the Facility's EDOP, Section 2.1.3 of the Solid Waste Regulations and CRS § 30-20-110.

Figure 1: Debris on ground surface outside of Materials Recovery Facility (MRF)

**Requested Action 1:** Within fifteen (15) days of your receipt of this Compliance Advisory, the Department requests that Twin clean up the area surrounding the material recovery facility (MRF). The Department additionally requests that Twin provide a short “letter report”, including photographs, documenting that the areas surrounding the MRF have been cleaned up.

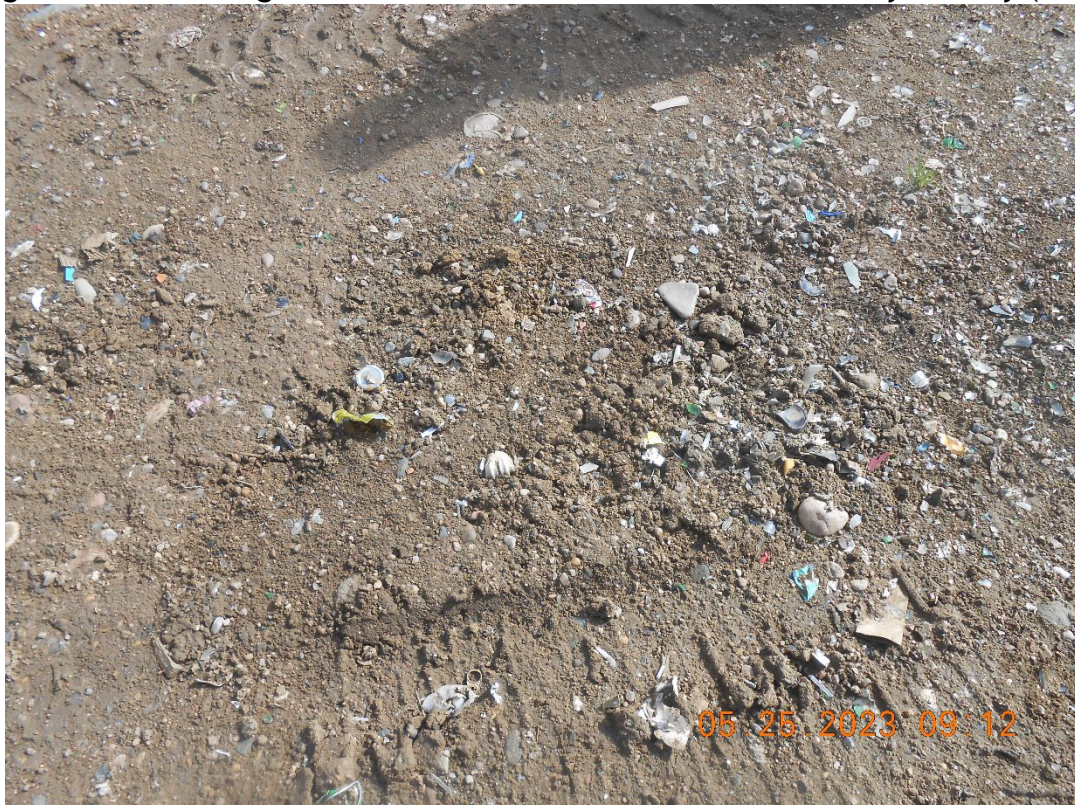
Photo 2: Significant amount of debris on ground surface outside of MRF

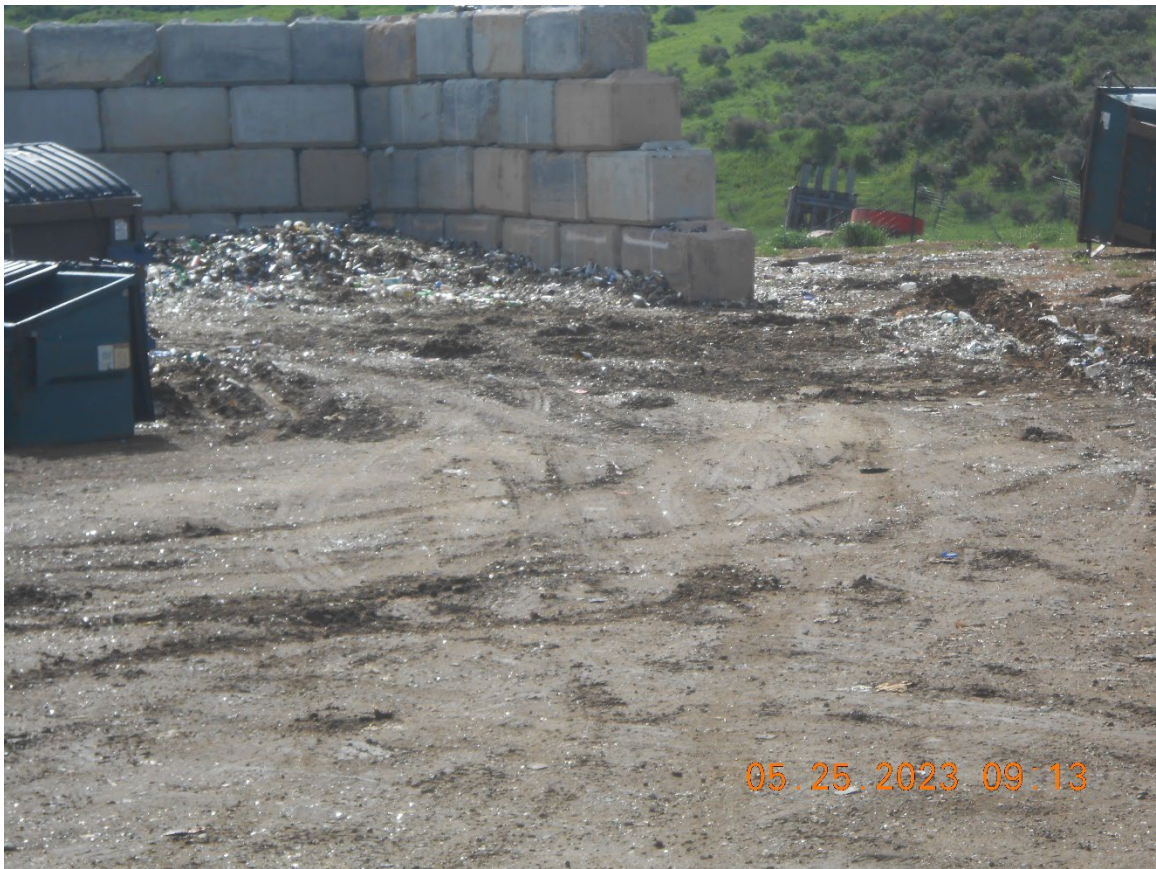
Photo 3: Debris on ground surface around glass storage area

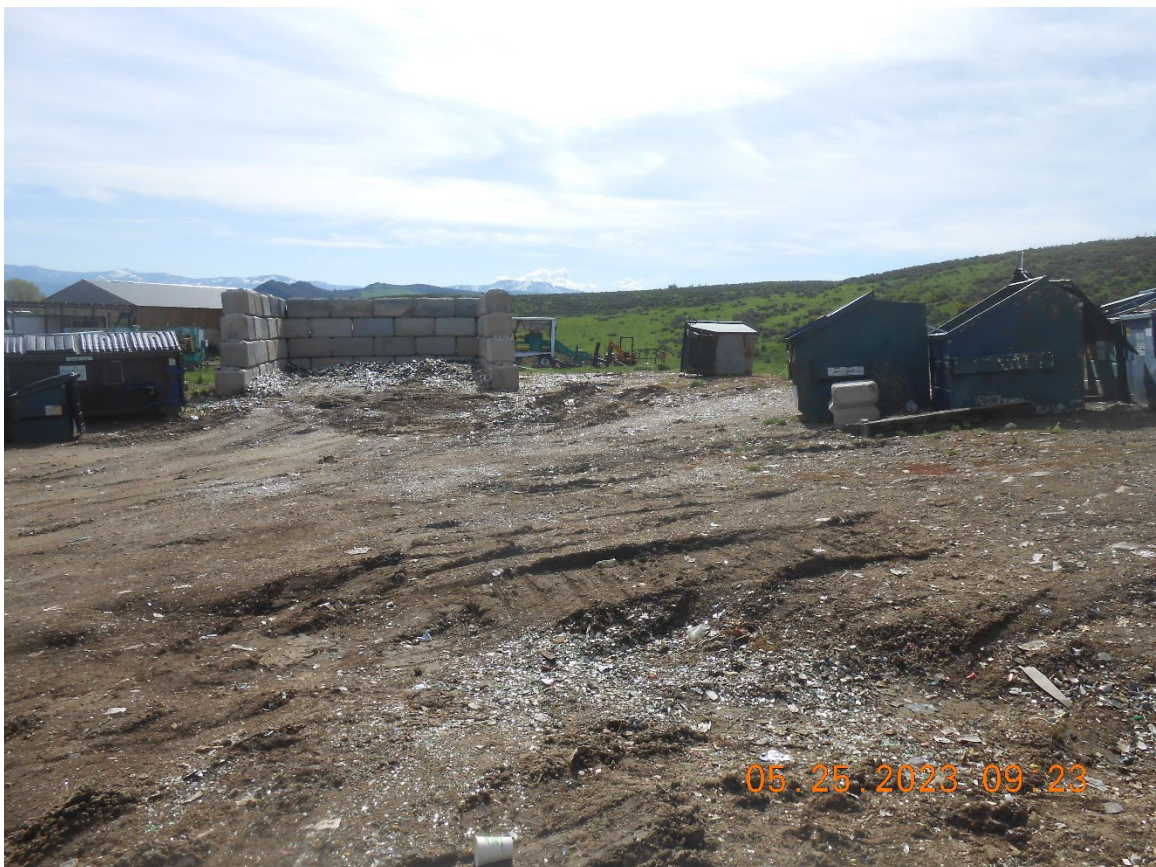
Photo 4: Debris on ground surface outside of MRF

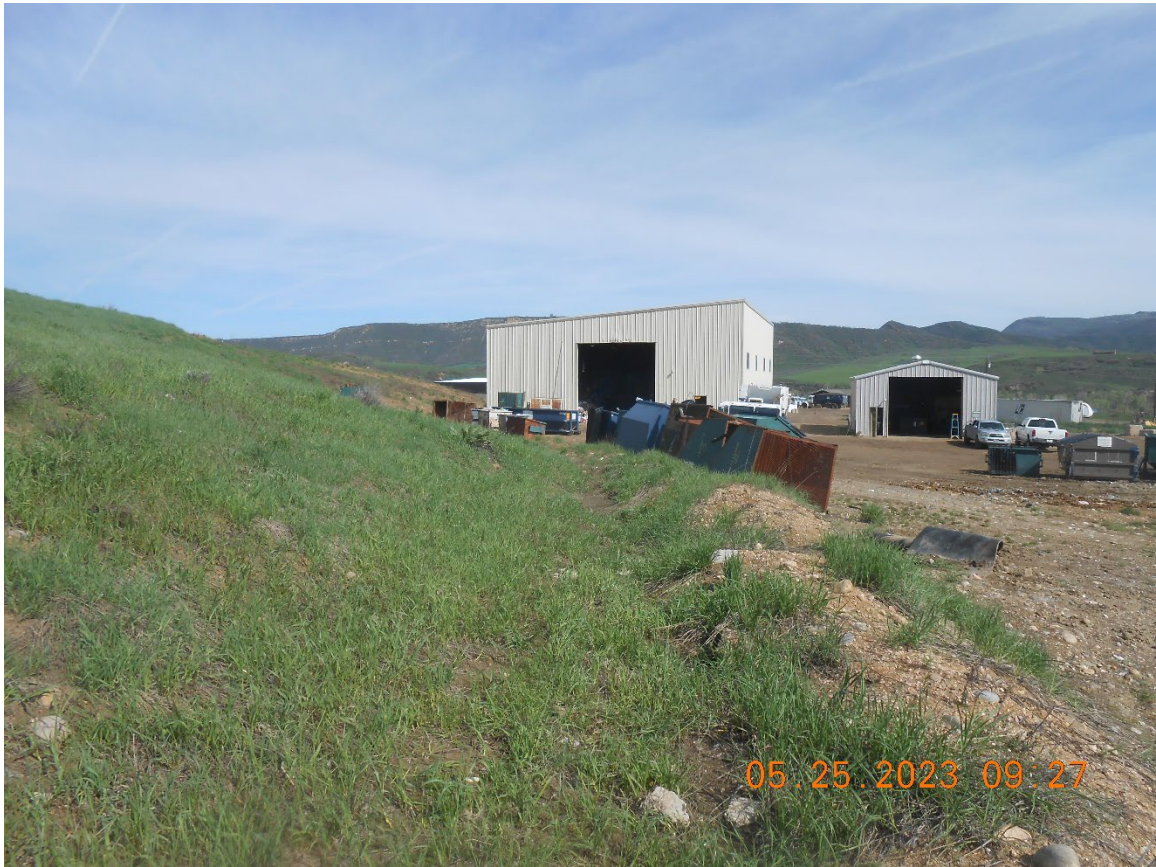
**Compliance Assistance Item 2:** The stormwater management channel at the perimeter of the Pit 5 area adjacent to the MRF was noted to be mostly filled in and not sloped to drain to the rest of the stormwater management system. This should be addressed so the stormwater is appropriately conveyed to the rest of the stormwater management system. Additionally, this temporary stormwater management structure will need to be replaced with a permanent stormwater management conveyance constructed in accordance with the approved EDOP and the Solid Waste Regulations in the future. Appropriate Construction Quality Assurance (CQA) reporting for this feature will need to be submitted to the Solid Waste Permitting Unit of the Department once this permanent feature is constructed.

Photo 5: Drainage channel south of MRF

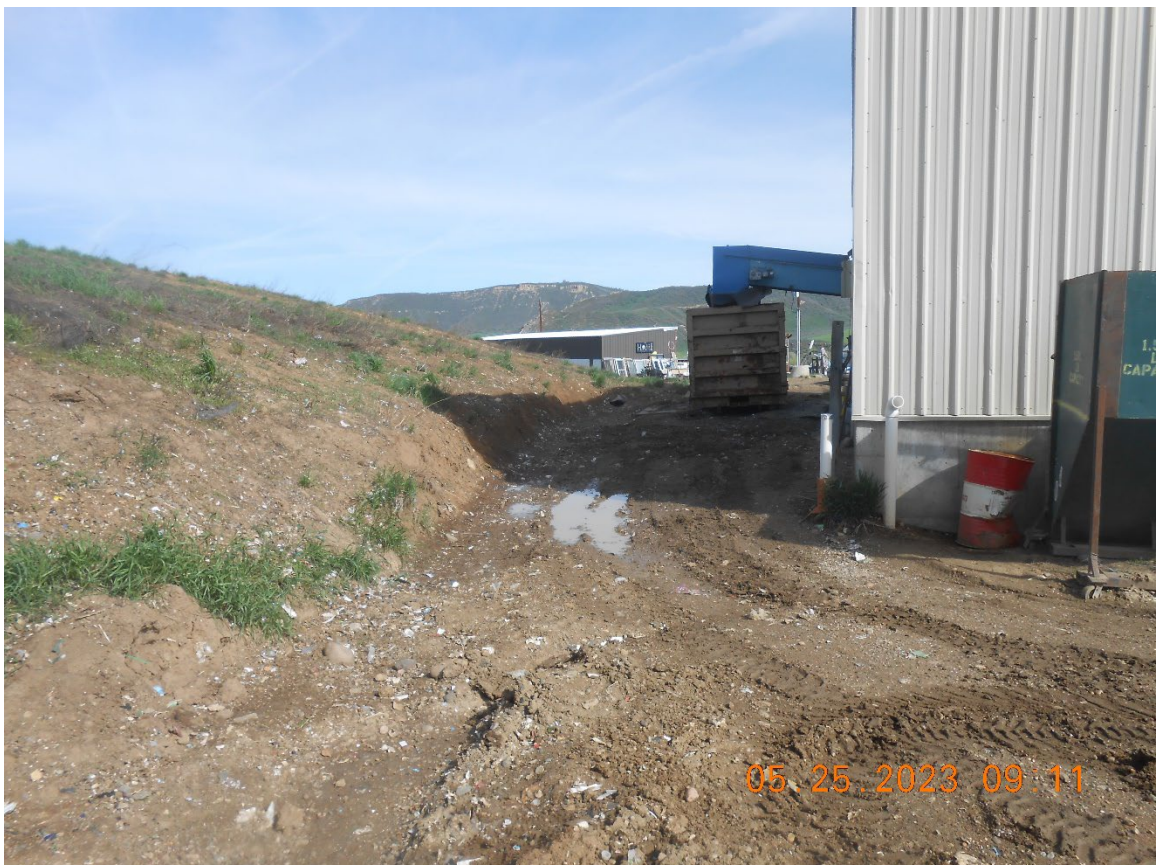
After introductions were made, the first destination of the inspection group was the Facility's Material Recovery Facility (MRF) located just to the south of the main office building. The group observed all sides of the Facility and noted that there was a substantial amount of material waiting to be processed on the floor of the MRF, but that the bulk material awaiting processing was largely contained to the interior of the building. However, when the group observed the areas surrounding the MRF building it was noted that there was a significant amount of litter present on the ground surface on the south and west sides of the building (see photos 1-4). Litter from glass storage was also noted to be present outside of the glass containment walls. This had been noted during previous inspection events, but the litter appeared to be more widespread and prolific than was noted during previous inspection events. Another observation on the west side of the MRF was that the stormwater management channel (serving as the perimeter stormwater management channel for the Pit 5 area) was not in a well-maintained state. The channel did not appear to be able to convey stormwater as per its design (see photos 1, 5, and 6). The stormwater channel did not appear to be adequately maintained to prevent the ponding of water in this location (see photo 6).

Photo 6: Area west of MRF (note debris on ground and lack of drainage (this drainage is continuous from drainage channel shown in Photo 5))

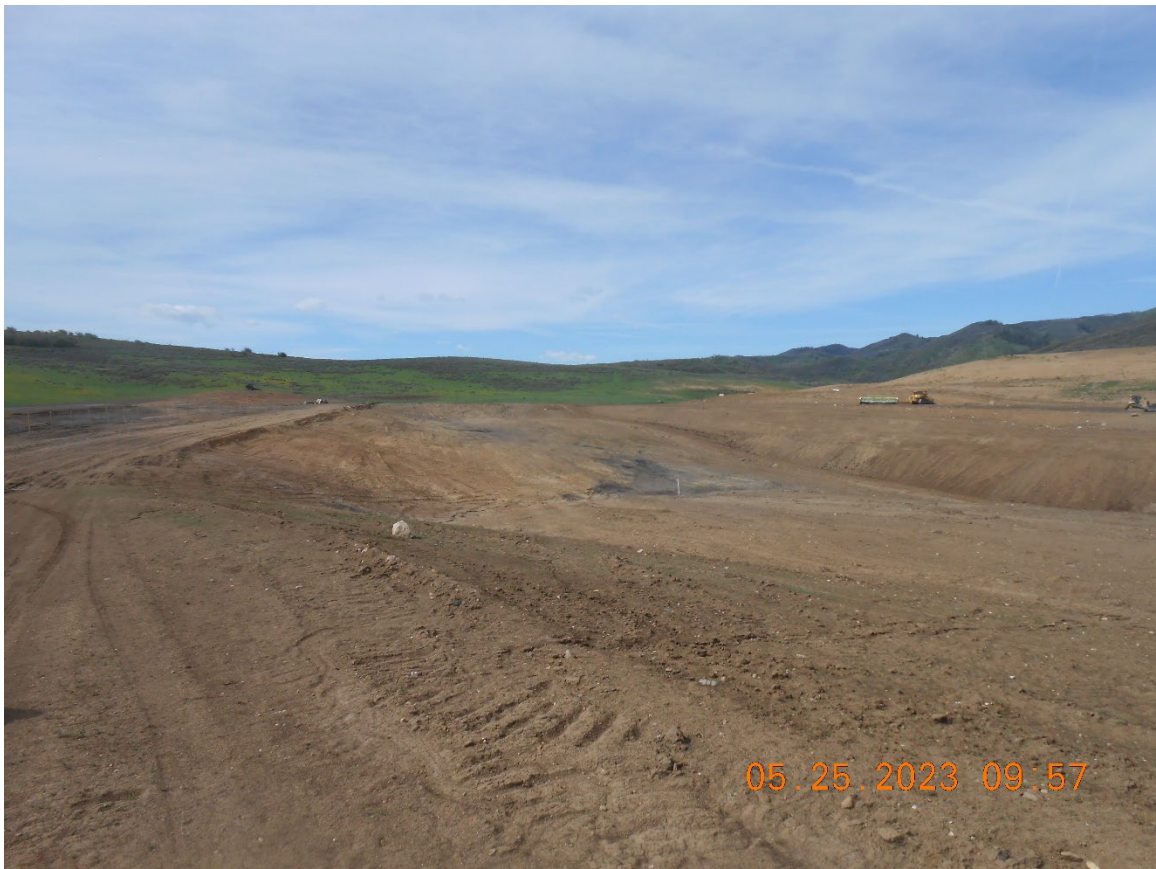
The group proceeded further south and observed areas where new perimeter fencing was being installed and the MOD 8 expansion area (see photo 7). Twin Enviro personnel said that the new perimeter fencing would help them patrol windblown litter better and keep any windblown litter within the landfill property. The inspection group continued to the south and observed the area where there had formerly been a cattle stock pond present on the adjacent property (Camiletti property). The stock pond had been relocated at some point prior to this inspection event. During previous inspection events groundwater seeping into the Module 8 (MOD 8) expansion area had been observed. There was still substantial water flowing into the MOD 8 area from the property to the east of the Facility (see photos 8-10). At the time of the inspection, it was not possible to determine if all of the water flowing into the Mod 8 area was due to previous snow melt, or if some of the water could be attributed to groundwater daylighting in this area. Twin Enviro installed several new piezometers in the area in 2022, and it is hoped that additional data from the new piezometers will further inform the source of water infiltrating the Mod 8 area. Another indicator that there was subsurface water present in this area was the presence of several depressions in the ground surface that appeared to have sunk (see photos 11-12). As the inspection group moved further to the south it was noted that there was not a berm present on the south end of the MOD 8 excavation area to prevent run-on of stormwater into this portion of the site (see photo 13). Additionally, the presence of uncovered solid waste was noted at the south end of the MOD 8 area and south of the fill area that was being utilized at the time of the inspection (see photos 13-15).

Photo 7: View of the MOD 8 excavation area

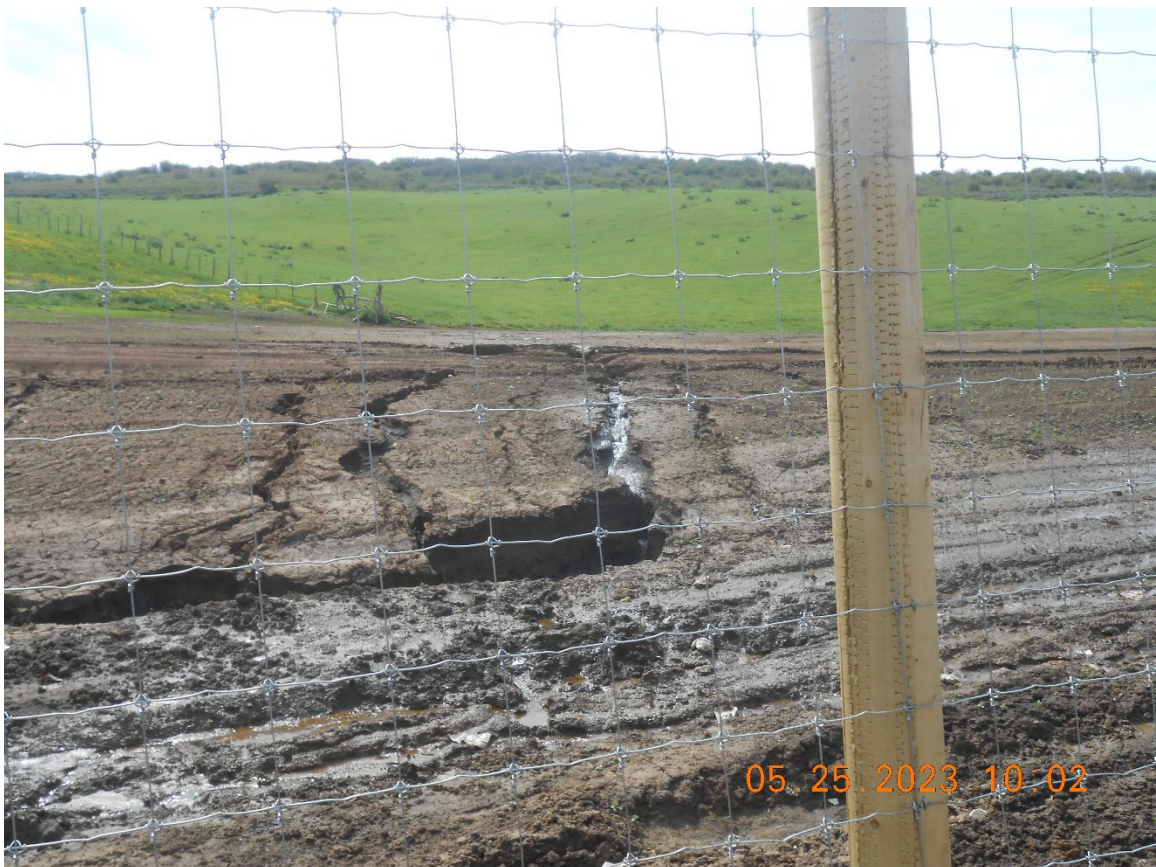
Photo 8: Water running from adjacent property to the east of Twin Enviro property

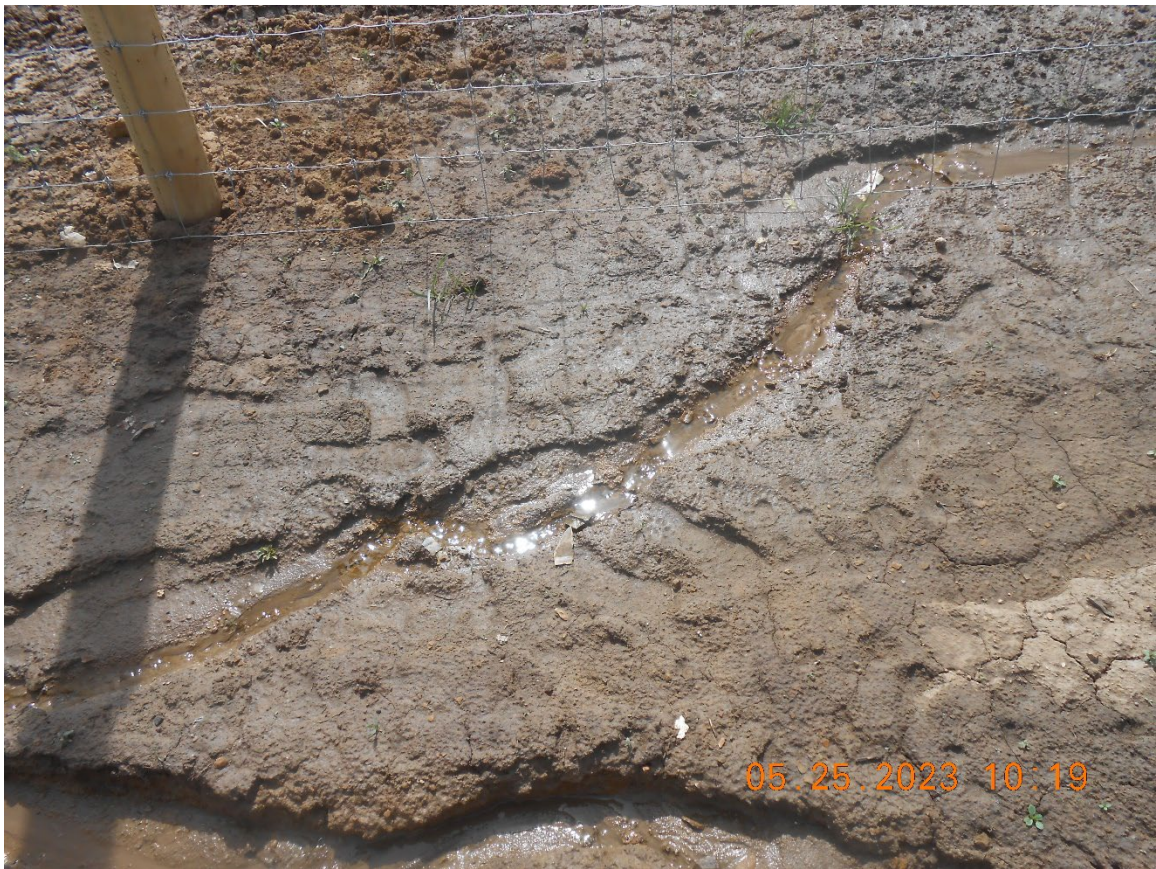
Photo 9: Closer view of water running onto Twin Enviro

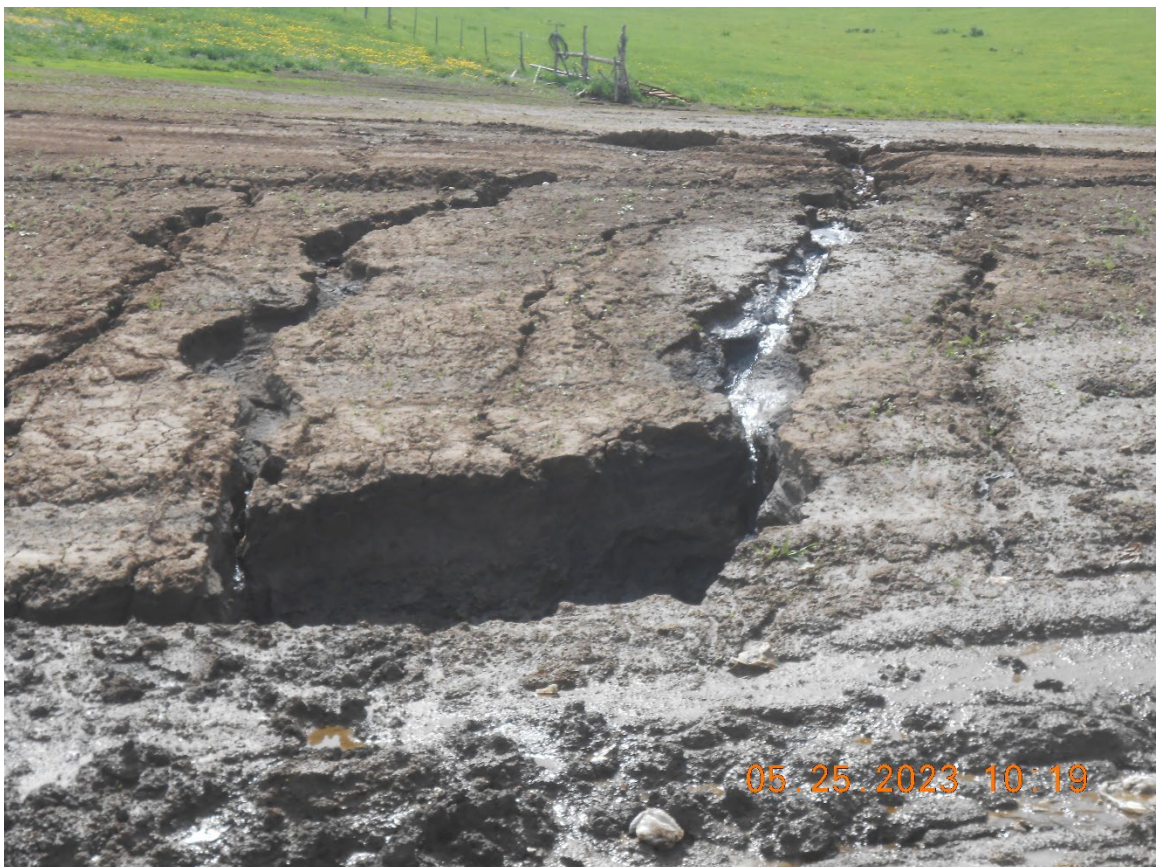
Photo 10: Run off from adjacent property to the east of Milner Landfill

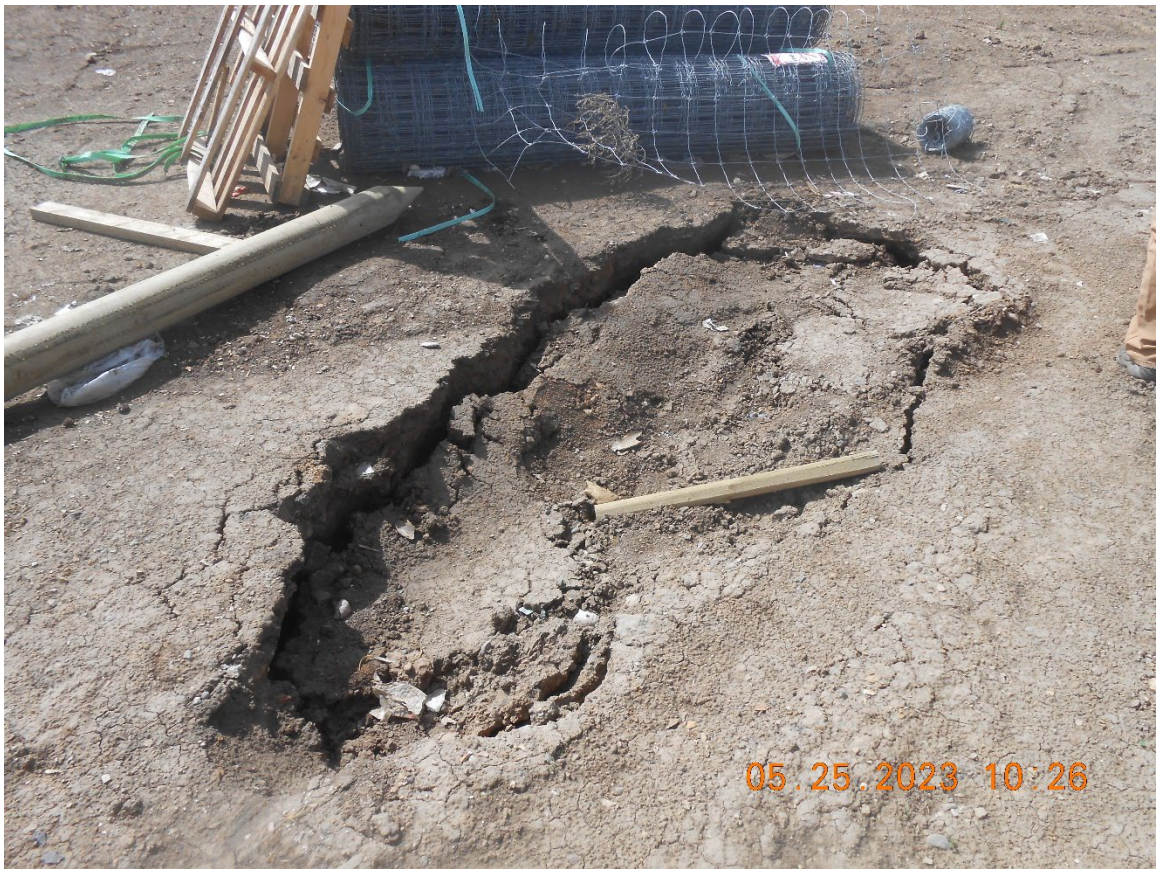
Photo 11: Sunken area attributed to saturated conditions

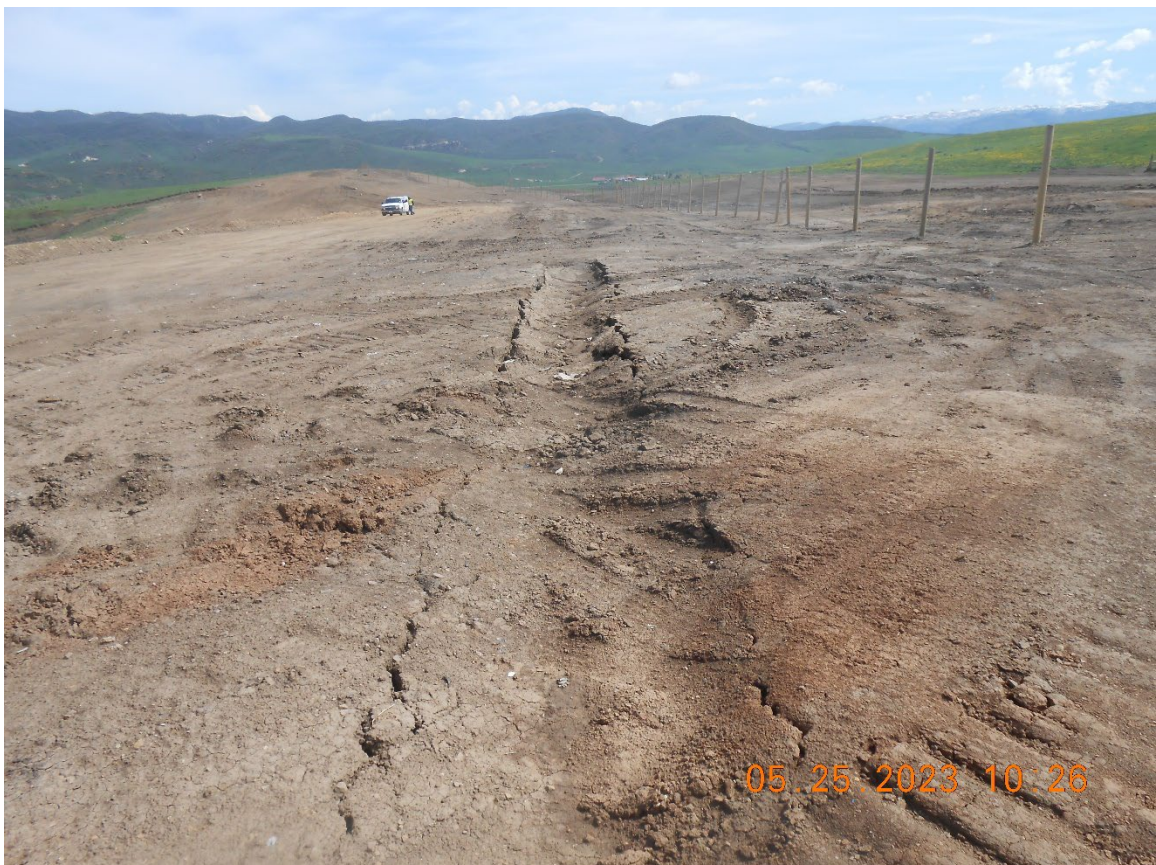
Photo 12: Collapsing ground surface presumably due to saturated conditions

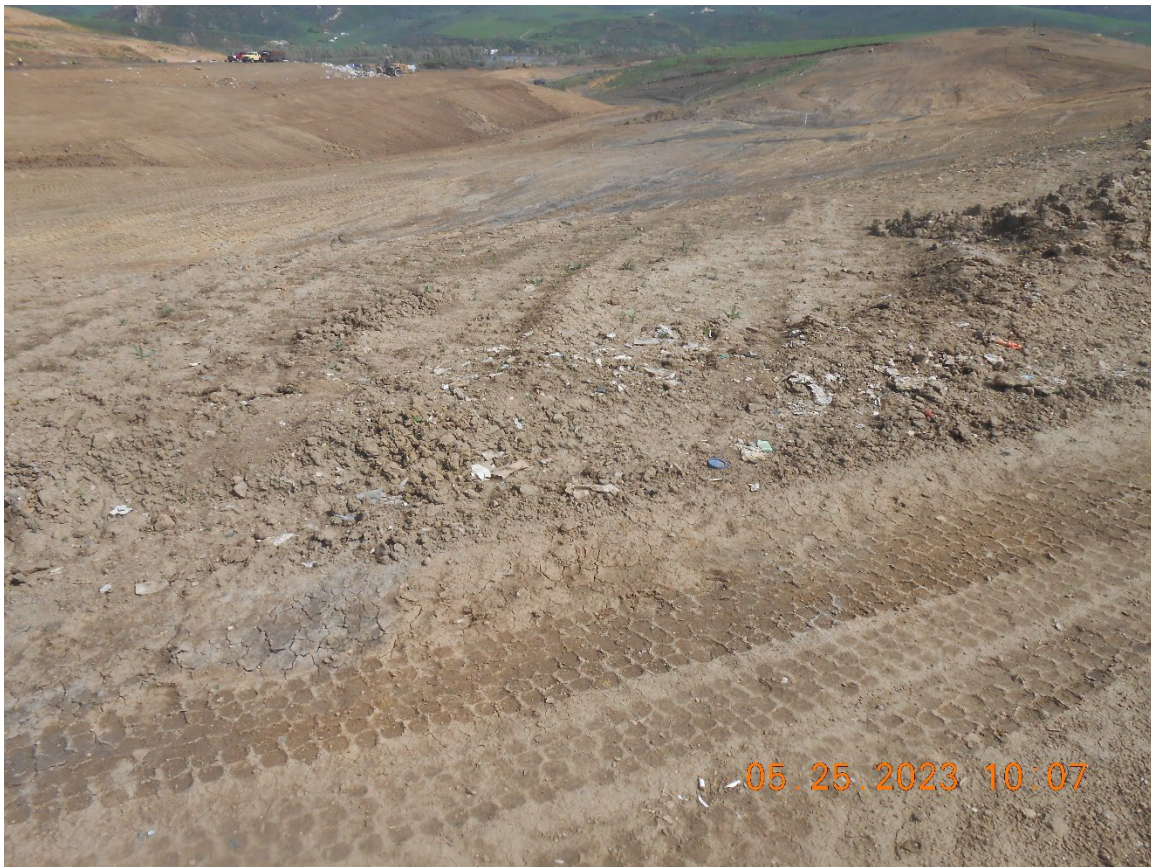
Photo 13: Area to the south of the MOD 8 excavation area (note no berm was present in this area to prevent run-on into the MOD 8 excavation area)

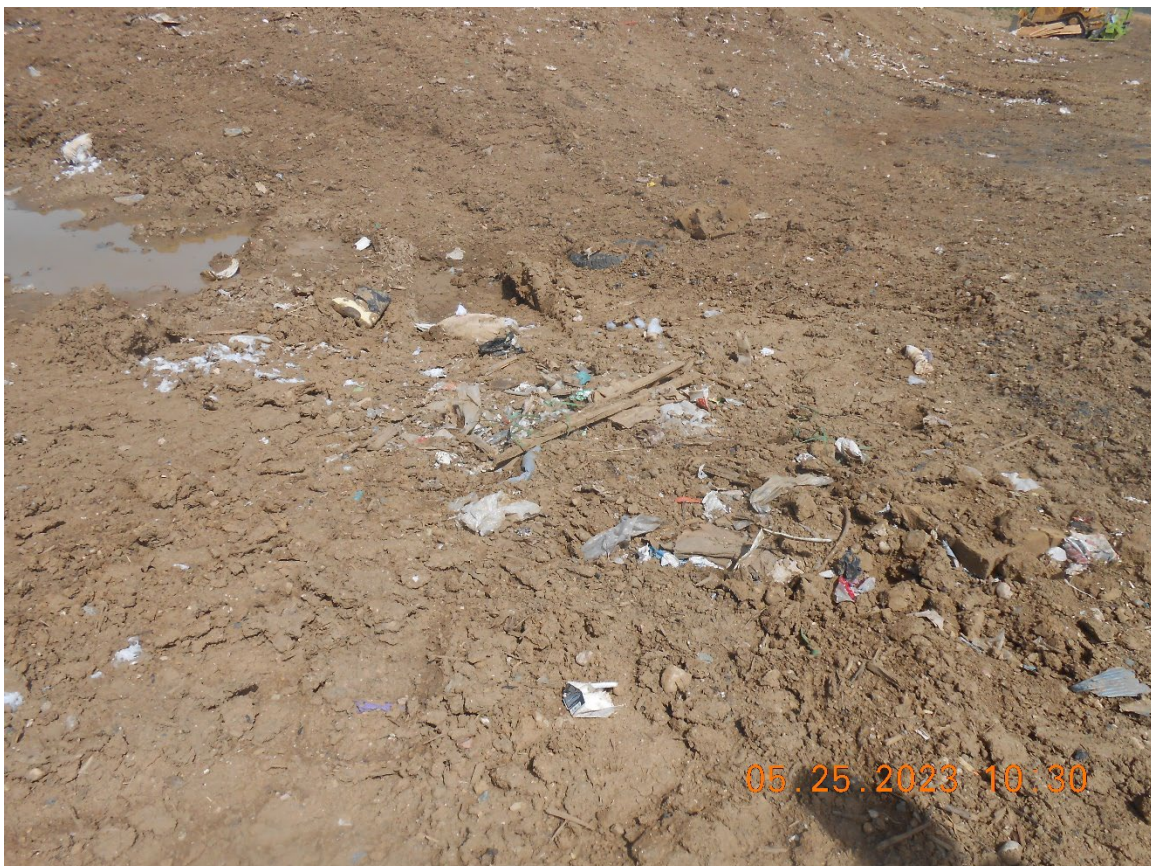
**Compliance Assistance Item 5:** Areas of exposed solid waste were noted to be present in various areas around the MOD 6 and 7 areas as well as on the top deck of the landfill. Additional cover should be added to any area where solid waste is visible at the ground surface. An appropriate amount of daily or interim cover should be placed over any waste materials to prevent this occurrence in the future.

Photo 14: Visible solid waste with insufficient cover south of the working face area

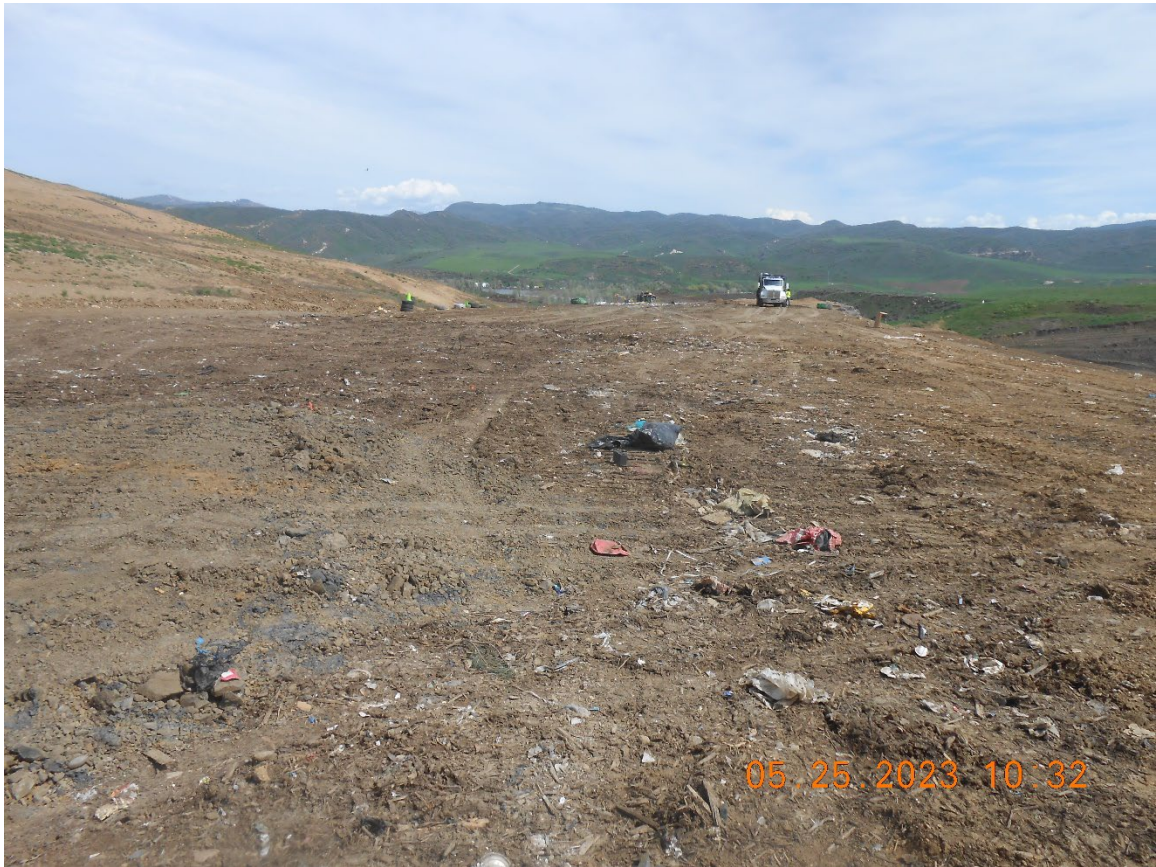
Photo 15: Insufficient cover noted south of the working face area

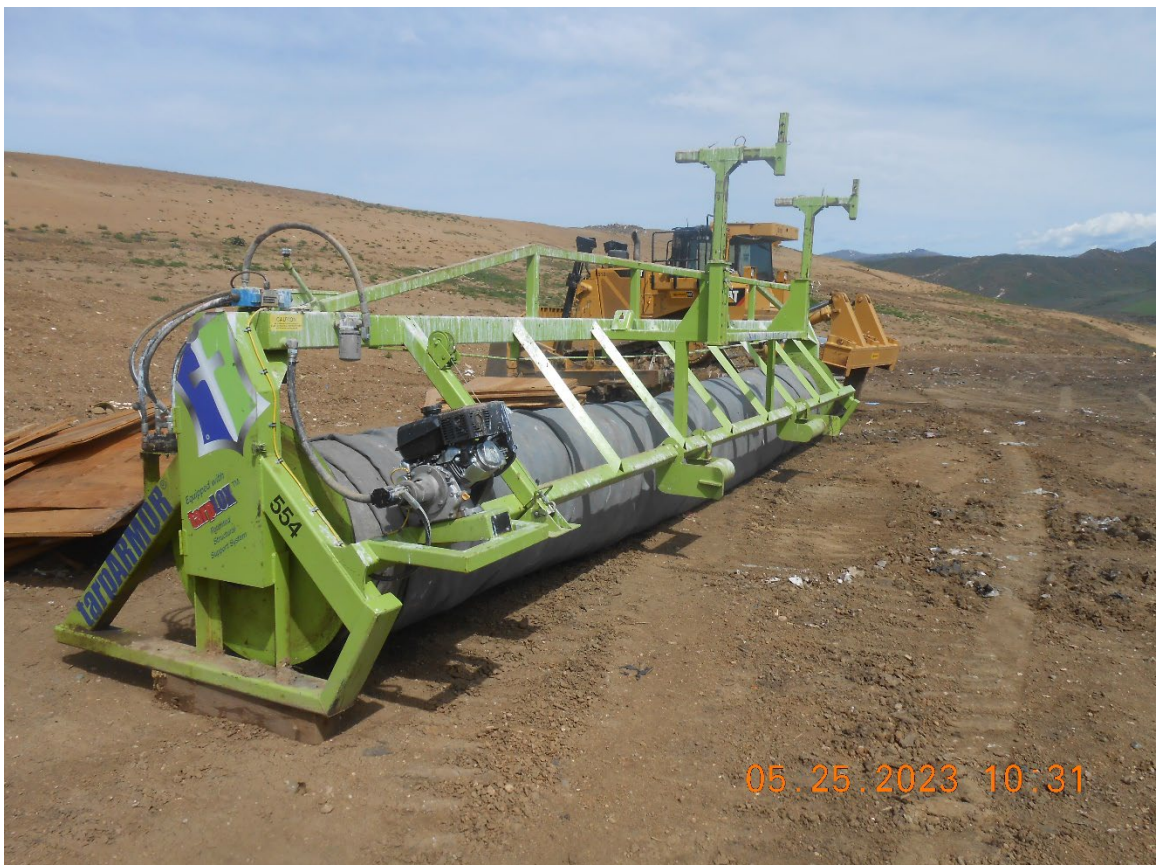
The inspection group then proceeded to the working face of the landfill. Just to the south of the working face, the inspection group stopped to observe the tarp system that Milner Landfill has been using as alternative daily cover (see photo 16). The tarp appeared to be in good condition, and Twin Enviro personnel said it has made the application of daily cover much easier. The working face of the landfill was observed, and no prohibited waste streams were observed by Department inspectors (see photos 17-18). The working face appeared to be adequately sized to the expected amount of waste volume accepted by Milner Landfill in a given day. The area of the working face also gave another opportunity to observe the MOD 8 excavation area, and again it was noted that there was a significant drainage channel present through this area (see photo 19). The top deck of the intermediately closed portions of MODs 4 and 5 was accessed. Department inspectors noted that there was some visible solid waste protruding through the soil cover in this area and requested that additional soil cover be applied to any areas where solid waste was visible.

Photo 16: Tarp system used for alternative daily cover at the working face of the landfill

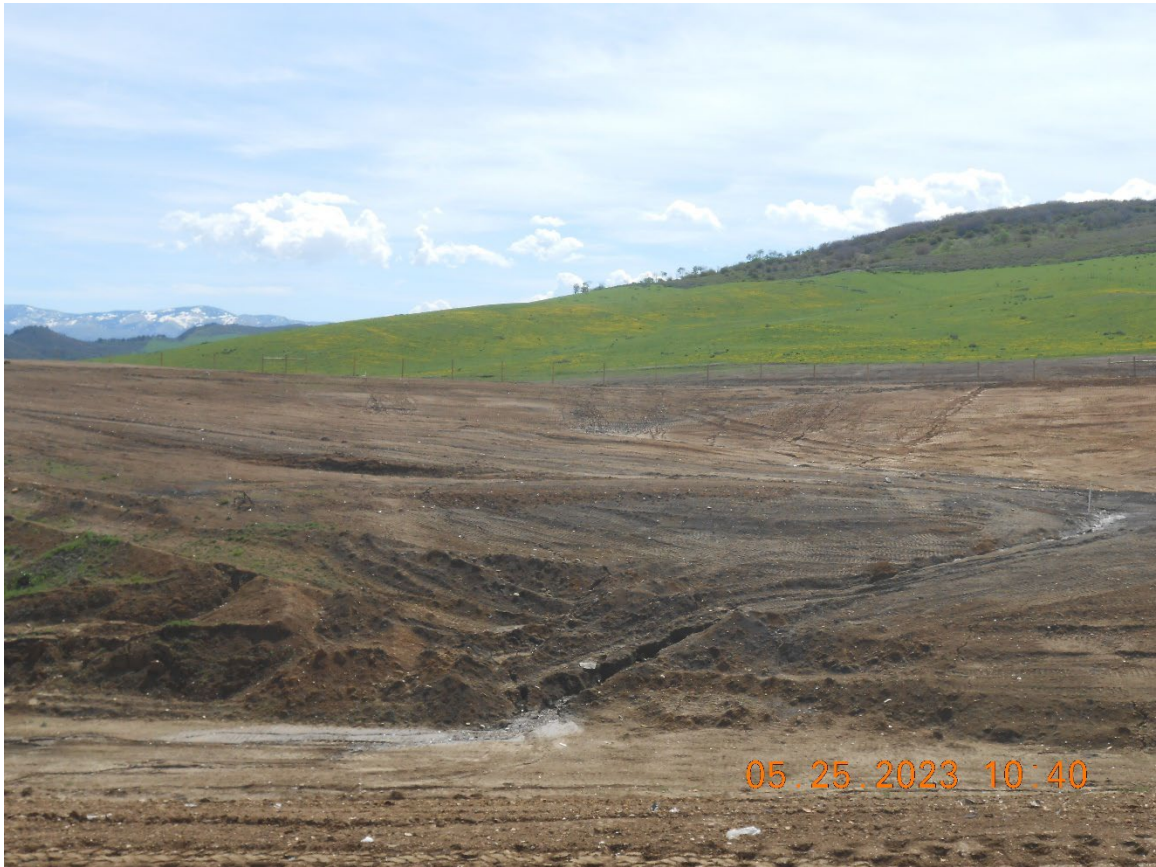
Photo 19: Excavation area for Module (MOD) 8 expansion area (note channel dug to convey runoff from area above and seepage area)

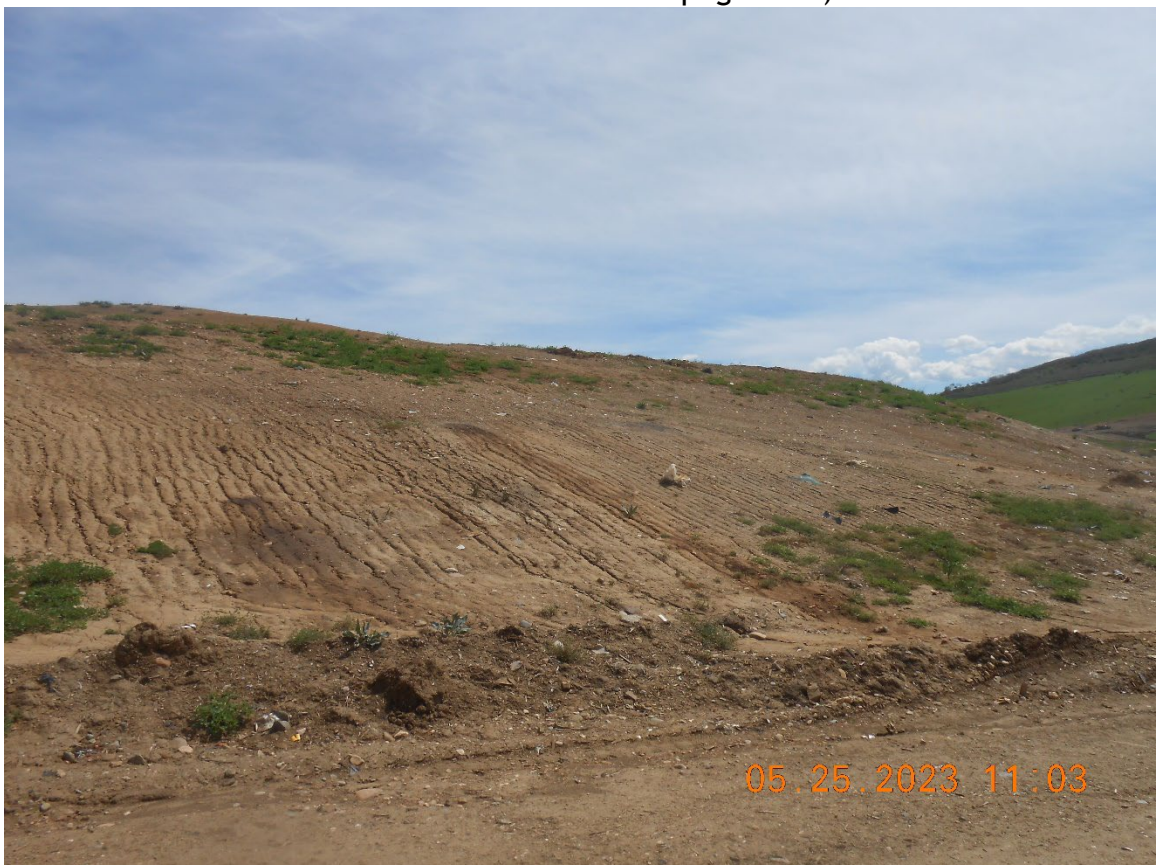
The inspection tour then proceeded back to the south and around the intermediately closed MOD 5 area. The outer slopes of the intermediately closed portions of the landfill along the western side of the Facility were observed as the group made their way north along the western perimeter haul road. A few seeps were noted to be present on this western facing slope at the time of the inspection (see photos 20-22). The inspection group passed an area where storage of shredded tires was located along the western edge of the Facility. Department inspectors had observed this storage during the last couple of inspection events and remarked that Twin Enviro should take care that these stored tire shreds do not migrate down the slope in this area. Twin Enviro personnel were again reminded that these tire shreds should be managed in such a way to prevent them from further spreading down the western slope of the Facility.

Photo 20: Western slope of landfill (note dark areas indicating seeps)

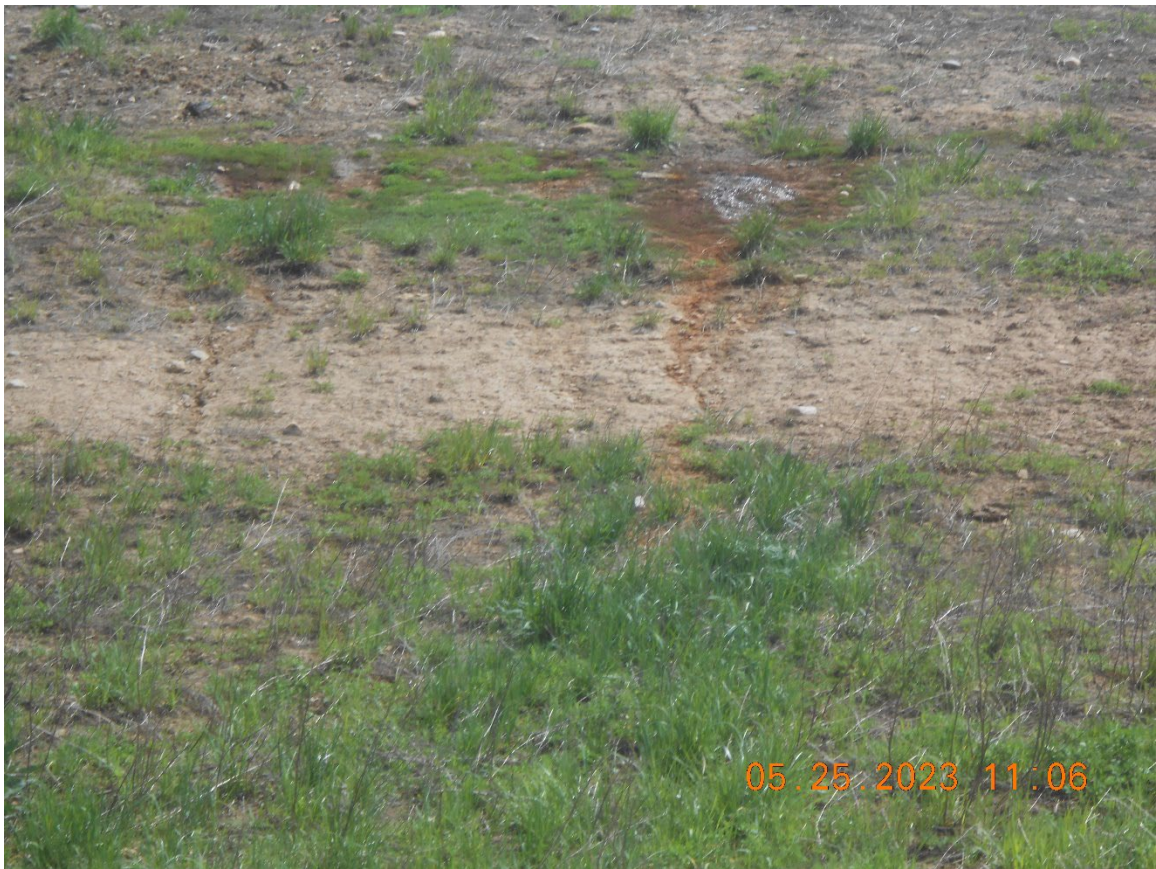
Photo 21: Small seep on side slope of landfill (western slope)

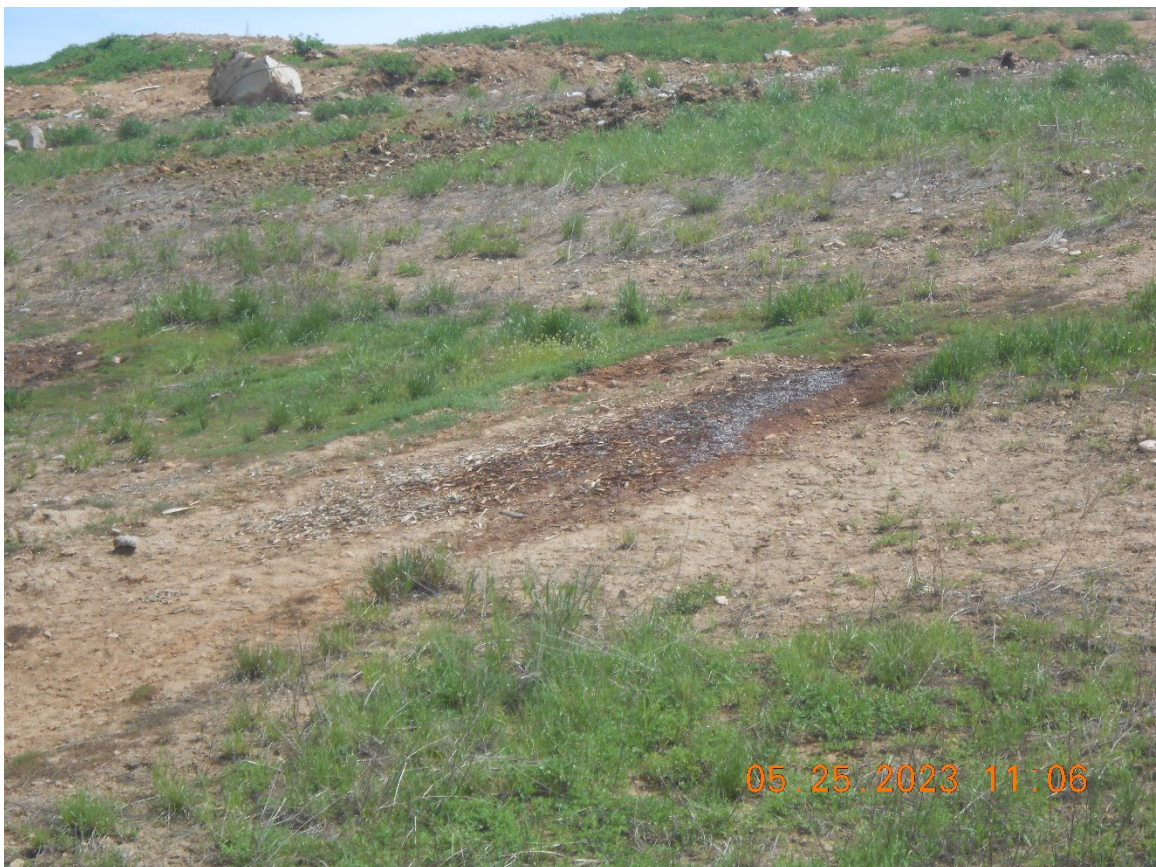
Photo 22: Seep on side slope of landfill (western slope)
