Re: **Compliance Advisory for the Milner Landfill:**  
20650 County Road 205  
Steamboat Springs, CO 80487

A Copy of the inspection report is enclosed with this Compliance Advisory.

# Attachment 1 - Photo Log

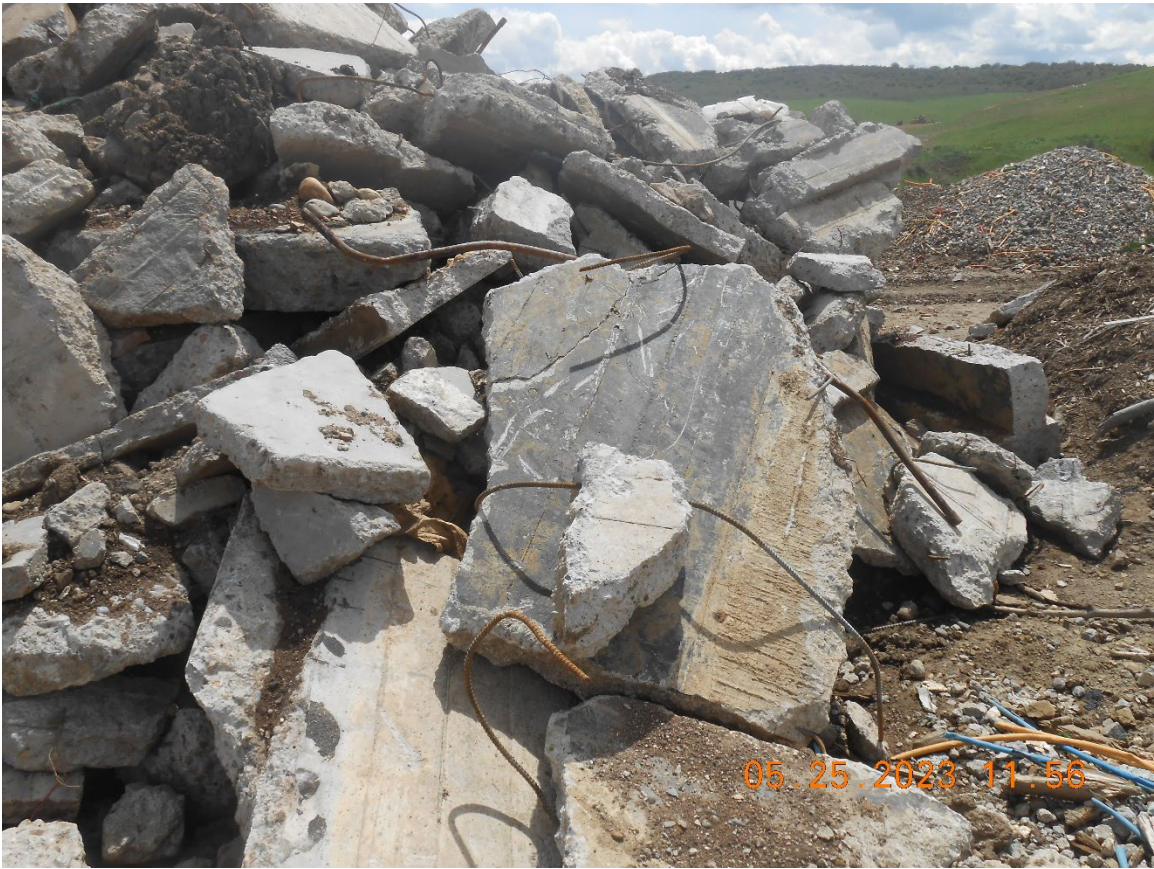
The inspection group stopped to view a concrete storage area that was located south of the shop and liquids transfer area of the Facility. Department inspector Long noted the presence of black sealant on several of the pieces of concrete being stored in this location awaiting recycling (see photos 23-24). Department Inspector Long urged caution with this material as it is a material that is suspected of containing asbestos. Department personnel informed Twin Enviro personnel that the concrete with adhered sealant (or other materials suspected of containing asbestos) should not be recycled because of the potential for these materials to create inhalation hazards. The suspect asbestos containing materials must either be assumed to be asbestos containing or sampled to confirm if the materials contain asbestos. Additionally observed in this area was the liquid waste transfer area of the Facility. No visual evidence of large spills was noted during the inspection event.

Photo 23: Concrete staged for recycling (note presence of sealant on concrete)

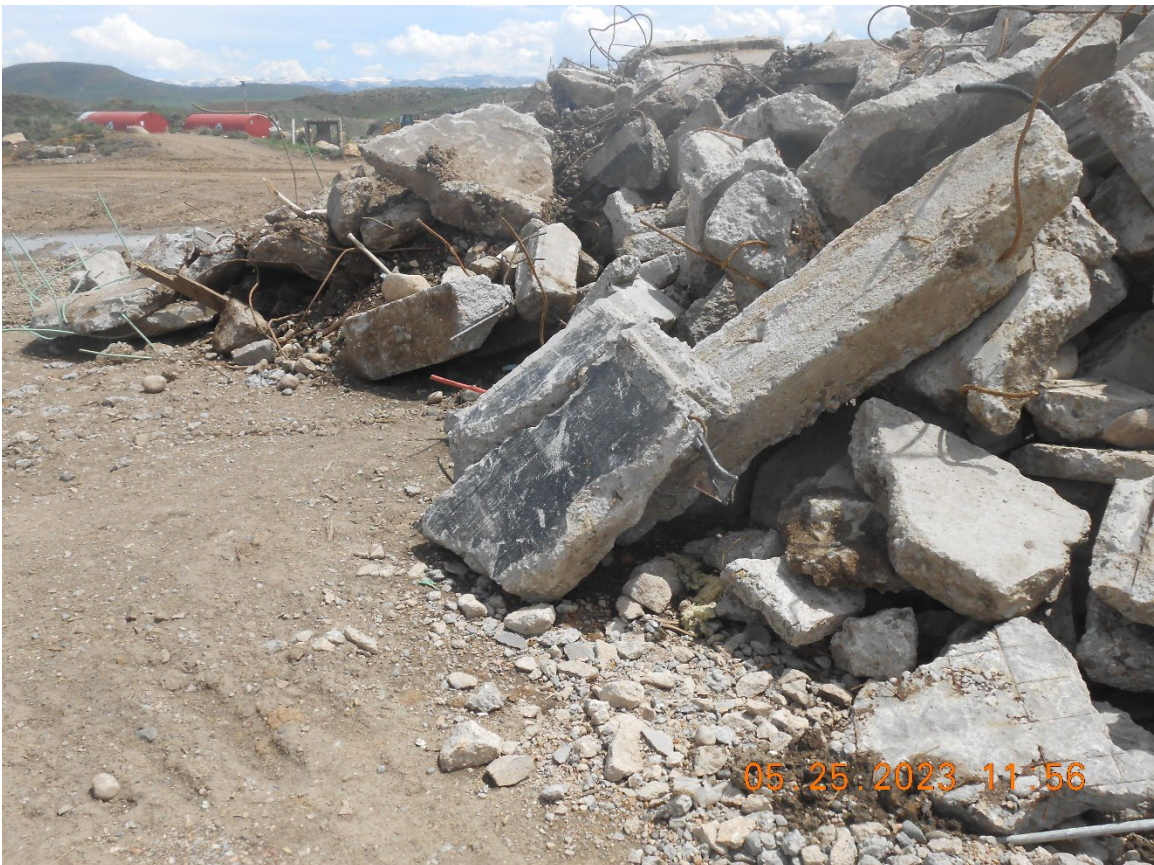
**Compliance Assistance Item 9:** An area of concrete storage was also observed, and was noted during Routt County's August 2022 inspection, near the wood waste storage area (see photo 24). It is fine for the Facility to process concrete for recycling, but care should be taken to ensure only "clean" concrete is accepted for recycling. Materials adhered to concrete (sealants, tars, caulking, adhesives, paints, flashing, flooring materials, etc.) may contain asbestos and would therefore require inspection by a Colorado Certified Asbestos Building Inspector prior to acceptance at the Facility. During the 2023 inspection, concrete with adhered sealant was noted to be present in the piles staged for recycling. Any material suspected to contain asbestos must either be assumed to contain asbestos and managed accordingly, or sampled to determine asbestos content. **Concrete with adhered materials that have not been sampled to determine asbestos content should not be recycled.**

Photo 24: Additional concrete staged for recycling (note sealant present)

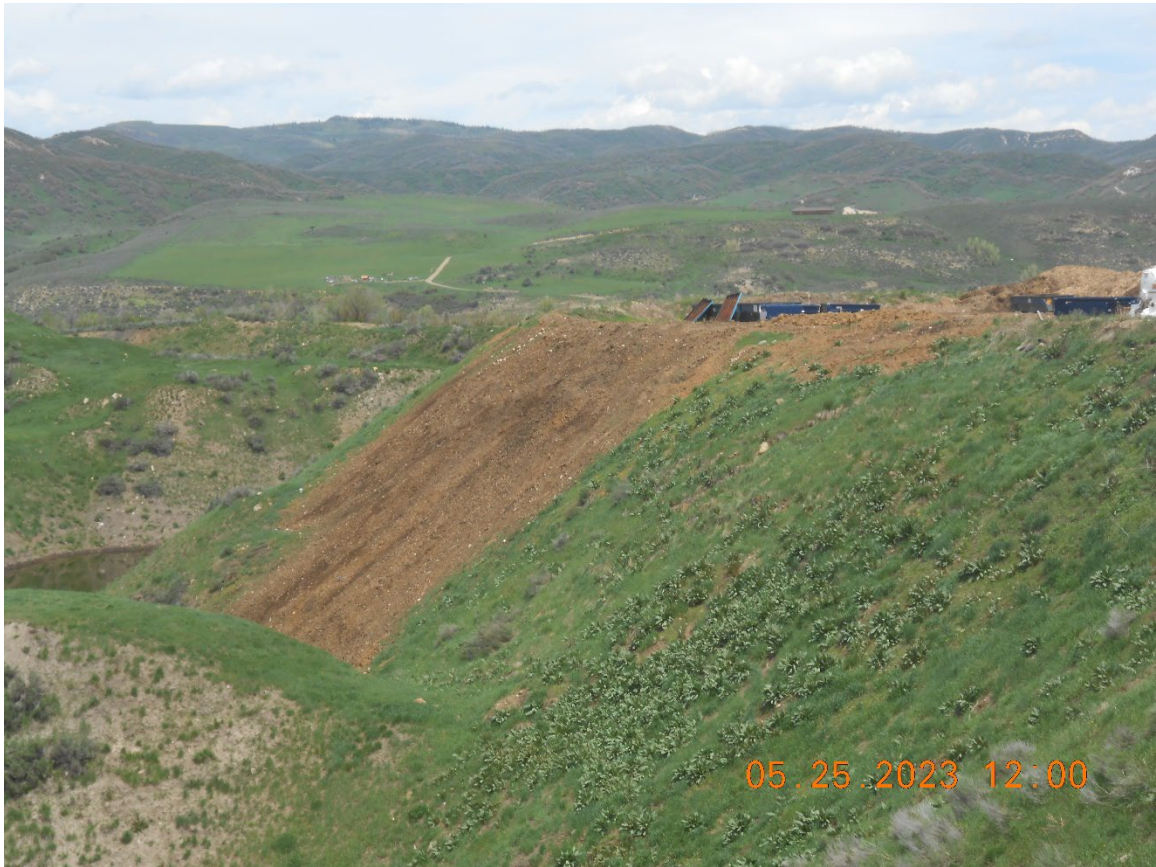
**Deficiency 2:** There was a substantial amount of material (mixed compost, feedstock, and woodchips) pushed over the perimeter berm on the south, west and east sides of the composting area, in apparent violation of Section 1.3.2 "Run-on/Runoff Control" of the Facility's Composting Design and Operations Plan (Appendix H to the Facility's EDOP), Section 14.4.3(B) of the Solid Waste Regulations, and CRS § 30-20-110.

Photo 25: View of western slope at western side of compost pad (note material has been pushed down the slope)

**Requested Action 2:** The Department requests that Twin take immediate action to stop material from being pushed over the berms surrounding the composting area of the Facility. Additionally, within thirty (30) days of your receipt of this Compliance Advisory, the Department requests that Twin clean up any material that has previously been pushed out of the compost area (especially around the south, west, and east sides of the composting area) and either return this material to the composting pad for appropriate processing as compost, or to the working face of the landfill for disposal. The Department also requests that Twin provide a short “letter report”, including photographs, documenting that the areas surrounding the composting area have been cleaned up.

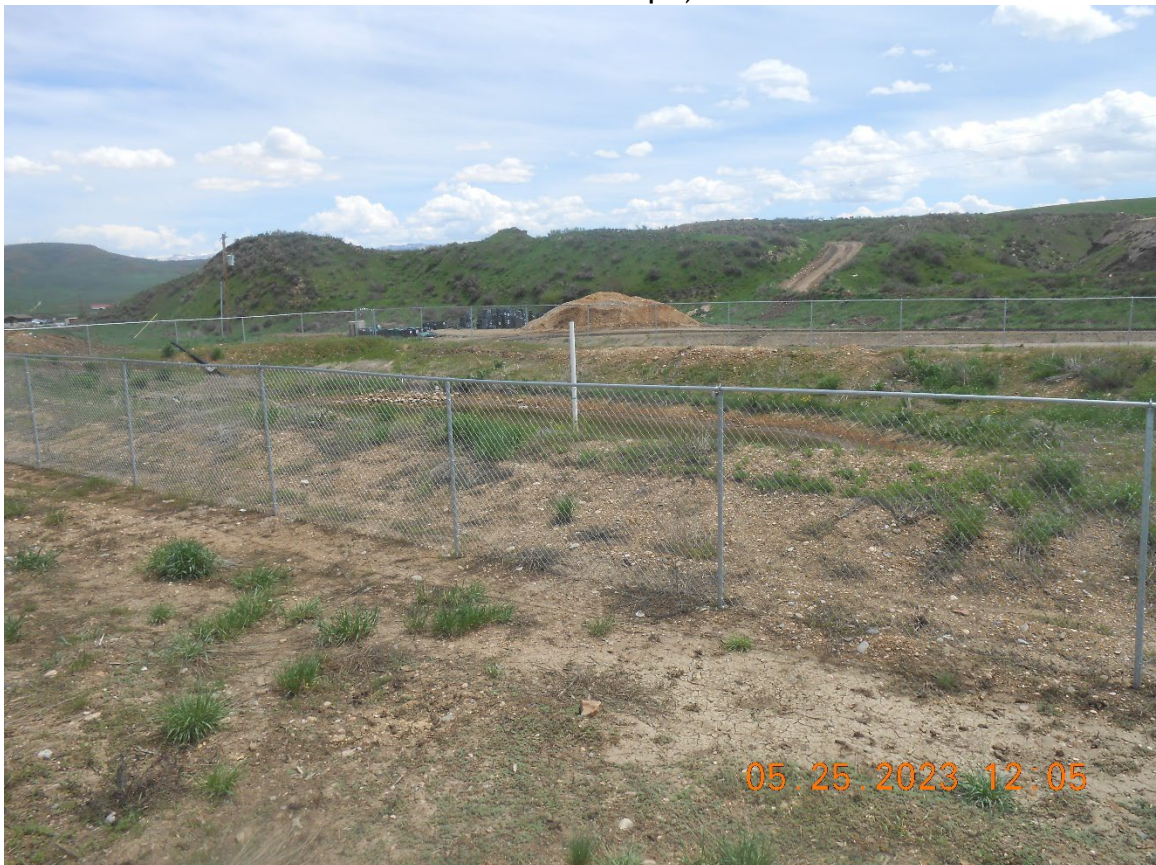
Photo 26: Fenced leachate pond

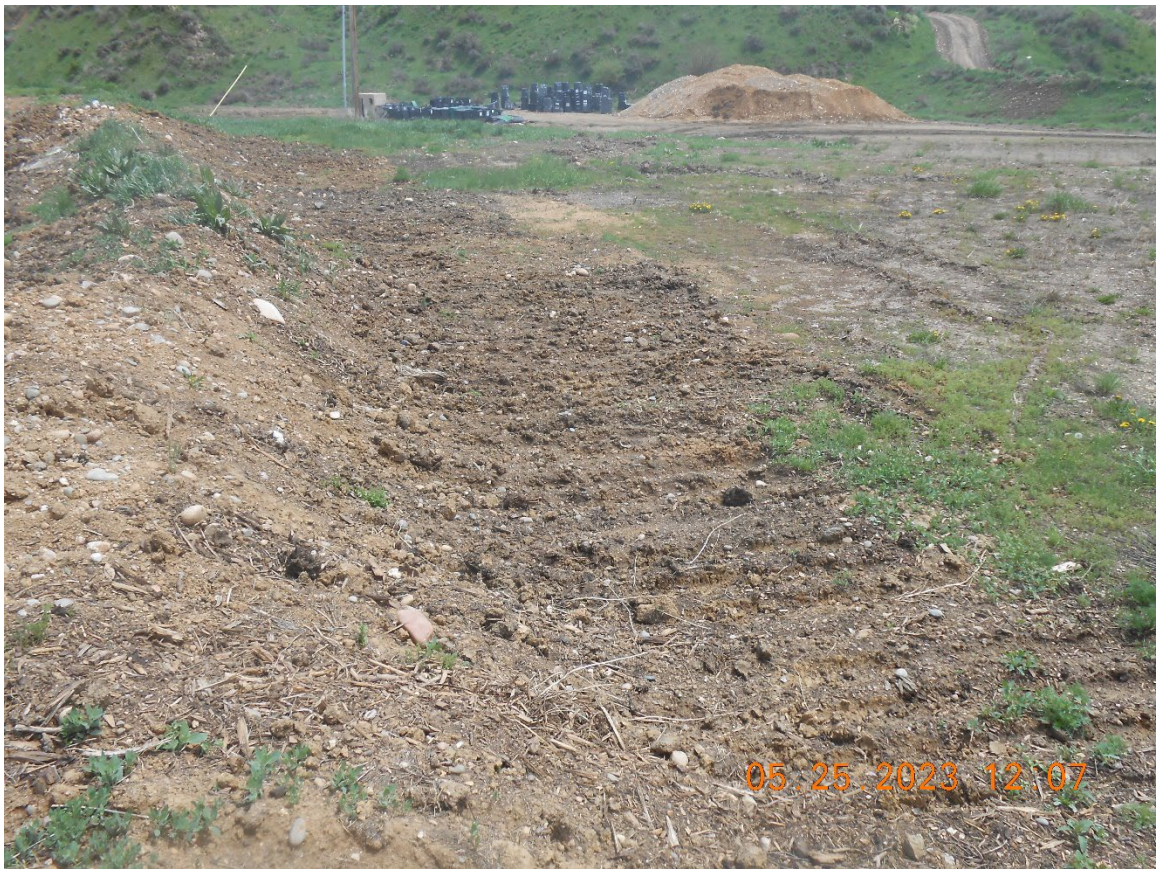
Photo 27: Berm along southern edge of compost pad (note material has been pushed over the berm to the south)

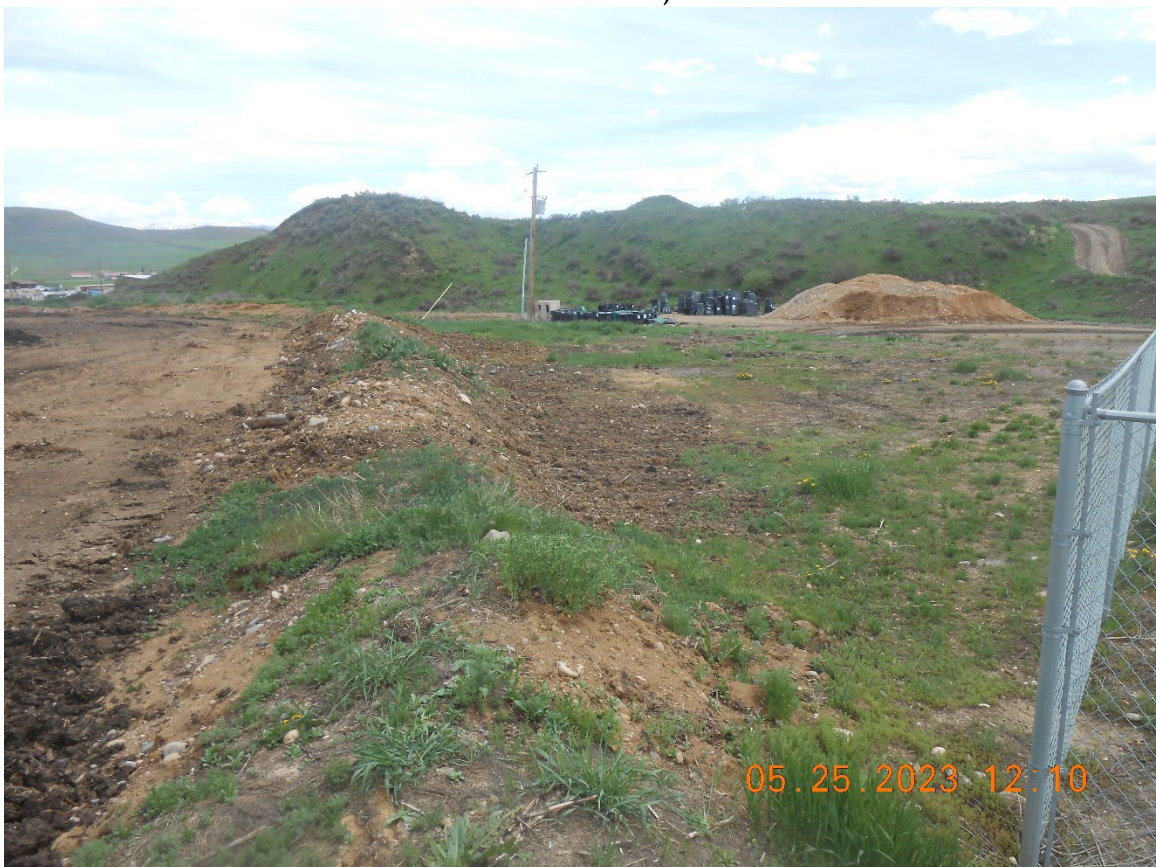
Photo 28: View looking east / northeast showing material pushed from compost pad over southern berm

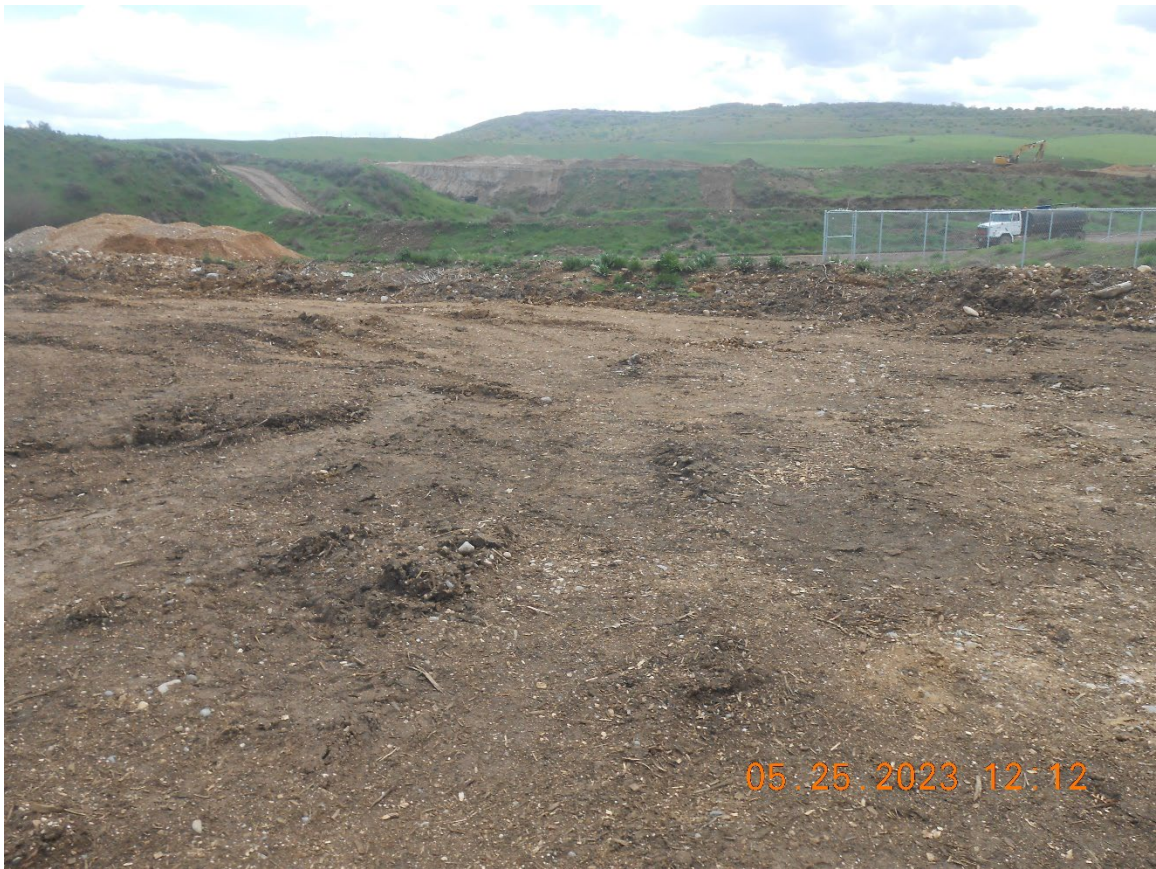
by Les Liman and Mark Berkley, and that no one else was privy to the operations at this part of the Facility. The composting work pad was also observed and was noted to have several low spots and did not appear to be contoured to drain to the composting leachate collection pond located just to the north of the composting work pad as required in the Facility's EDOP (see photo 29). Twin Enviro personnel remarked that this was likely due to the heavy snow and associated snow removal operations that the Facility dealt with during the winter season. As a component of snow removal operations, Twin Enviro personnel had used machinery to push snow over the edge of the composting area on several sides (see photos 25, 27-28, and 35-37). This material was noted to be a mixture of dirt, snowmelt, compost, wood chips, and feedstock. This was most concerning in locations where the material had been scraped and pushed over the berms adjacent to the compost work pad due to there being unfinished compost and unprocessed feedstocks staged in these locations (including biosolids). Department personnel notified Twin Enviro personnel that the material pushed out of the composting area was problematic because of the materials located here and because the materials in question are required to remain on the compost pad until the composting process is finished and holding times and temperatures have been met (as well as any applicable analytical testing requirements). Twin Enviro personnel Greg Underwood and Tony Matt said they did not know why the materials in question had been pushed out of the composting area. Department personnel reiterated that snowmelt must be managed in such a way as to prevent the migration of unfinished compost or feedstocks off of the compost pad and to keep the pad graded to drain to the compost leachate pond.

Photo 29: Compost work pad (note grading does not slope north to compost leachate collection pond)

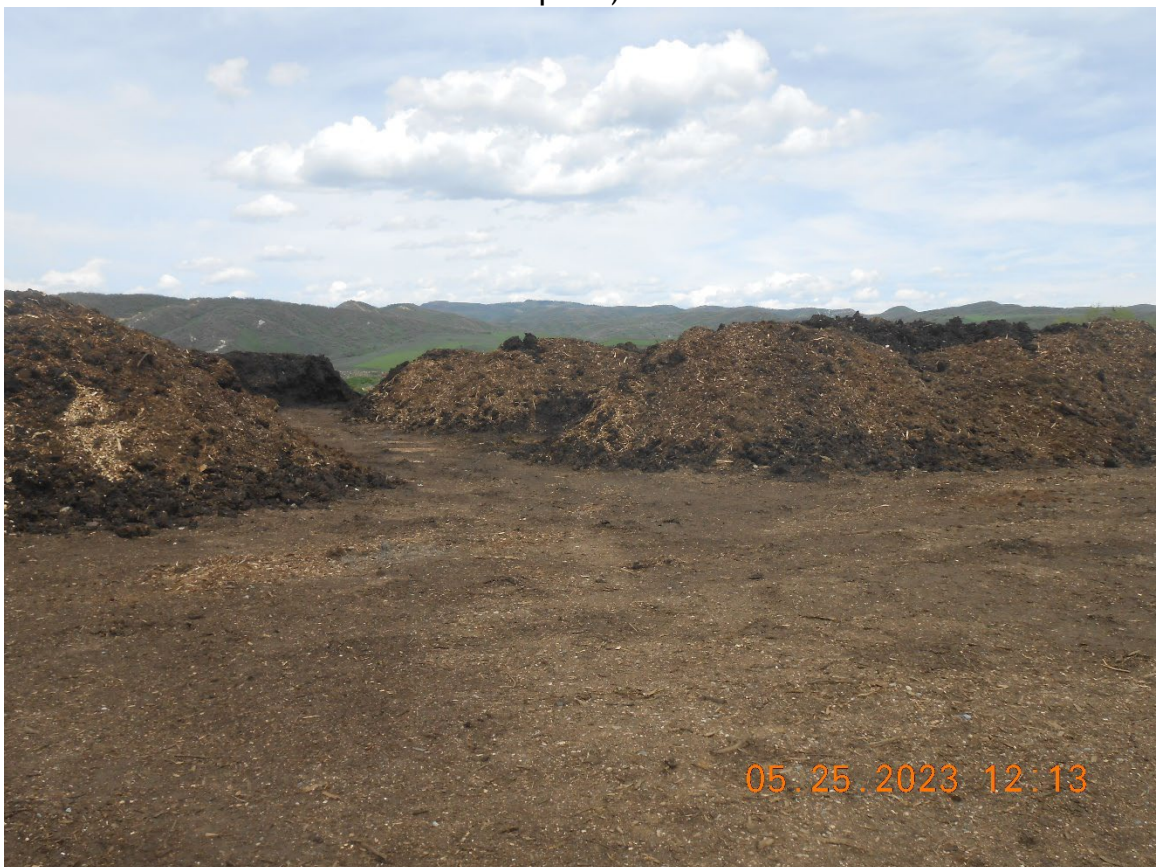
The group then headed to the compost work pad. There were several piles/windrows of in-process compost and feedstocks (biosolids) present at the time of the inspection (see photos 30-32). It was interesting to see that one of the in-process compost windrows appeared to be set up to use the Facility's aeration system as this had not been seen during the last several inspection events. It did not appear as though the blowers were hooked up at the time of the inspection, but they were in place under one of the compost windrows. It was again noted that material from the compost pad appeared to have been pushed over the berm on the south side of the pad (see photos 27-28). Department personnel remarked that it was very important to keep all unfinished compost and composting feedstocks (especially biosolids) on the composting work pad. Twin Enviro personnel that were participating in the inspection indicated that they had little information on how the composting operation was being run as all operations related to composting were being managed

Photo 30: In-process compost on compost work pad

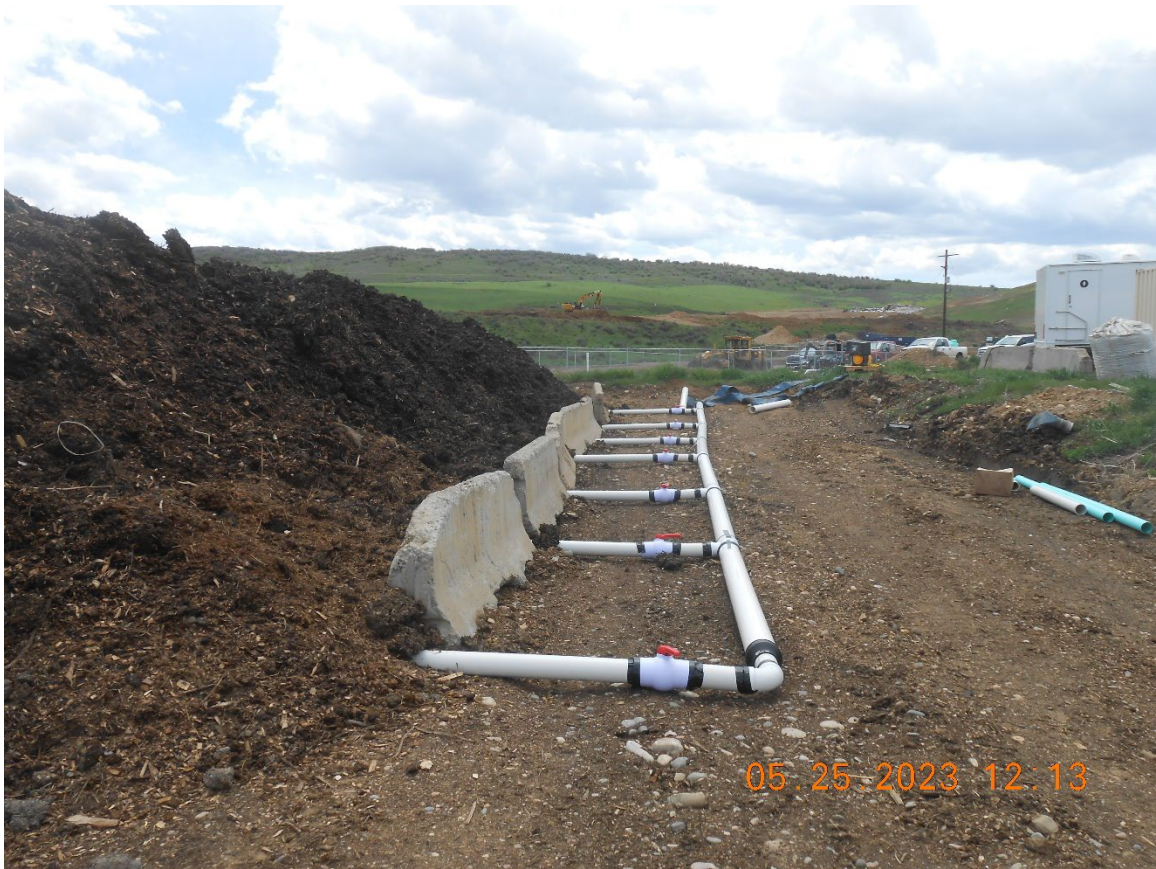
Photo 31: Aeration system along western side of compost work pad (blowers did not appear to be connected at time of inspection)

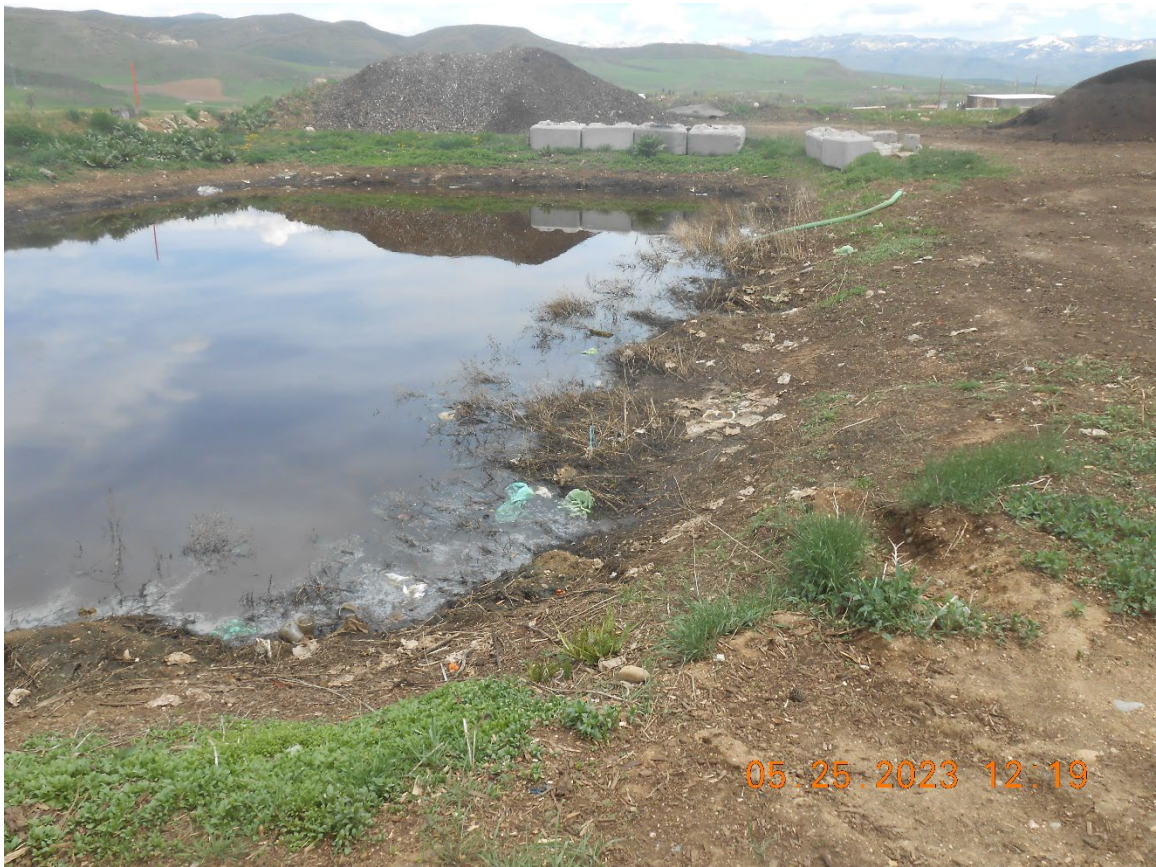
The composting leachate collection pond was observed and was noted to have a minor amount of windblown litter present (see photo 33). Additionally, the pond appeared to be fuller than has been noted during previous inspection events. When asked by Department staff, Twin Enviro personnel did not know when the last time that the composting leachate collection pond had been dewatered. Department staff also inquired as to how Twin Enviro personnel measured the remaining freeboard in the compost leachate collection pond, and was told that a stick was used and that the measurements were more of a guestimate than an exact measurement. Department staff reminded Twin Enviro personnel that the amount of freeboard required to be maintained in the pond by the Facility's EDOP (two feet) should be maintained at all times, and that the pond should be de-watered within 30 days of a storm event.

Photo 33: Compost leachate collection pond

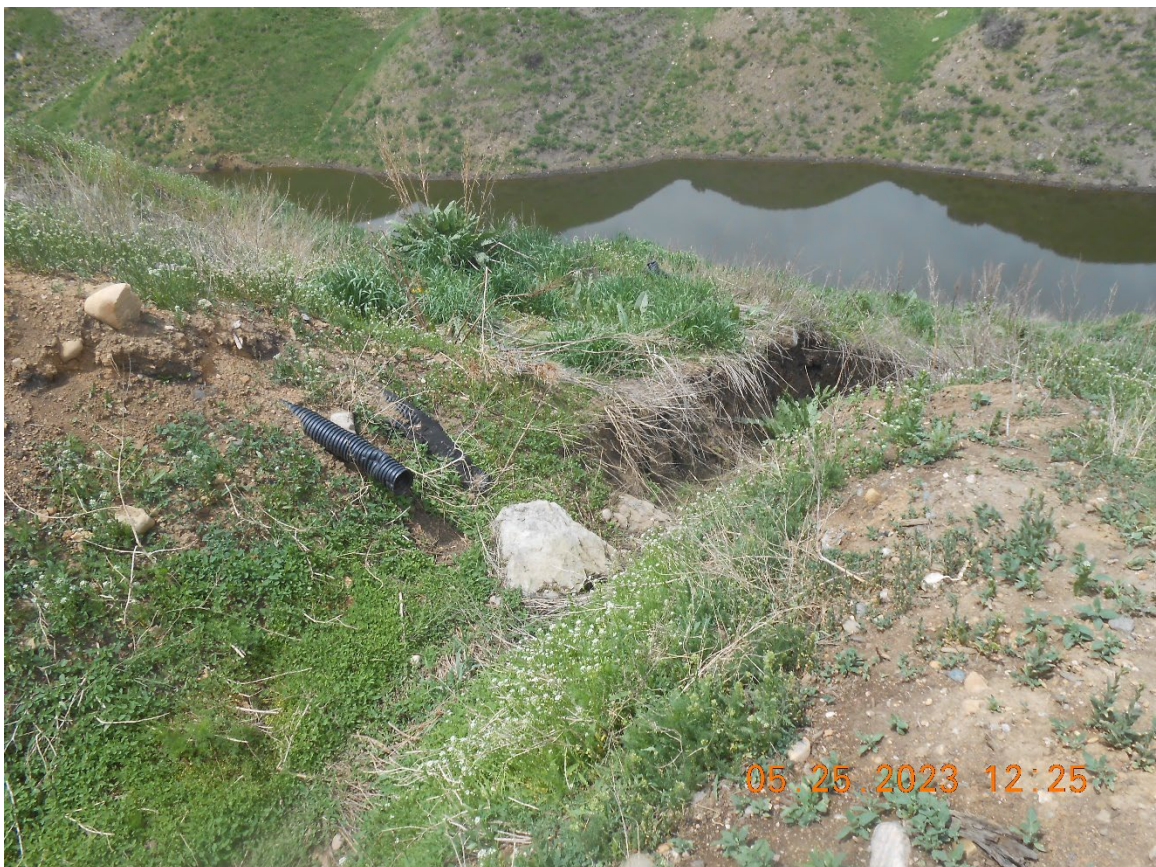
Department personnel noted the presence of a significant breach in the perimeter berm around the northwest section of the composting area (near northwest corner) (see photo 34). It appeared as though Twin Enviro has been utilizing this breach of the berm to allow snowmelt and stormwater runoff to exit the compost area in this location and run down the hill into the surface water feature below. The presence of this feature has been noted during previous inspection events. It is unclear as to why this crack in the berm at this location has not been remedied, but the presence of irrigation piping terminating at the crack location points to this being utilized as a makeshift stormwater discharge point. It is important that Twin Enviro either makes repairs to this damaged portion of the berm, or updates the Facility's Stormwater Management Plan to reflect current conditions at the site.

Photo 34: Drainage channel at northwest corner of compost area

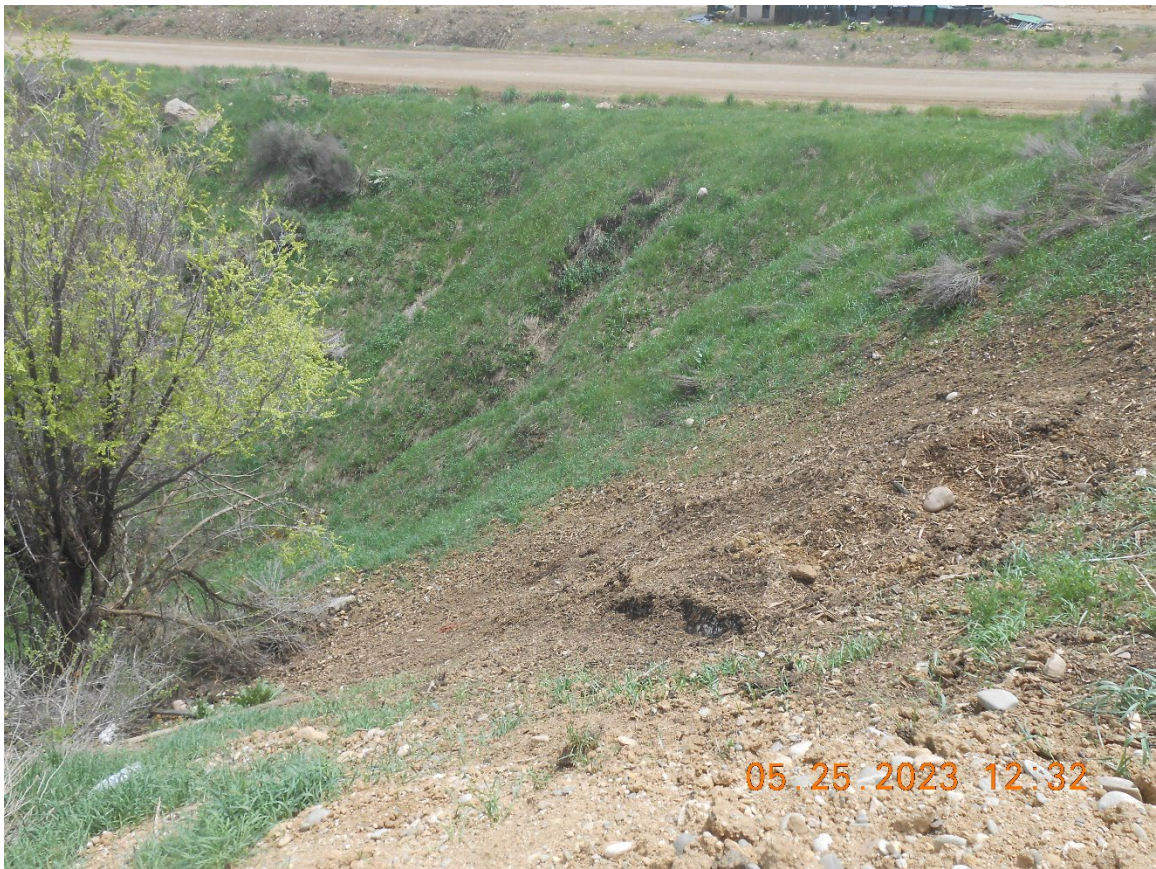
Photo 35: View looking east / northeast showing compost material had been pushed down the slope on eastern side of compost area

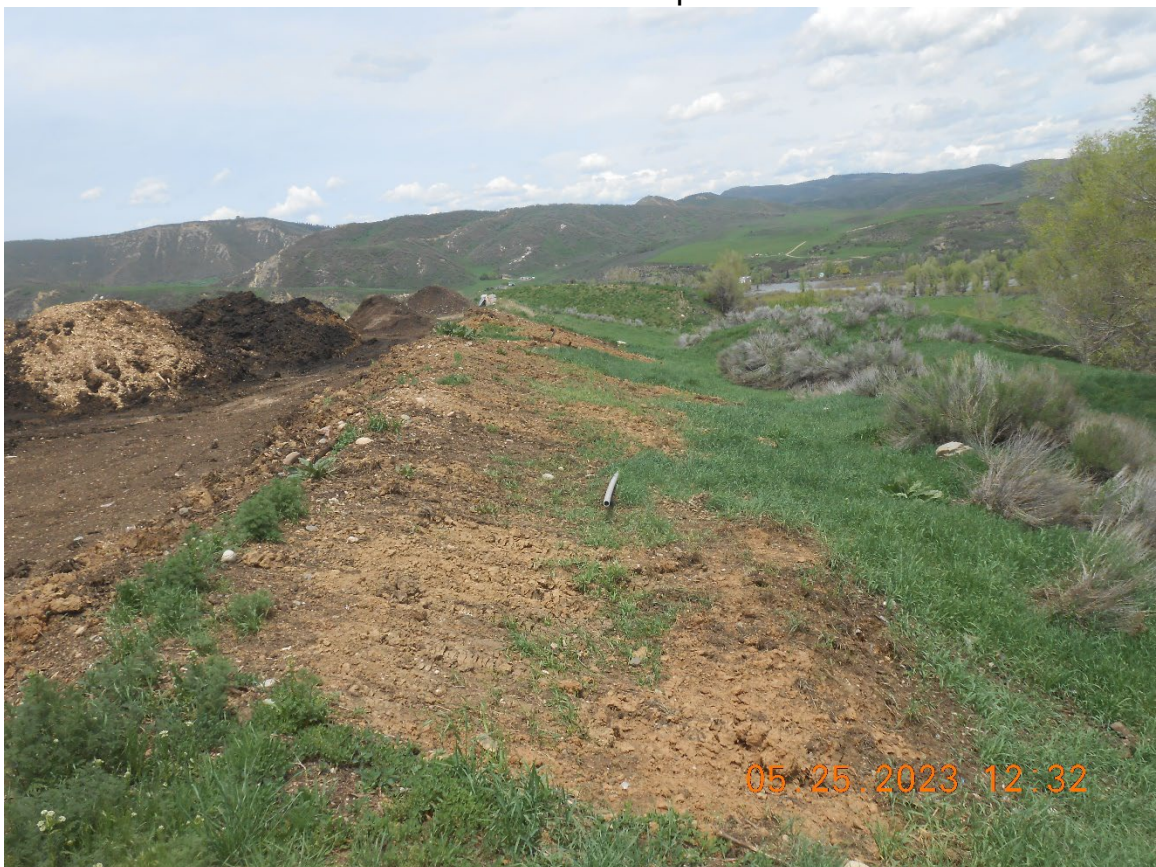
Photo 36: Additional view of material that was pushed off compost work pad onto slope on east side of compost area

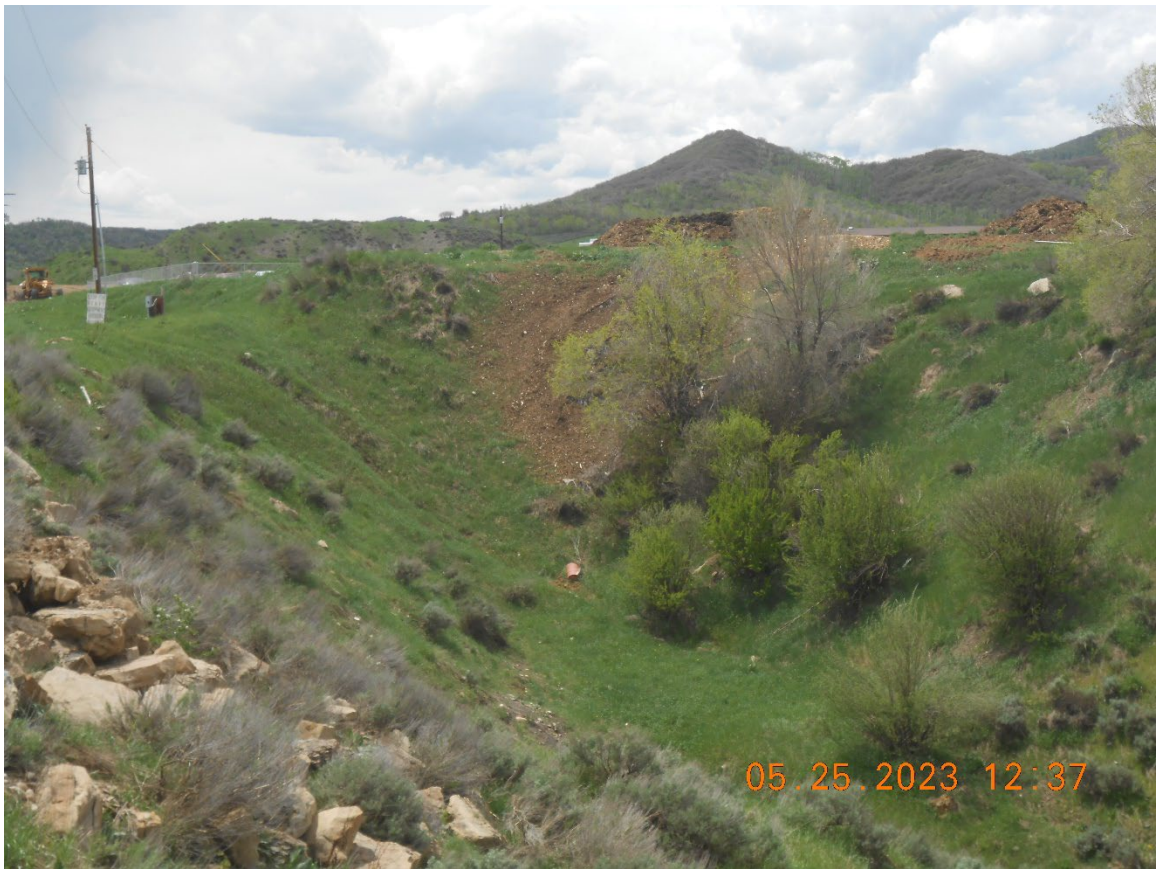
Photo 37: View showing material from compost work pad pushed down slope at southeast corner of compost work pad

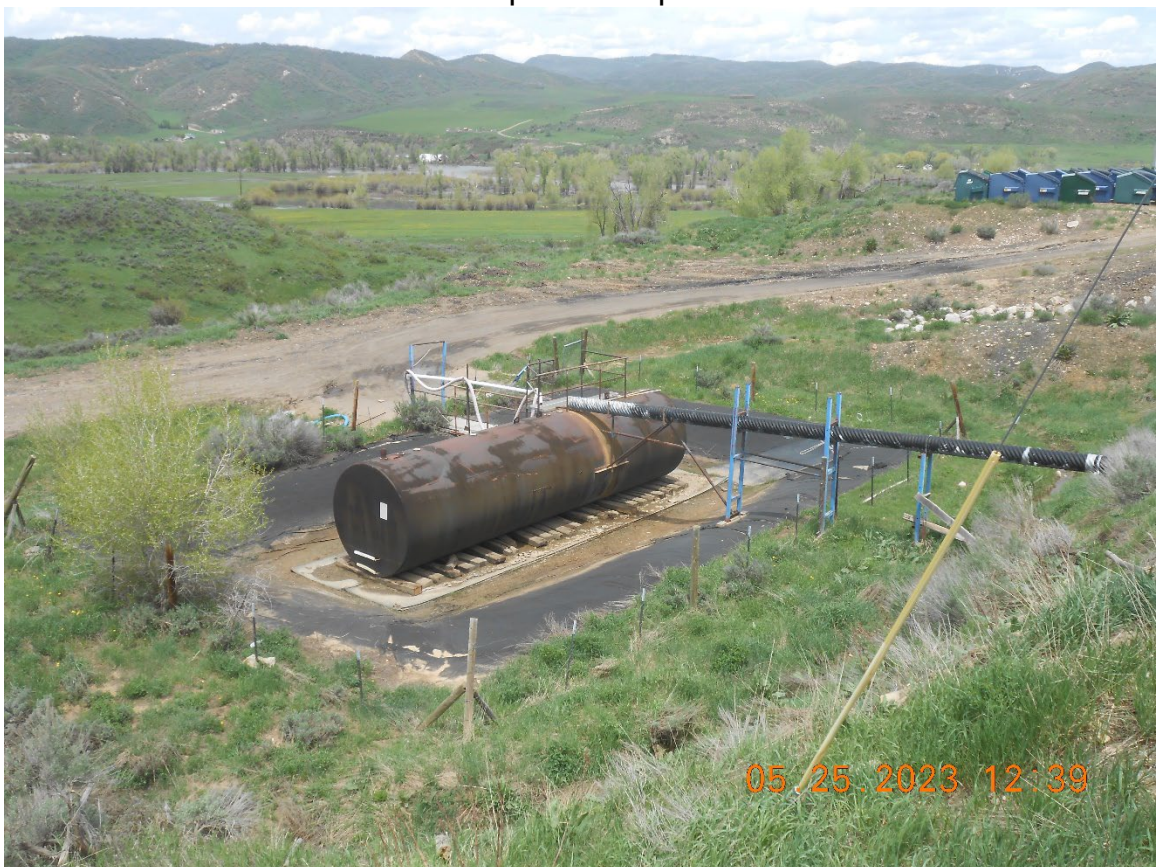
The inspection group proceeded further north after leaving the compost area and observed the leachate collection tank on the way back to the main office building at Milner Landfill. The leachate collection tank was observed from an elevated position from the road above and no issues were identified at the time of the inspection (see photo 38). Department personnel reminded the Twin Enviro representatives to make sure that adequate headroom was left in the tank, especially when temperatures are below freezing at the Facility.

Photo 38: Leachate holding tank and surrounding containment

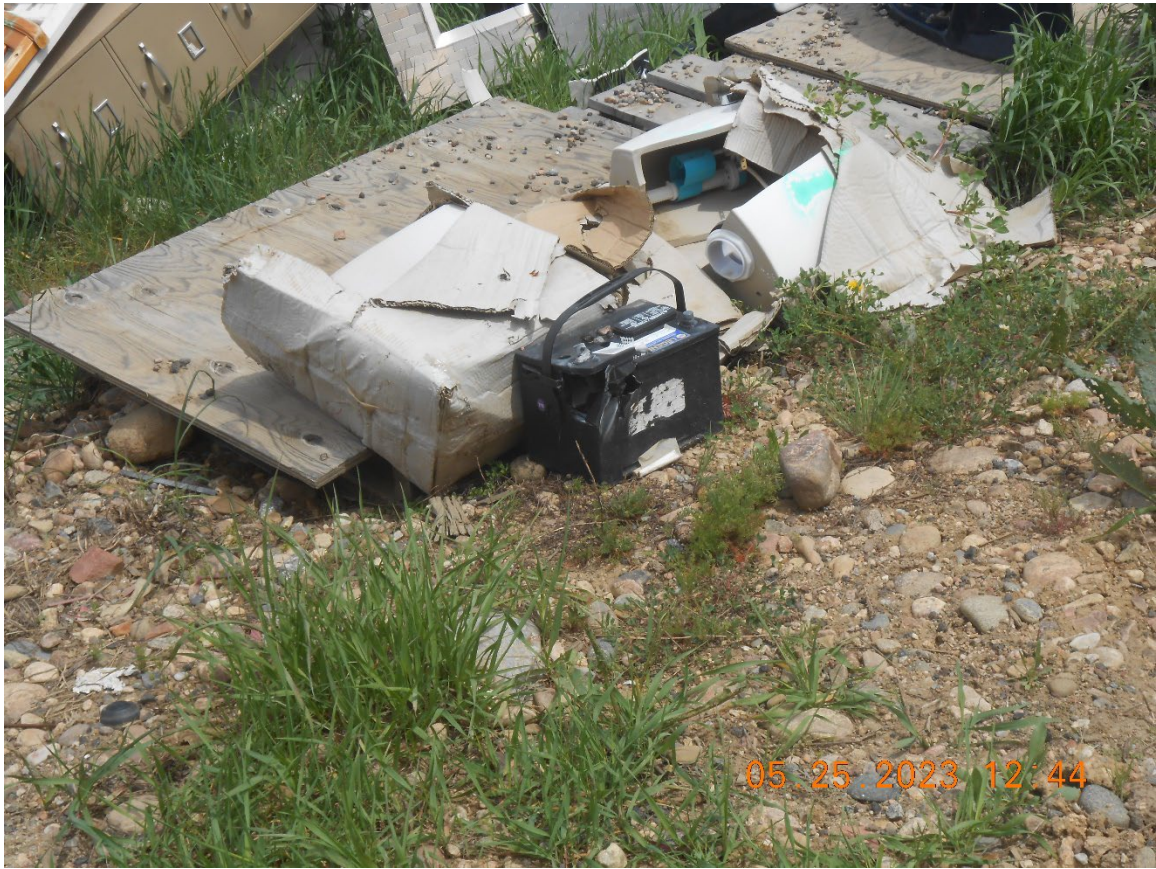
The group proceeded to the Milner Mall area of the Facility. The only prohibited item that was noted to be present at this portion of the Facility was a used and damaged lead-acid battery that was on the ground surface at the time of the inspection (see photo 39). Twin Enviro personnel said that it was likely that an external customer placed this battery here without permission. Department staff requested that this item be moved to a more secure location and be stored off of the ground surface. Twin Enviro personnel said that they would get the battery moved on the day of the inspection and make sure it was processed for appropriate recycling. It is important that Twin Enviro makes sure that prohibited items do not make their way into the Milner Mall and that the Facility's waste acceptance plan is being implemented appropriately.

Photo 39: Lead acid battery stored on ground surface outside Milner Mall
