September 26, 2023

RE: Compliance Advisory for the Milner Landfill

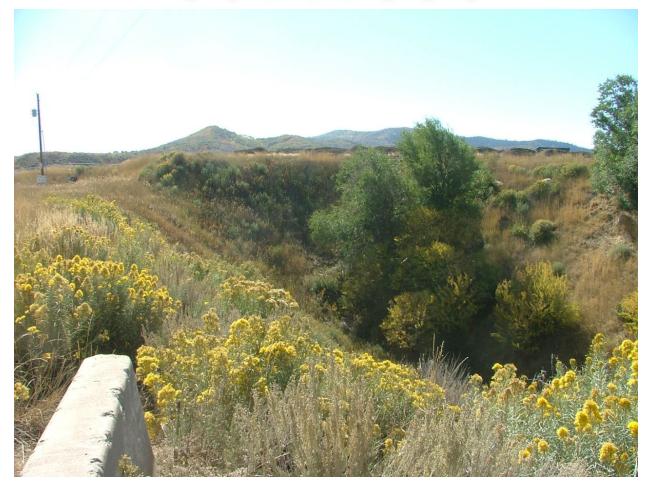
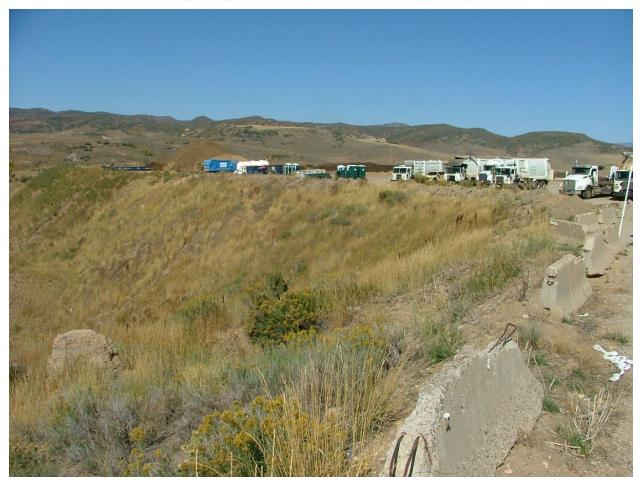
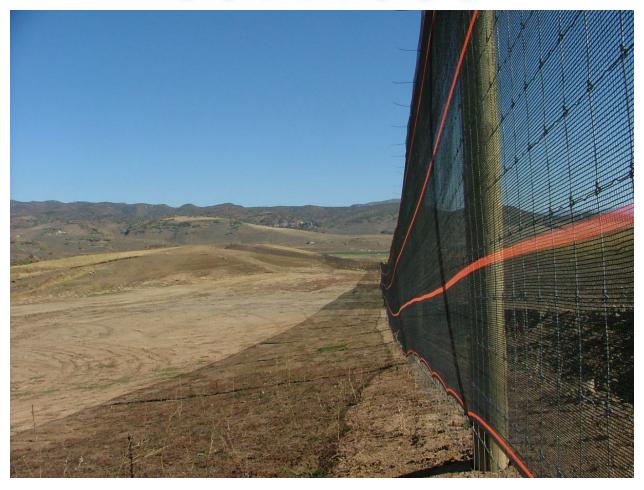
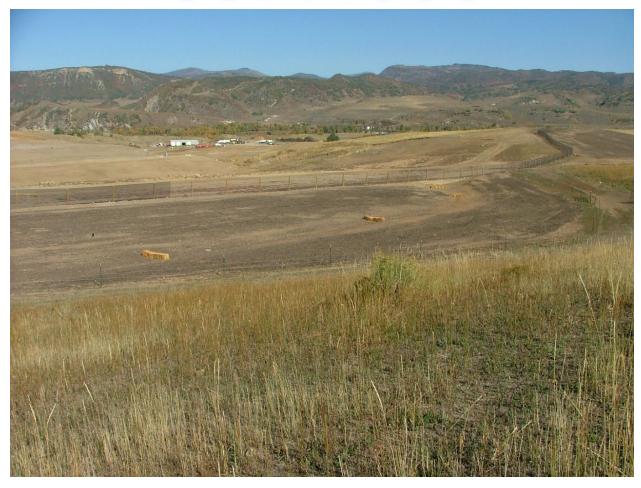
Deficiency 1: **Litter around MRF**. Pictures of current conditions are attached and we believe it to be in good shape. Our glass recycling indicates very little contamination at the processor in Denver. The pictures attached were intended to match the perspective of the pictures included with the Compliance Advisory.

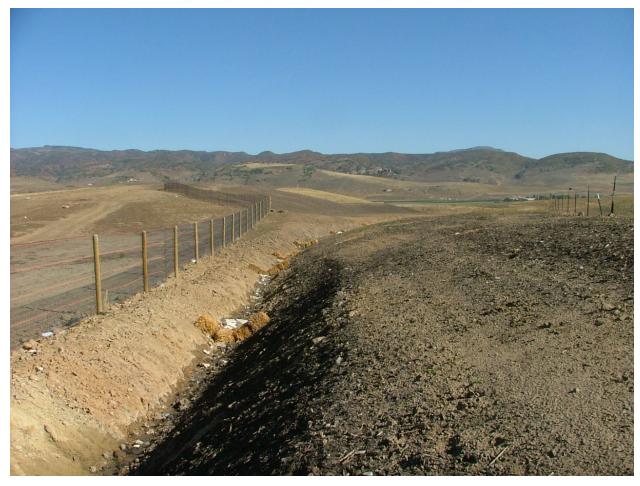
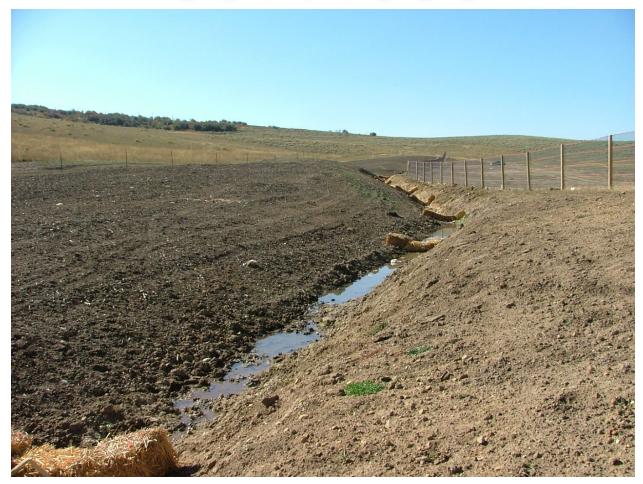
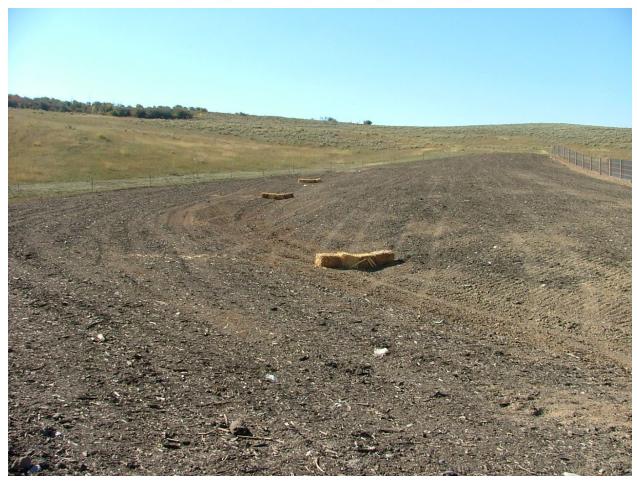
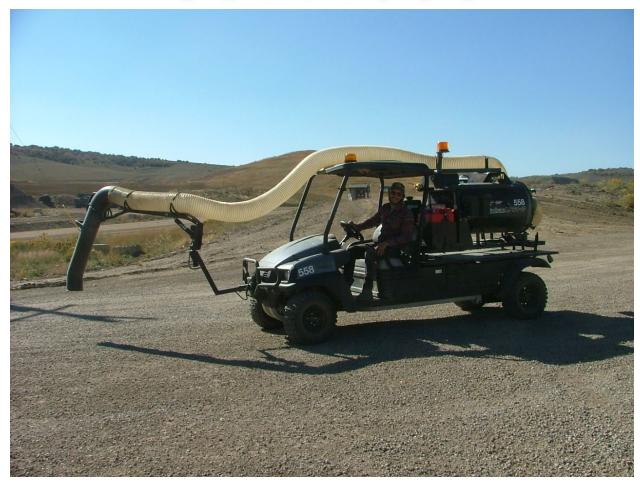
Deficiency 2: Compost/wood chips/dirt pushed over perimeter berms. Twin cleaned this up last spring using an excavator to recover the contamination. Perimeter berms around the compost pad and other areas are being restored where necessary. Operators will be trained to avoid pushing snow over berms and not scraping the pads. The pictures attached were intended to match the perspective of the pictures included with the Compliance Advisory.
