Re: On-Site Wastewater Treatment System Evaluation

The Clark Store

54173 County Road 129 Routt County, Colorado

Western Slope Geotech Project No. 23-1045

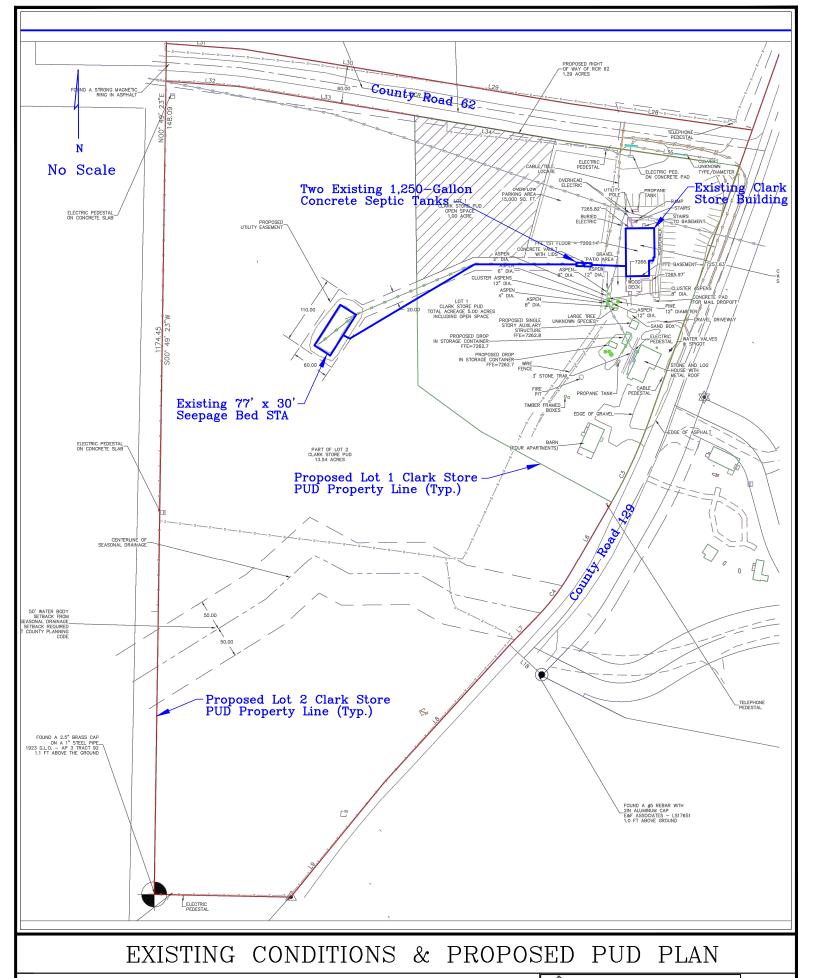
Figure No.: 1

WSG conducted site visits to the project site on August 16 and 22, 2023 to observe existing site conditions and OWTS components. On both site visits we observed two apparent concrete septic tanks and the STA located at the approximate locations shown on Figure 1. The top (lid) portions of both tanks were exposed and appeared to be in good condition with no apparent structural defects or leakage.

The STA site was mounded above natural surrounding site grades by approximately two to three feet and two apparent observations pipes were observed at the approximate southwest and northeast corners of the STA site. The pipes were not capped and had been broken off by apparent livestock activity. Apparent liquid was noted in the northeast observation pipe and the southwest observation pipe was dry. We also observed one area near the center of the west side of the STA where apparent effluent had surfaced. Lush vegetation was noted to the west of this area.

Based on WSG's visual evaluation, it appears the perimeter soil cover of the STA seepage bed is compromised resulting in surfacing effluent. It is unknown whether clogging of seepage bed gravel and underlying natural soils has occurred throughout the bed or in portions of the bed, although it is suspected at least at the northeast side of the STA based on observation of standing liquid in one of two inspection pipes. WSG recommends placement of additional soil cover (four to five feet minimum topsoil) over and around the west side of the seepage bed and lush vegetation area to the west. In addition, capping of inspection pipes and additional soil cover over the building sewer piping (near the building) are recommended. Livestock and human activity in the STA area should also be prohibited and periodic monitoring of the STA for surfacing effluent should be conducted. WSG recommends fencing around the STA to prohibit activity in this area.

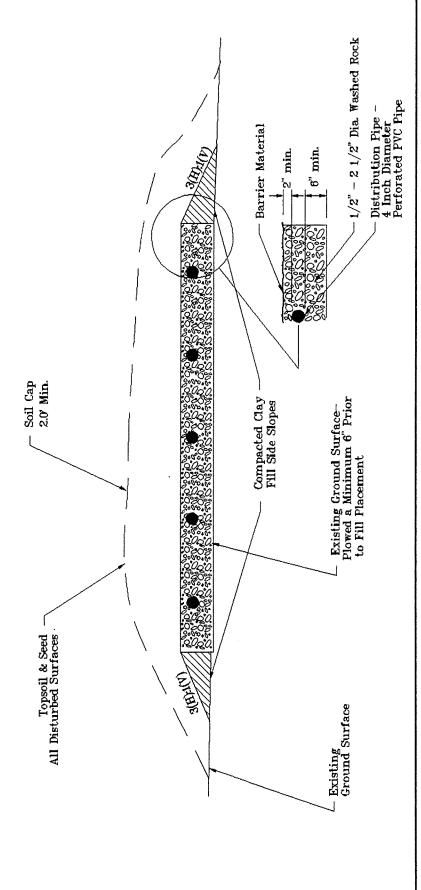
Job Ivaine: Clark Store Sewage Disposal System	Job No. 94–1774
ocation: 54175 County Road 129, Routt County, CO	Figure #4

Based on these design values we have calculated a minimum absorption bed area of 2,282 square feet. We have designed the bed to measure 30' x 77' in plan dimension to provide the necessary bed area. Due to the presence of a high groundwater table, the system must be placed at the existing ground surface elevations. This will require the use of compacted clay fill along the perimeter of the bed to reduce seepage and providing adequate soil cover over the surface of the bed. The absorption bed system design is shown in Figures #3 and #4 and the design calculations and specifications are given in Appendices A and B, respectively.
