July 13, 2017

Re: Compliance Advisory for Phantom Landfill  
2500 County Road 67, Penrose, CO 81240  
Fremont County  
SW/FRM/PH3 1.6

**Attachment A - Photo Log**  
**Phantom Landfill, June 8, 2017 Inspection**

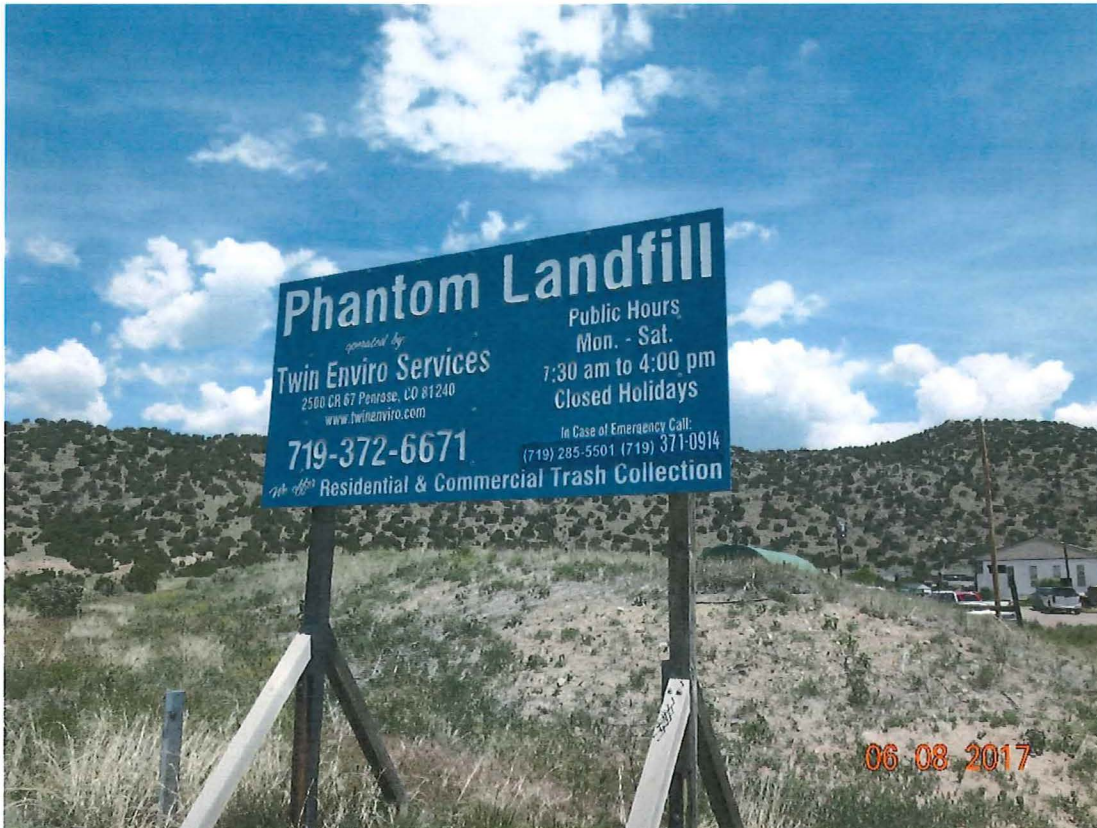
Photo 1: Looking northeast at signage adjacent to the Facility entrance gate.

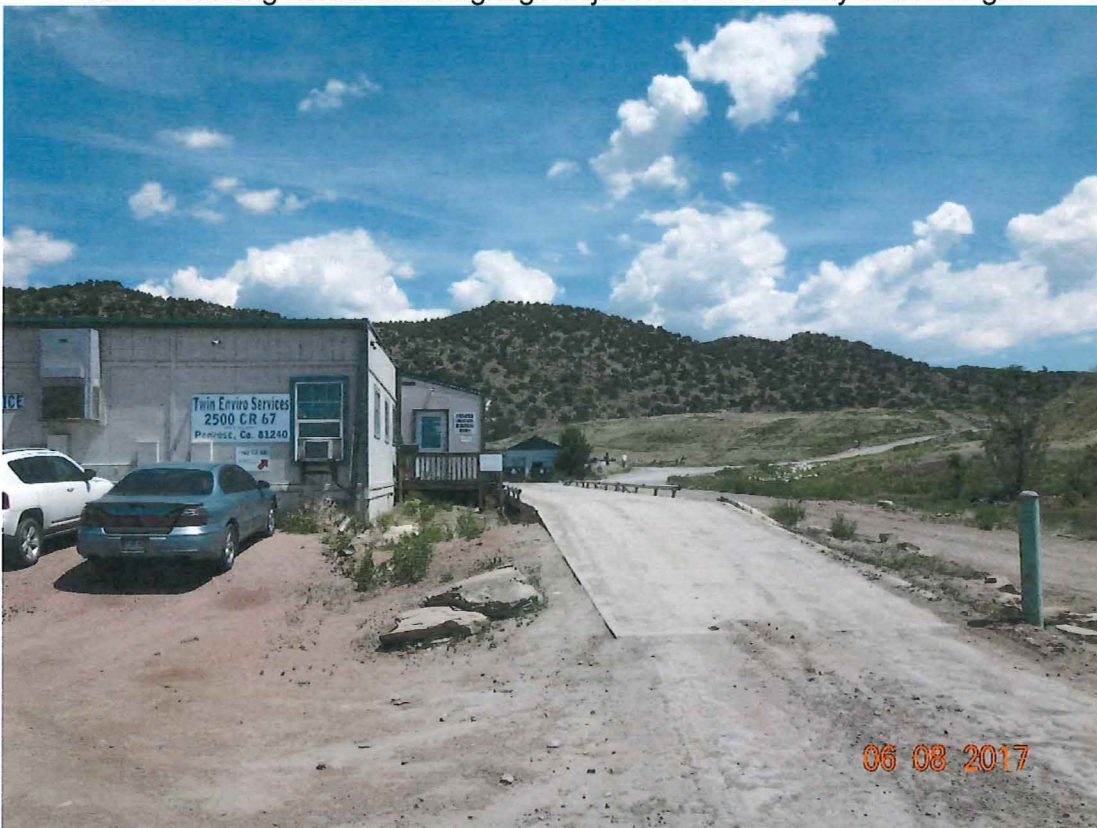
Photo 2: The Facility office and scale at the west portion of the site. Looking northeast.

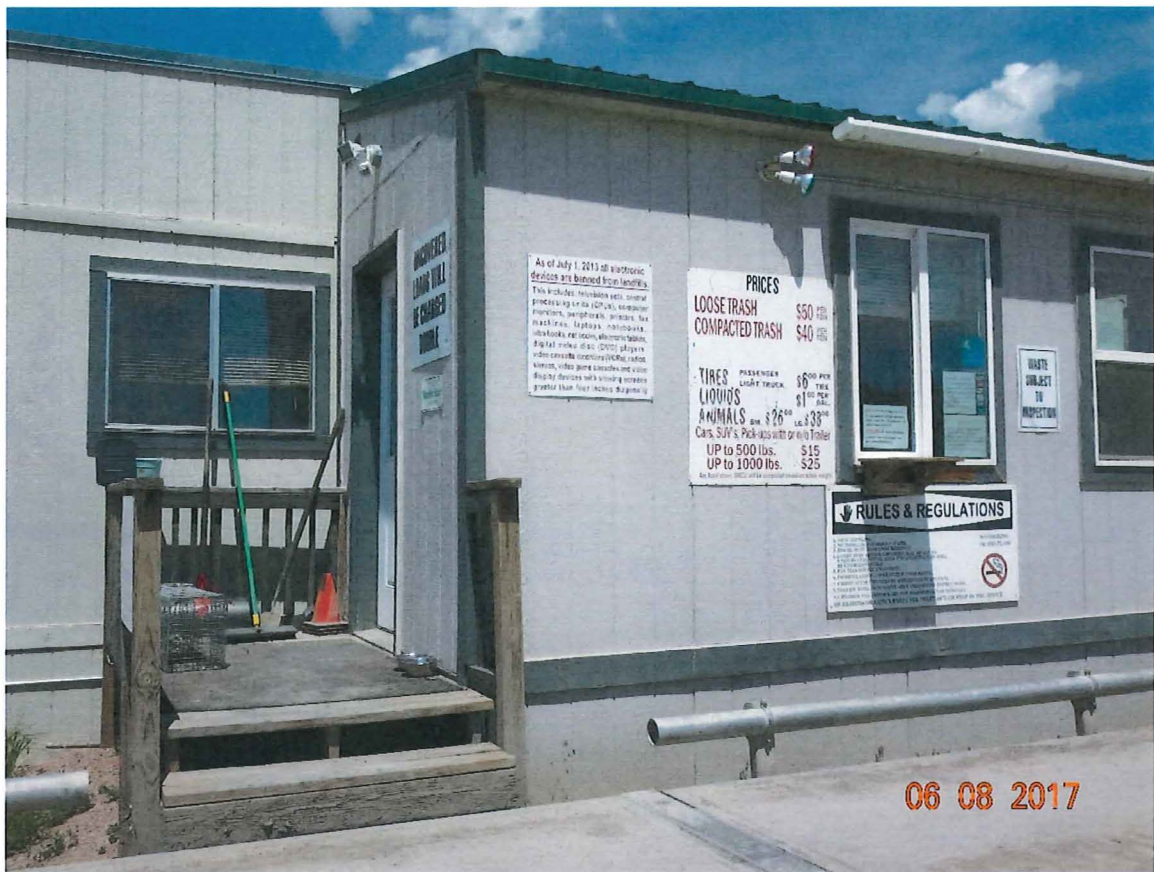
Signage near the Facility's entrance gate and at the Facility office indicate the hours of operation, disposal fees, the prohibition for disposal of e-waste, an emergency contact phone number, and a sign indicating that no toxic or hazardous waste is allowed. The Facility's hours of operation are Monday through Friday from 7:30 AM to 4:00 PM Monday through Saturday. A vehicle scale is located along the southeast side of the office building. Please see Photos 1 through 3 in Attachment A.

Photo 3: Signs on the Facility office indicating prohibitions, fees, and regulations. Looking north.

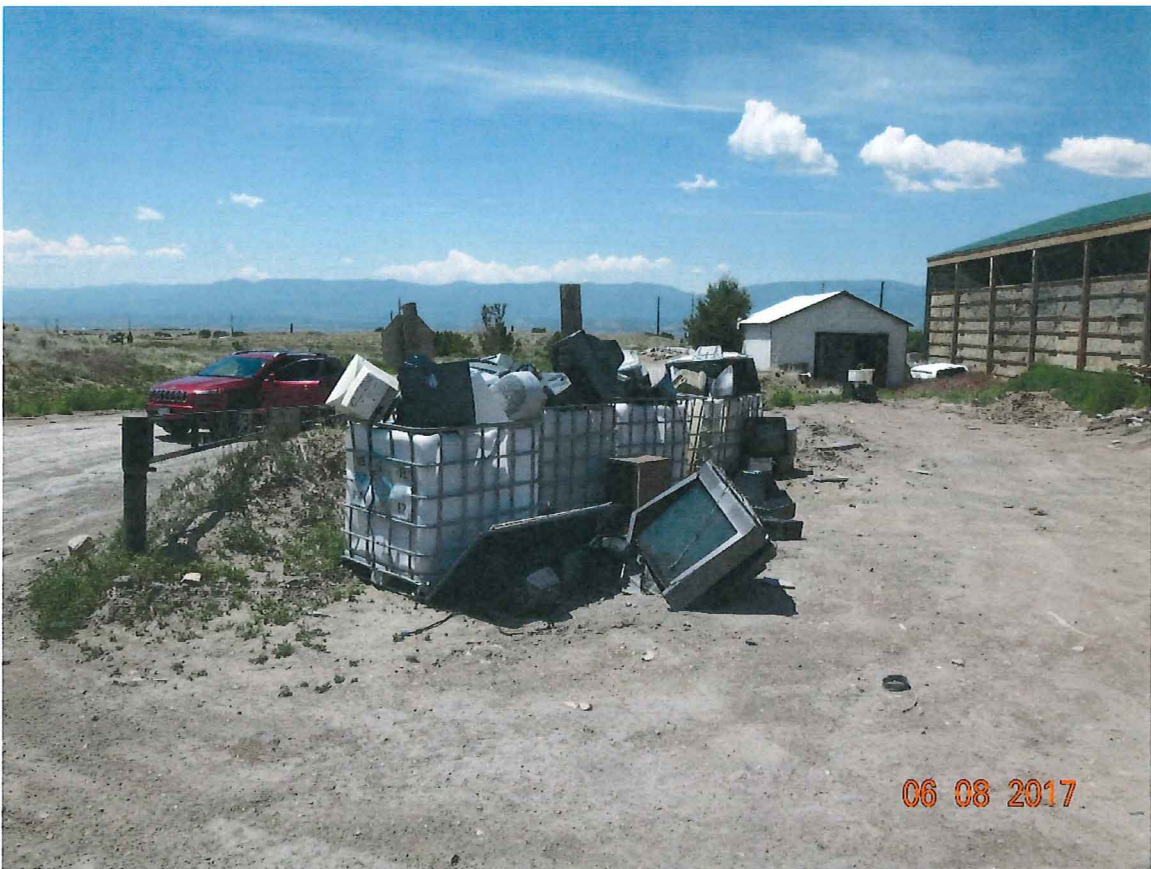
**Deficiency 14:** Failure to manage e-waste in a manner that prevents the release of waste or waste constituents to the environment. A portion of e-waste at the Facility was exposed to the elements and placed directly on the ground surface. This has the potential to impact the underlying soils with heavy metals. This is a violation of Sections 16.5.1 and 16.5.5 of the Regulations.

Two buildings are located north of the office area, including the recycling building which is used to store recyclable materials, and the equipment maintenance building. An area for collecting e-waste is located outside and to the east of the recycling building. Much of the e-waste was contained in plastic bins; however, several waste televisions were sitting directly on the ground surface, a violation of Section 16.5.5 of the Regulations. See Photos 4, 5 and 6.

Photo 6: Looking southwest at the e-waste collection area. Some e-waste is stored directly on the ground.

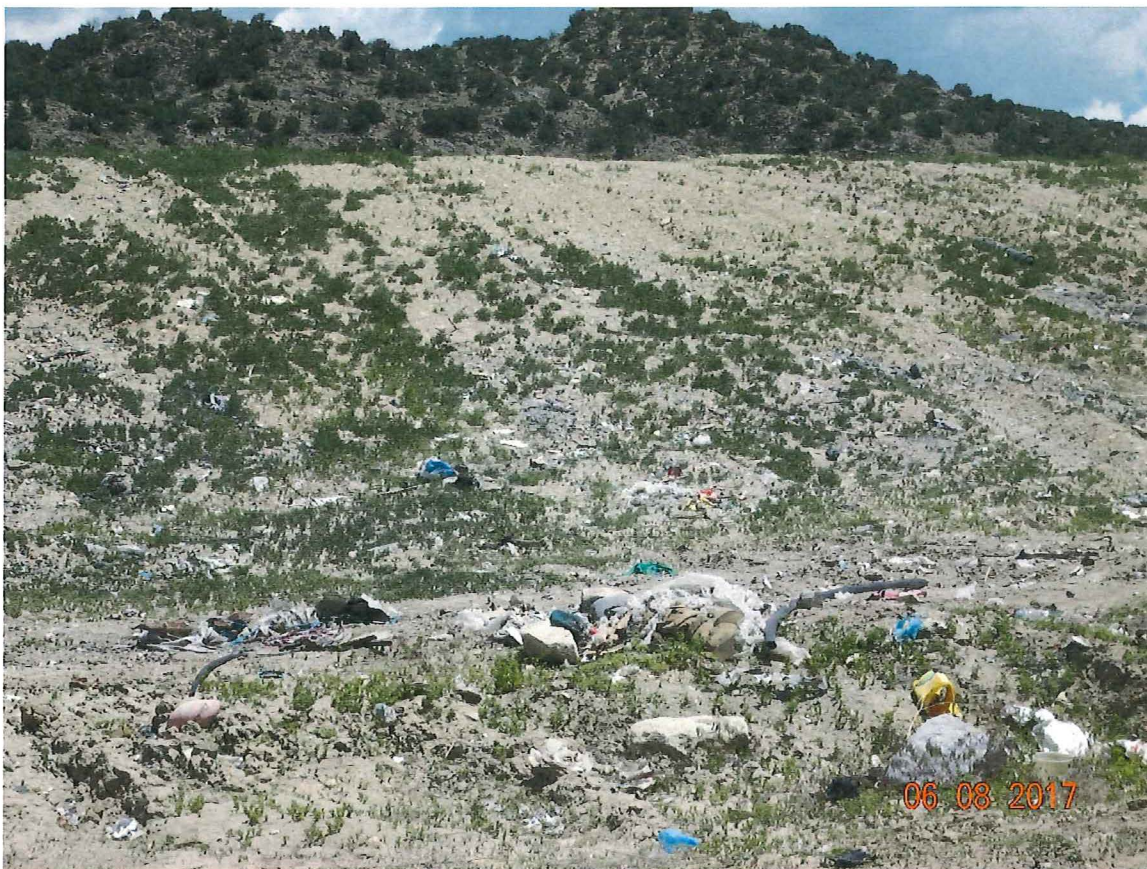
**Deficiency 6:** Failure to apply sufficient daily and intermediate cover in several areas along the south slope of the waste disposal cell, near the working face, and at the fly ash removal area. This is a violation of Sections 2.1.10 and 3.3.4(A) of the Regulations; Section 4.4.8 of the approved EDOP; and Section 2.8 of the Ash Mining Plan.

The waste disposal cell slope located east of the leachate extraction pipe exhibited some areas where windblown waste and previously buried waste were exposed. This indicates inadequate nuisance control methods and a lack of intermediate soil cover in those areas. See Photo 9.

Photo 9: Looking north at the south slope of the disposal cell. Exposed solid waste is visible.

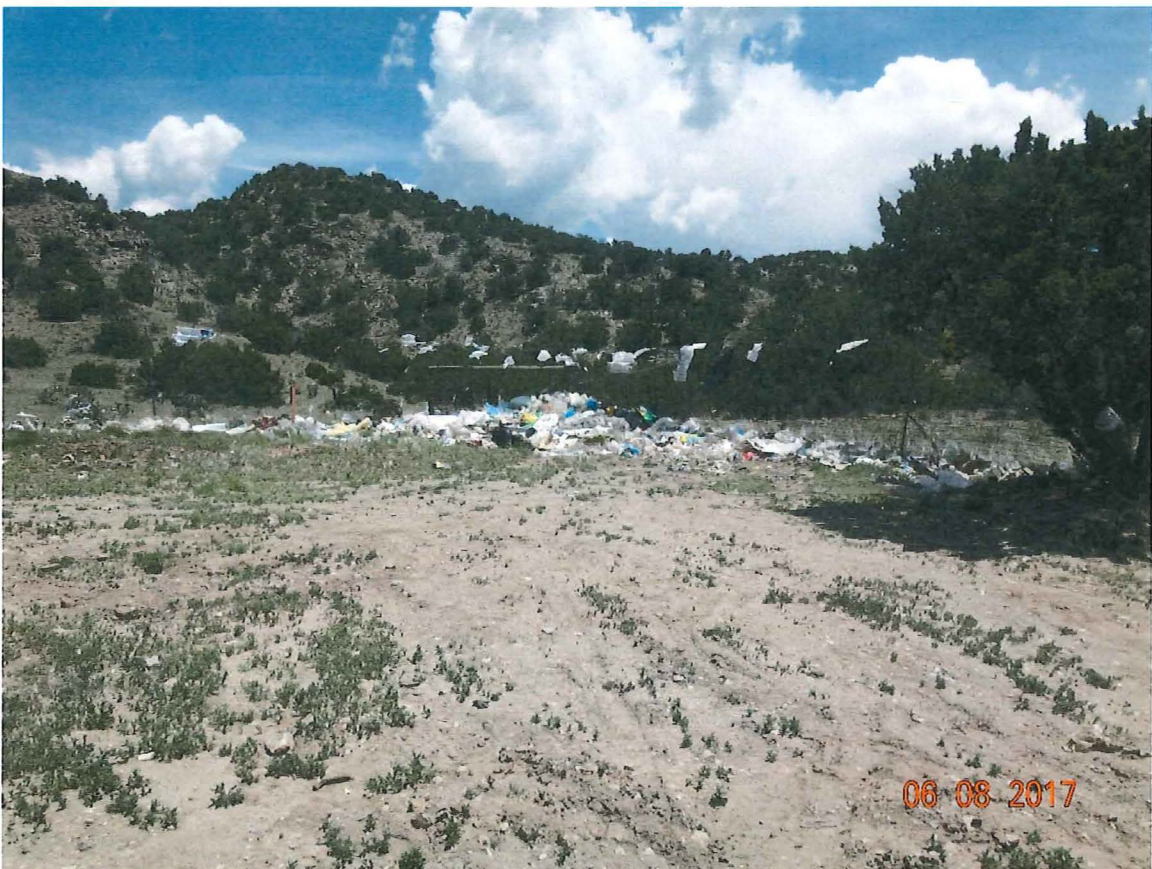
**Deficiency 13:** Windblown solid waste has created a nuisance condition along the Facility's eastern and northern fence lines and beyond the Facility boundary. Fly ash solid waste has created a nuisance condition in the run-on ditch and on the roadway along the north boundary. In addition, strong chemical odors were present in the vicinity of the working face, fly ash removal area, and solidification basin areas. This is a violation of Sections 2.1.3, 2.1.7, and 2.1.11 of the Regulations, and Section 3.0 of the approved Ash Mining Plan.

While driving along the east boundary of the Facility, significant wind-blown trash was observed along the fence line. The wind-blown waste was also present and more pronounced at the northeast corner of the Facility and along the east portion of the north fence line. Some wind-blown waste was observed beyond the east and north fence lines on adjacent property. Please see Photos 12 and 13.

Photo 12: Wind-blown trash at the northeast corner of the Facility. Looking northeast.

**Requested Action 13:** Within thirty (30) calendar days of your receipt of this Compliance Advisory, employ reasonable measures to collect, properly contain, and dispose of scattered litter along and beyond the Facility boundary fences to limit nuisance conditions. In addition, fly ash covering portions of the roadway and run-on ditch along the Facility's north boundary and in the vicinity of the solidification basin should be removed and properly disposed of in accordance with the Regulations, EDOP, SBD&O Plan and Ash Mining Plan. To help control odors at the Facility, apply adequate daily and intermediate cover where required.

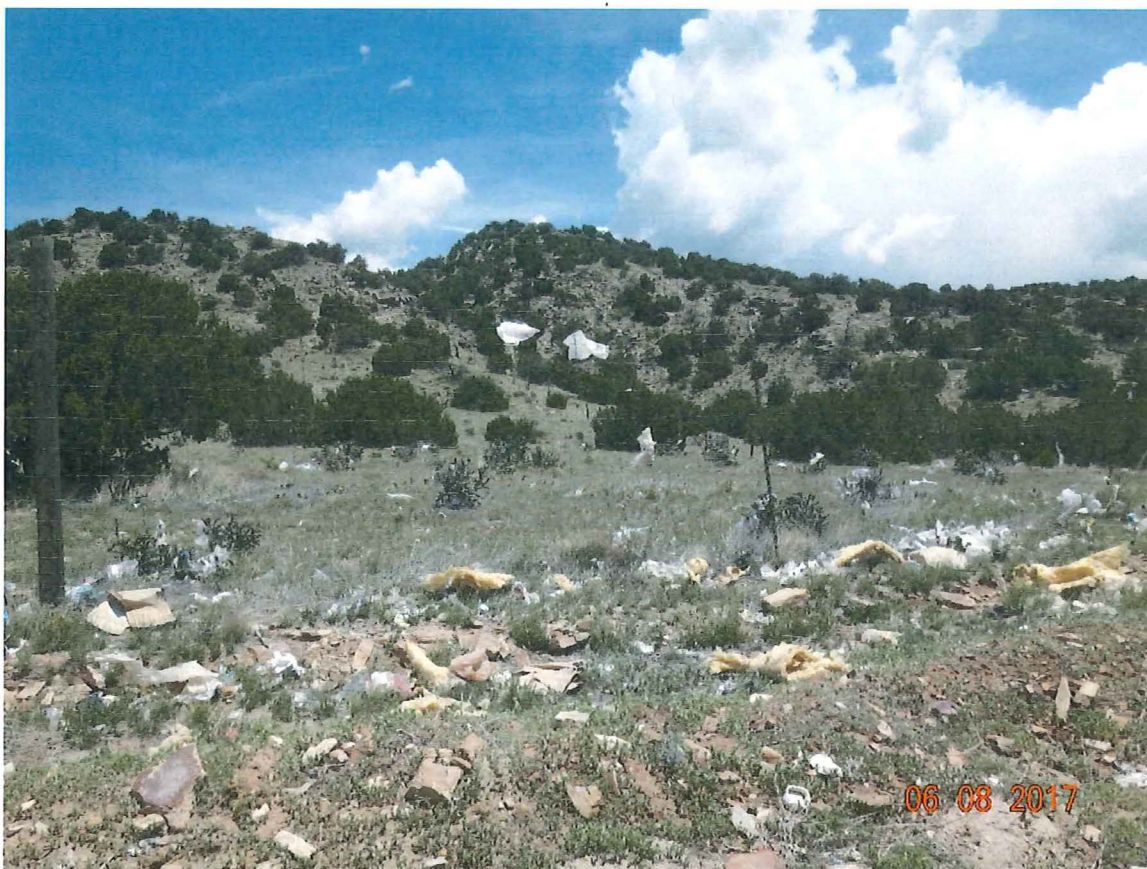
Photo 13: Looking north at wind-blown trash along and beyond the Facility's north fence line.

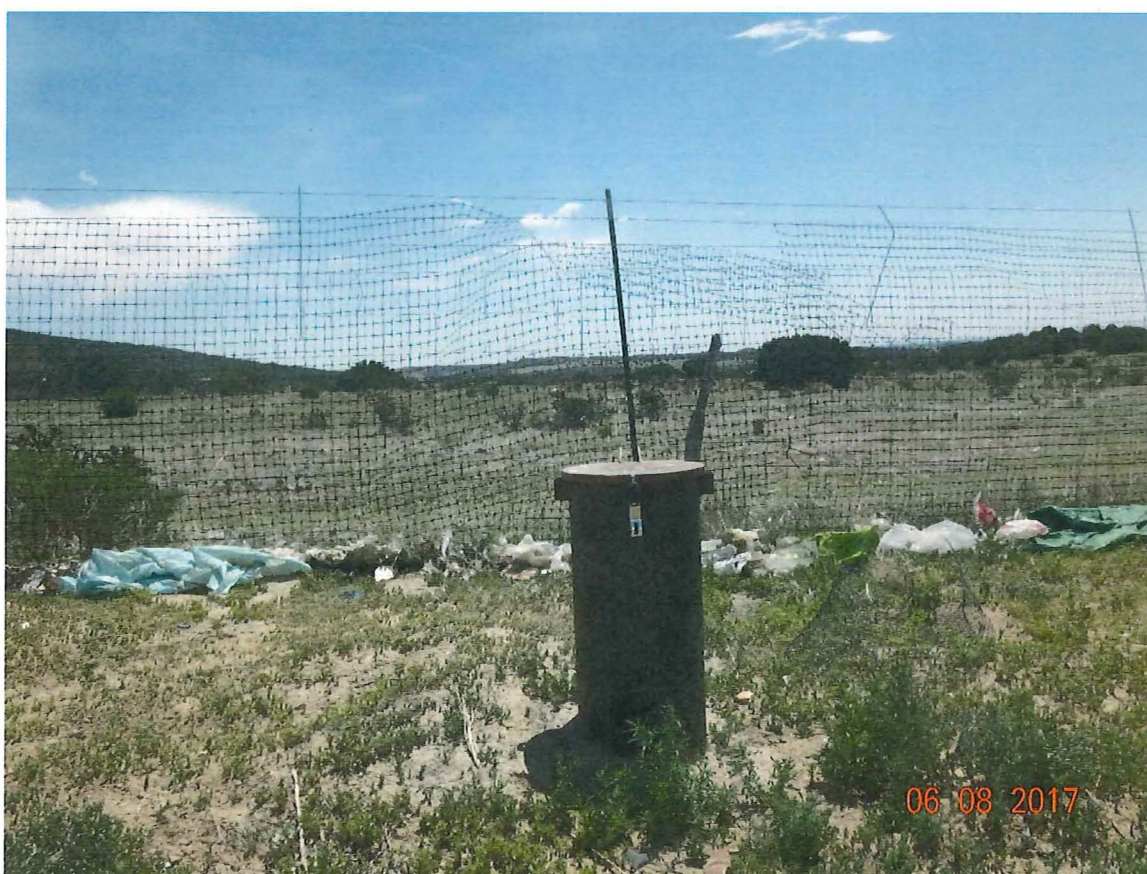
During the inspection, groundwater monitoring wells and gas probe wells were observed. They appeared to be in good condition; however, they were not locked. See Photos 14 and 15. The main entrance gate, another gate at the east portion of the Facility, and fences surrounding the Facility appeared to be in generally good condition.

Photo 14: A groundwater monitoring well adjacent to the east boundary fence. Looking east.

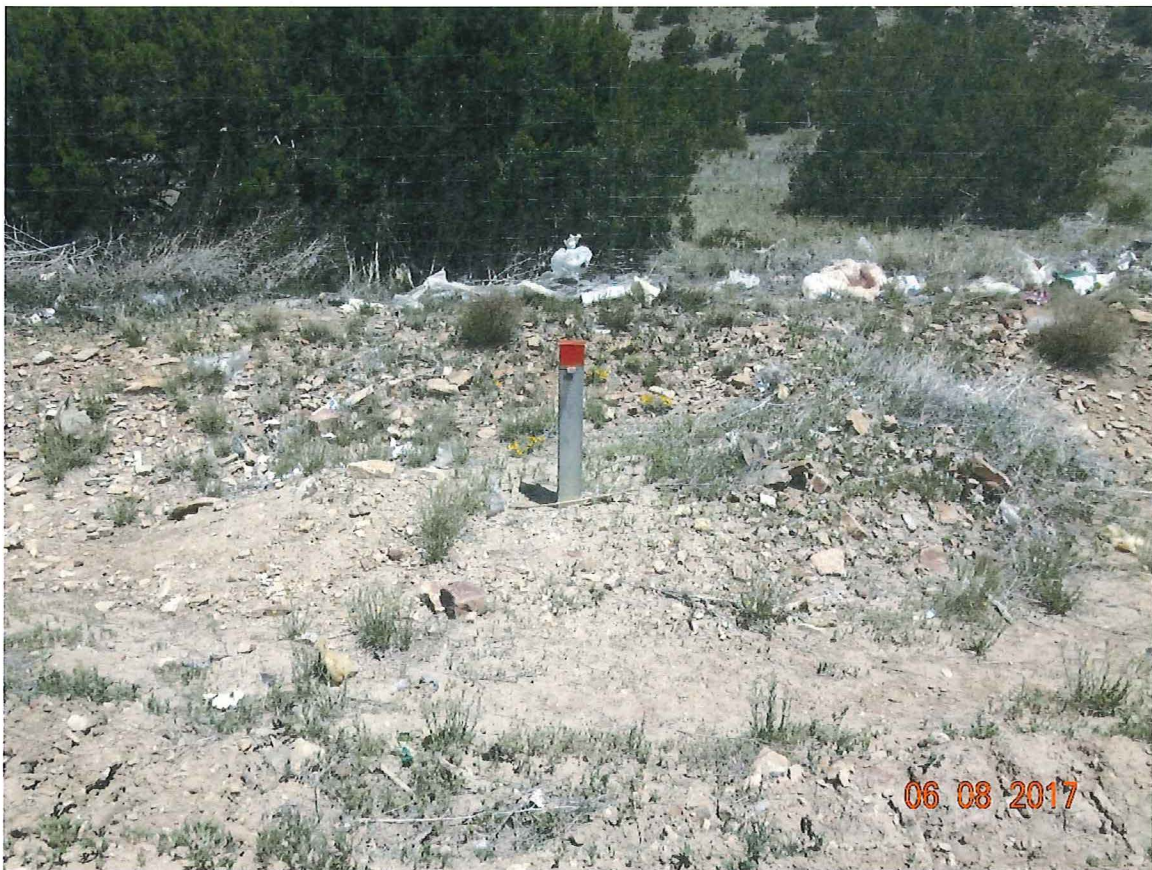
Photo 15: Looking north at a gas monitoring point adjacent to the north boundary fence.

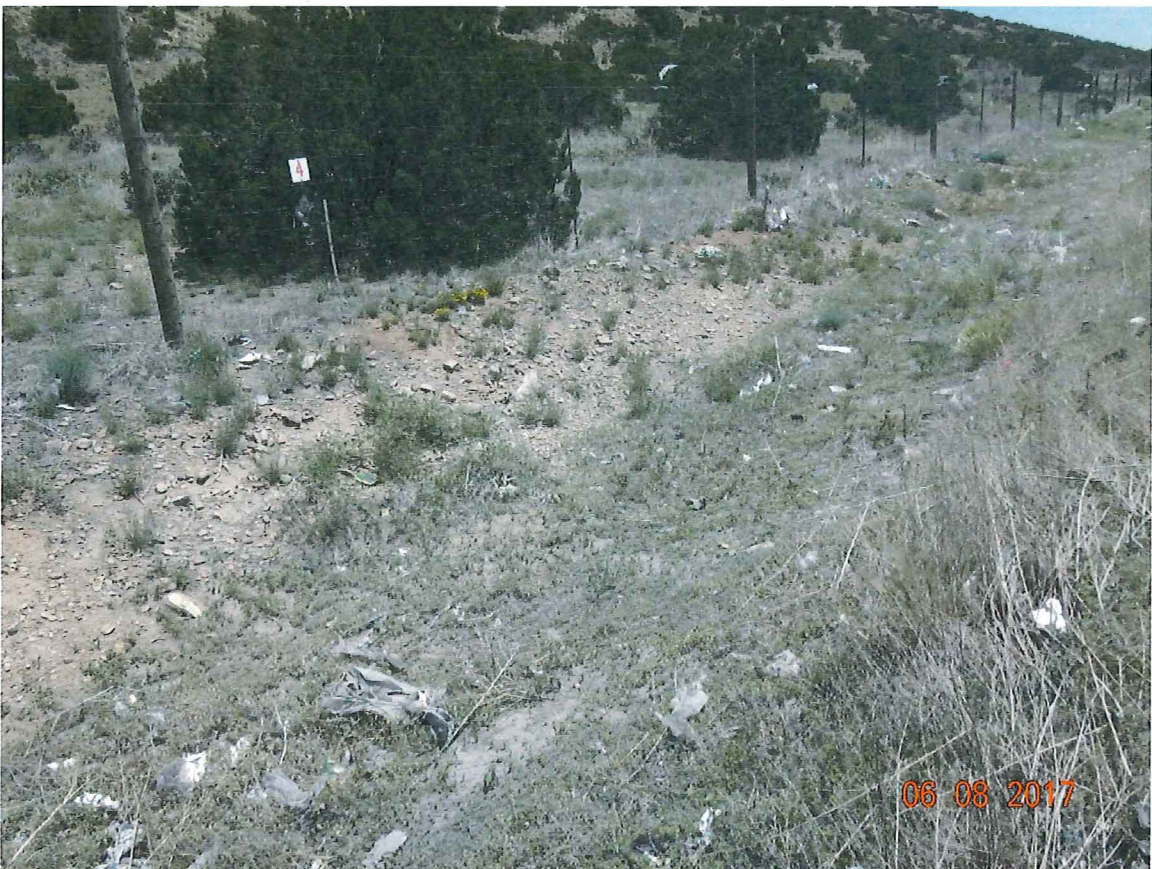
Storm water run-on and run-off ditches appeared to be in generally good condition. However, gray fly ash was present on portions of the run-on ditch near the north boundary as seen on Photo 16. The fly ash in this ditch may impact surface water flowing through the ditch during storm events and these ditches are located in areas not underlain by the landfill's liner system.

Photo 16: Looking northeast at the stormwater run-on ditch partially covered with gray fly ash.

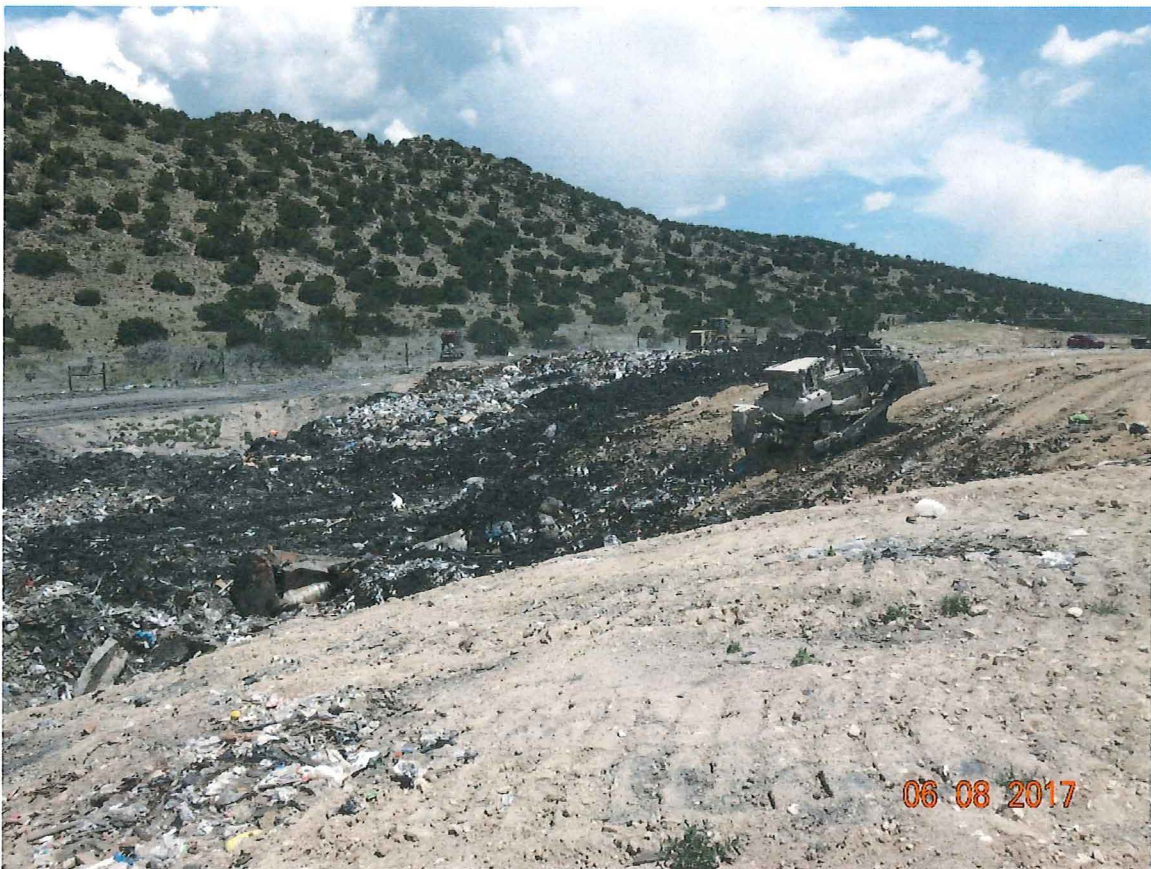
**Deficiency 9:** Failure to limit the size of the active working face and the fly ash removal face. This is a violation of Section 2.1.10 of the Regulations.

The size of the combined working face area and fly ash removal area was relatively large, estimated to be at least 200 feet across from east to west, and over 100 feet from north to south. This exceeds the 16,000 to 17,000 square feet of open recovery area defined by the approved 2014 Ash Mining Plan intended to limit exposed solid wastes and provide for a manageable area where daily cover could be reasonably applied by Twin Enviro to control nuisance conditions in accordance with both the SBD&O and 2014 Ash Mining Plan. See Photos 18 through 21.

Photo 18: The large working face area at the north-central portion of the Facility. Looking northeast.

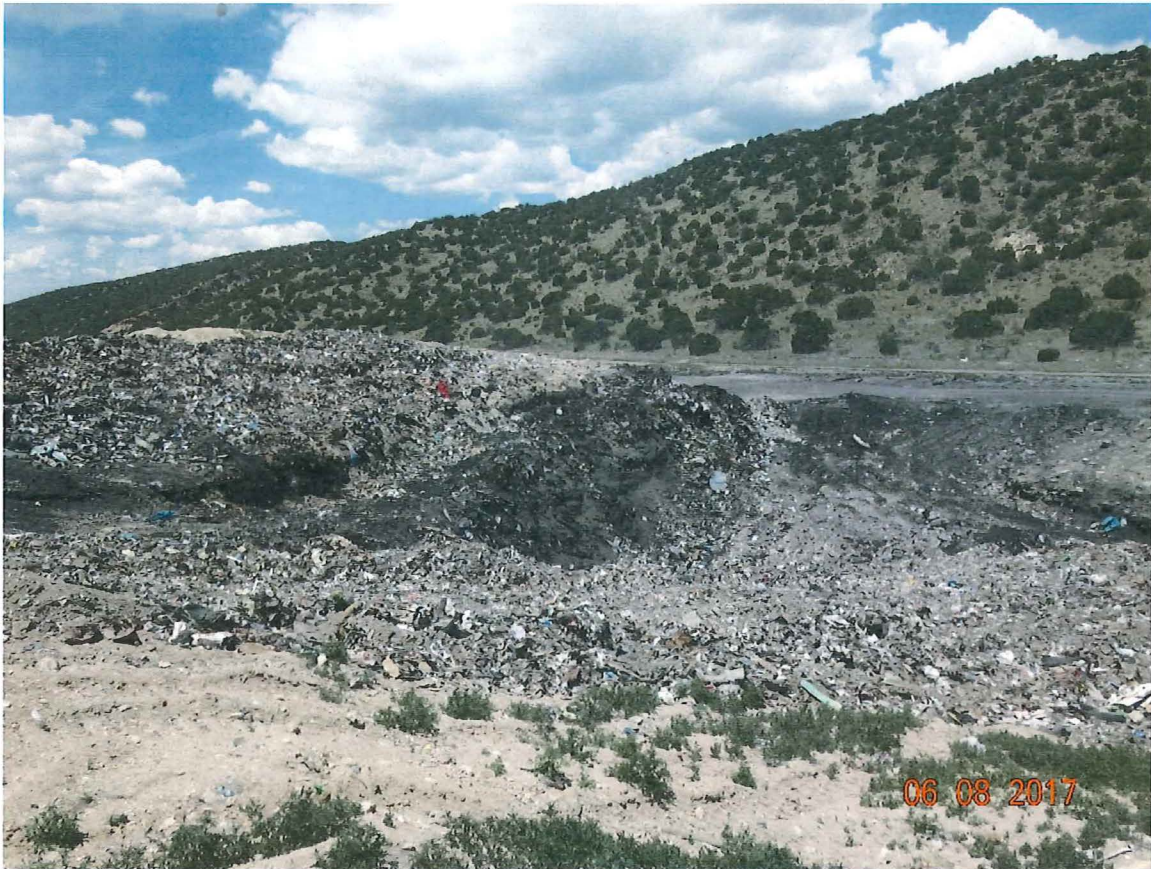
Photo 19: Looking northwest. Fly ash mixed with municipal waste is removed from this area for use at the solidification basin.

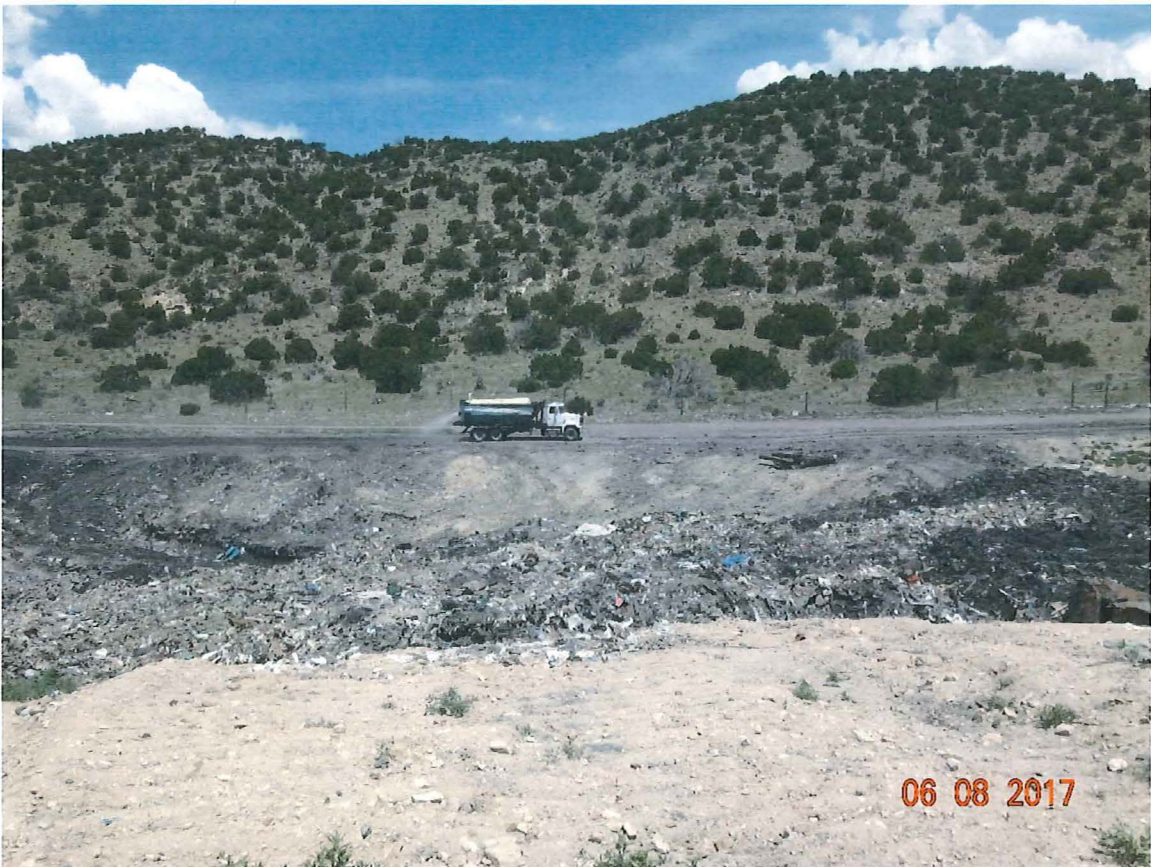
Photo 20: Water being applied north of the combined working face and fly ash removal area. Looking north.

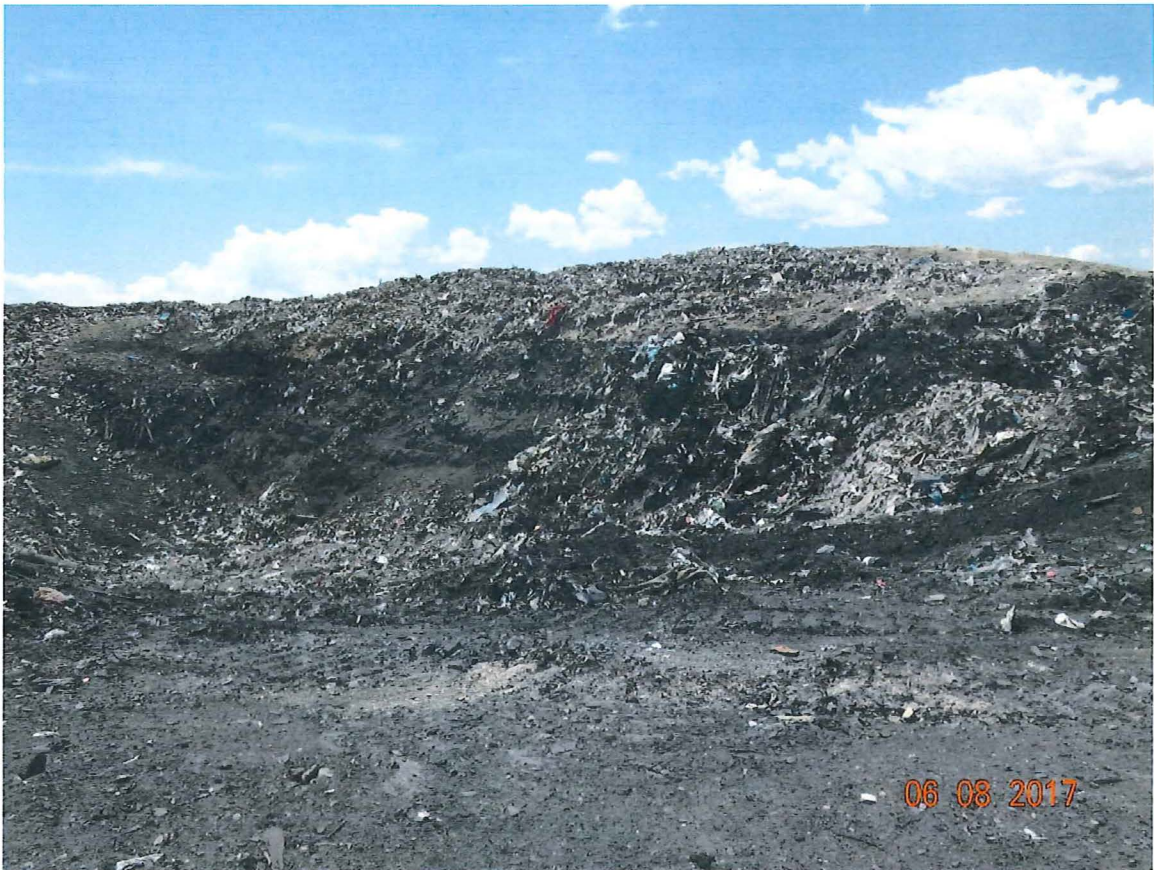
Photo 21: Looking southwest at the area where fly ash mixed with municipal waste is removed.

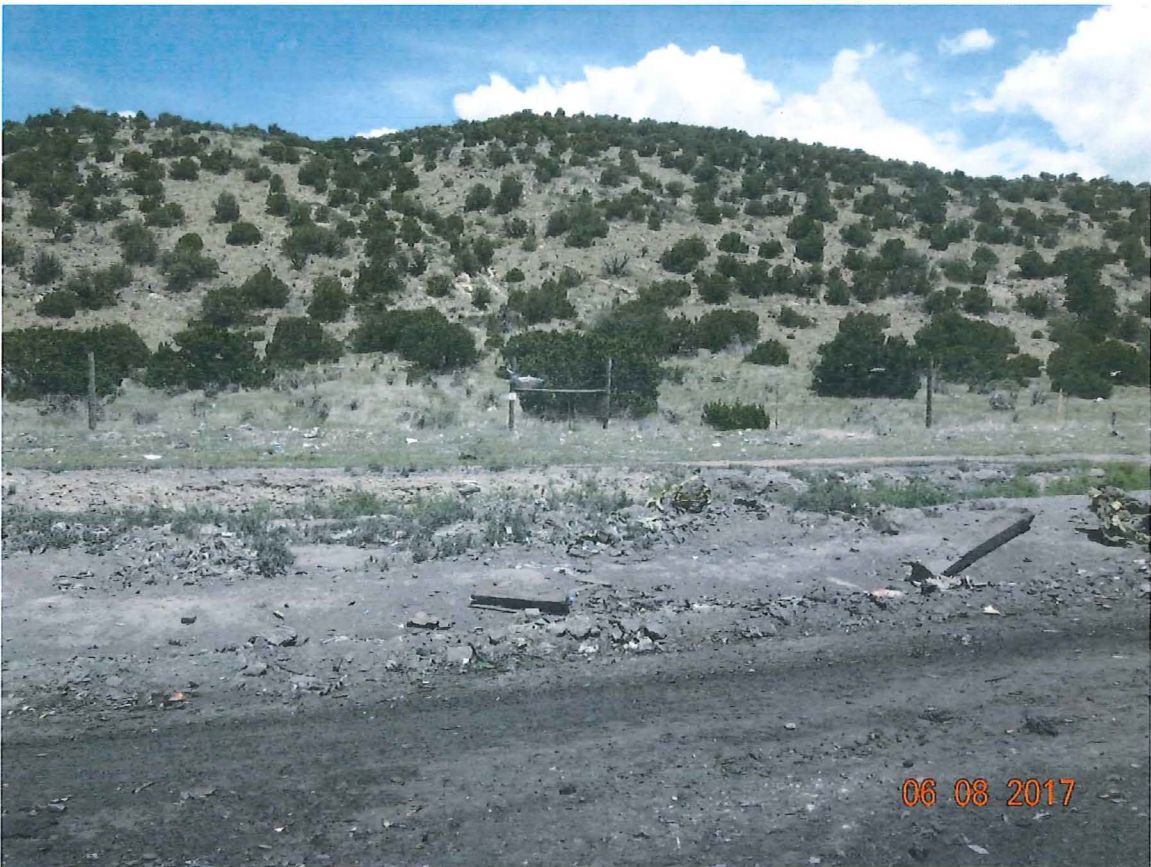
The dirt road connecting the working face and fly ash removal areas to the waste solidification basin at the northwest portion of the Facility was mostly covered with fly ash residue which violates requirements in the 2014 Ash Mining Plan. In addition, the Inspectors did not observe required track-out pads which are required to be installed at the ash mining area to control this condition. The fly ash residue was also present on the storm water run-on trench that parallels the north boundary fence as previously stated. See Photos 22 through 24. Inspectors did not observe any silt fencing or sediment control logs required by the 2014 Ash Mining Plan to assist in

Photo 22: The road covered with fly ash between the working face and solidification basin. Looking north.

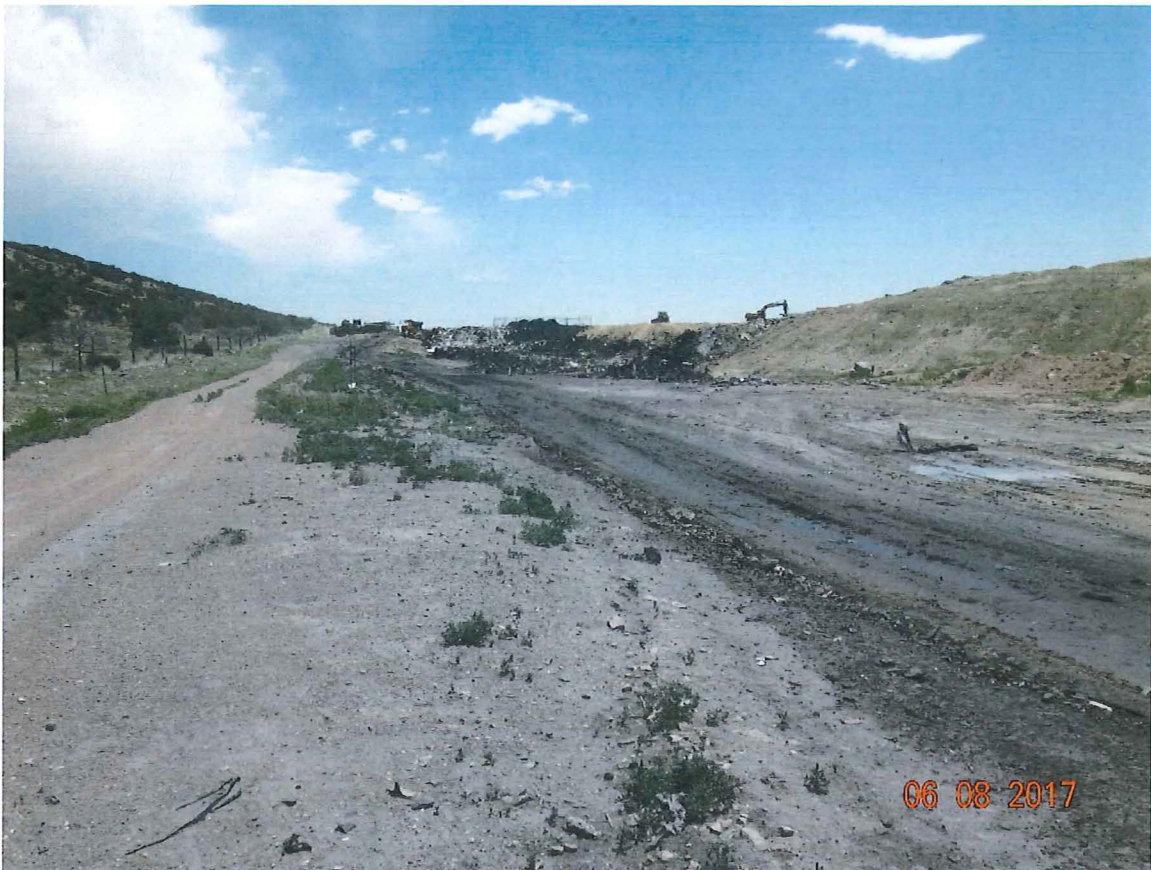
Photo 23: Looking east at the Facility's north boundary road covered with fly ash residue.

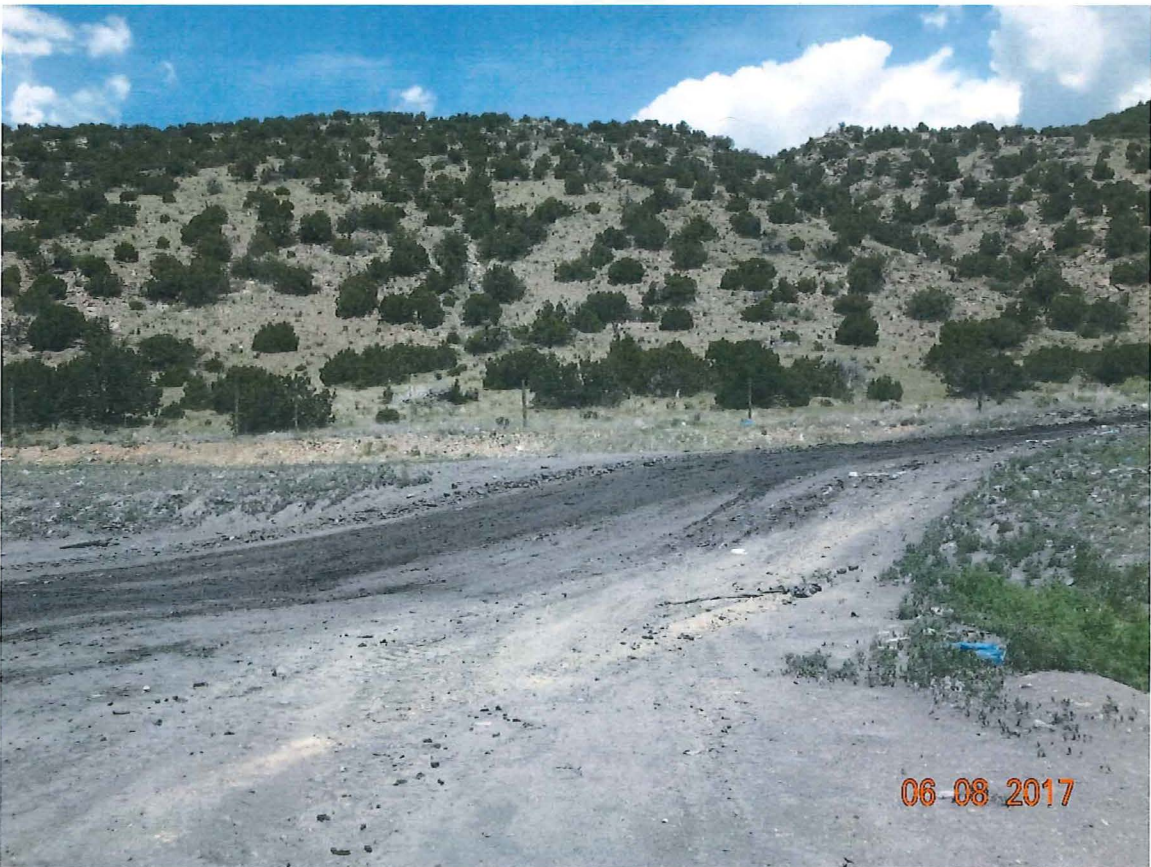
Photo 24: The fly ash-covered road near the Facility's solidification basin. Looking north.

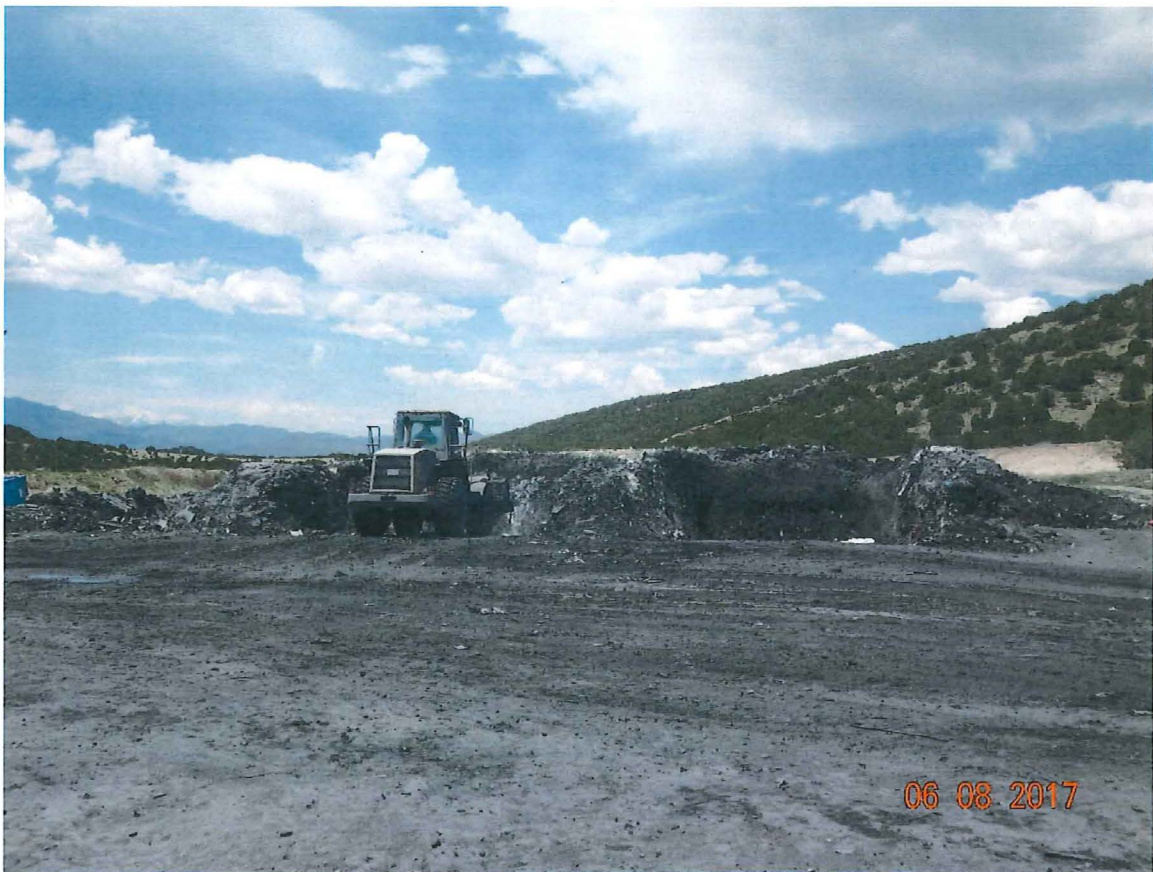
**Deficiency 7:** Storage of uncovered fly ash materials mixed with municipal waste was observed at the solidification basin. Uncovered stockpiles/berms of fly ash with mixed municipal waste extended several feet above ground level at the solidification basin. This is a violation of Section 5.5 of the SBD&O Plan; and Section 2.8 of the Ash Mining Plan.

**Deficiency 8:** Failure to properly manage fly ash for use in the solidification basin. Berms of fly ash mixed with municipal waste were present at three sides of the solidification basins. This material was being handled as a product and not as a solid waste. It did not have adequate daily cover to limit nuisance conditions or contact with surface water. This is a violation of the Regulations pursuant to Section 1.2 (reference the definition of a solid waste); Section 2.1.10 (requirements for adequate cover, distribution of solid wastes in the smallest area consistent with handling traffic, and solid wastes are to be placed in the most dense volume practicable); Section 2.1.11 (sites and facilities shall have minimum wind-blown debris); and Section 3.3.4 (requirements for cover materials). In addition, the use of this solid waste as a berm material is inconsistent with Section 5.5 of the SBD&O Plan, and Sections 2.1, 2.6, 2.8, 2.9, and 3.1 of the approved Ash Mining Plan.

Photo 25: Looking west at the solidification basin pits with berms of fly ash mixed with municipal waste.

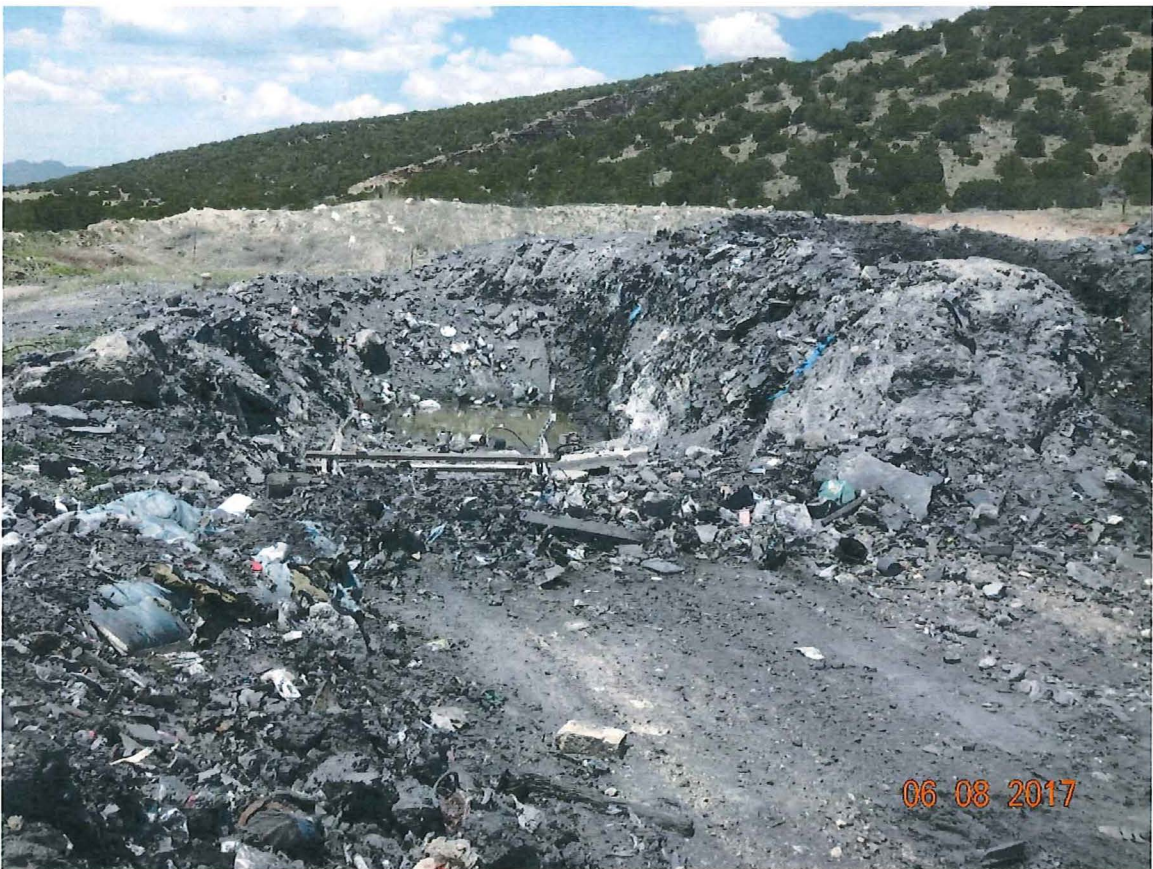
Photo 26: The Facility's southern solidification basin pit and solid waste berms. Looking west.

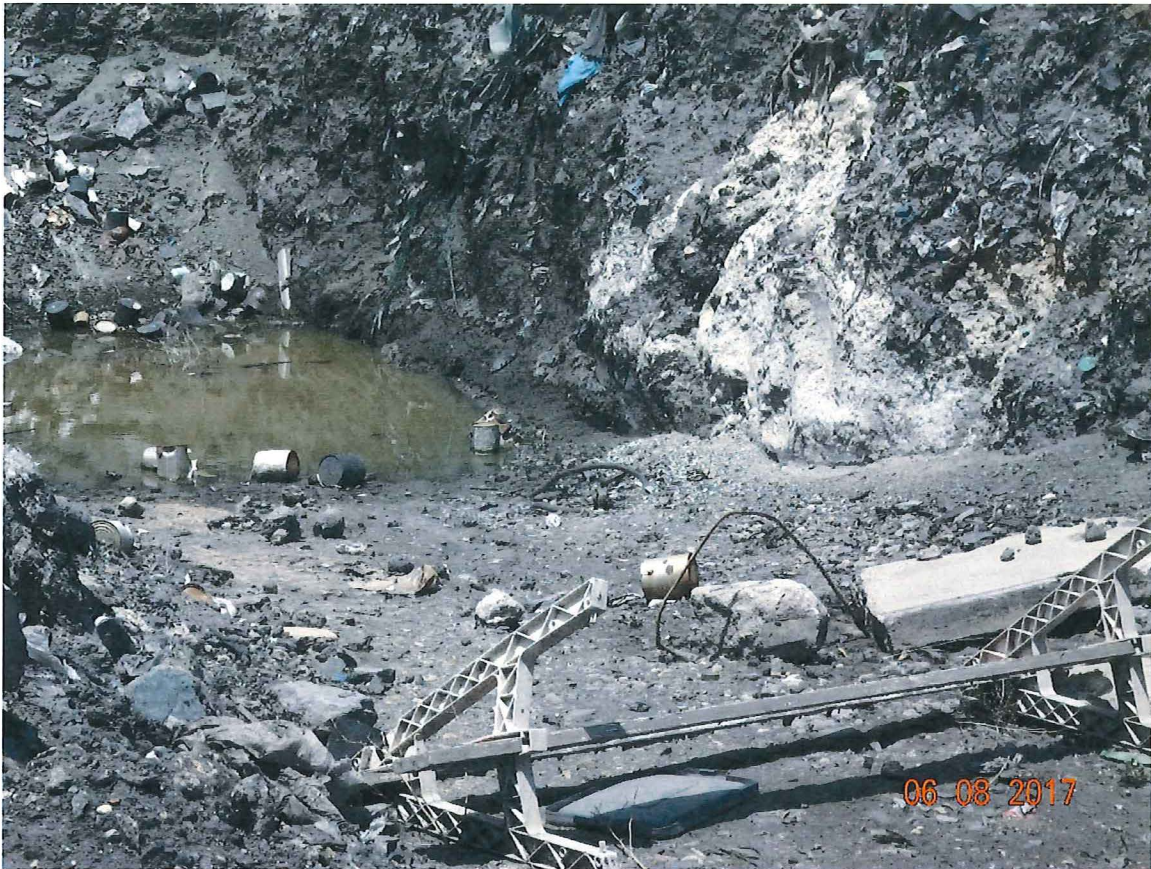
Photo 27: Standing water and waste in a pit at the solidification basin area. Looking west-northwest.
