July 13, 2017

Re: Compliance Advisory for Phantom Landfill  
2500 County Road 67, Penrose, CO 81240  
Fremont County  
SW/FRM/PH3 1.6

**Attachment A - Photo Log**  
**Phantom Landfill, June 8, 2017 Inspection**

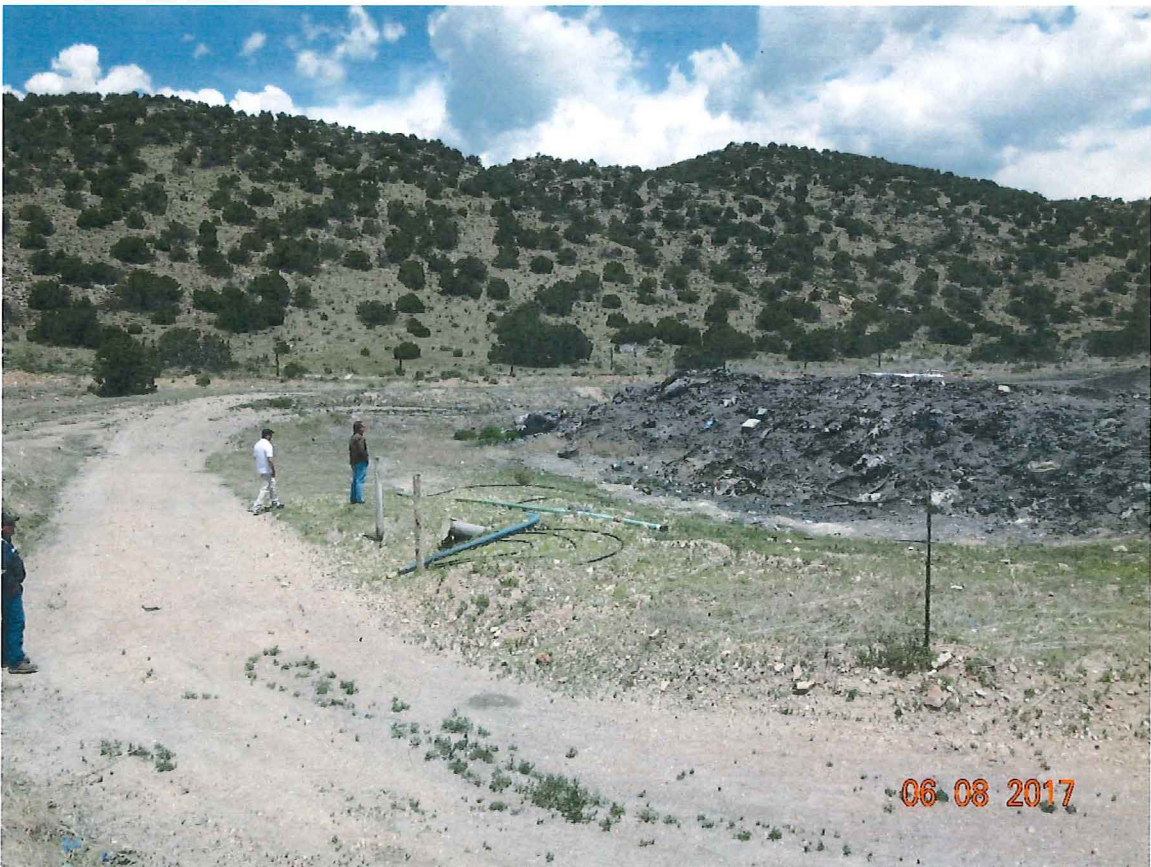
Photo 28: Looking north at the solidification basin leachate removal pipe and uncovered solid waste berms.
