COLORADO
Department of Public
Health & Environment

Re: Compliance Advisory for the Milner Landfill:
Twin Enviro Services
20650 County Road 205
Steamboat Springs, CO 80487
SW RTT MIL 1.6

Attachment 1 - Photo Log

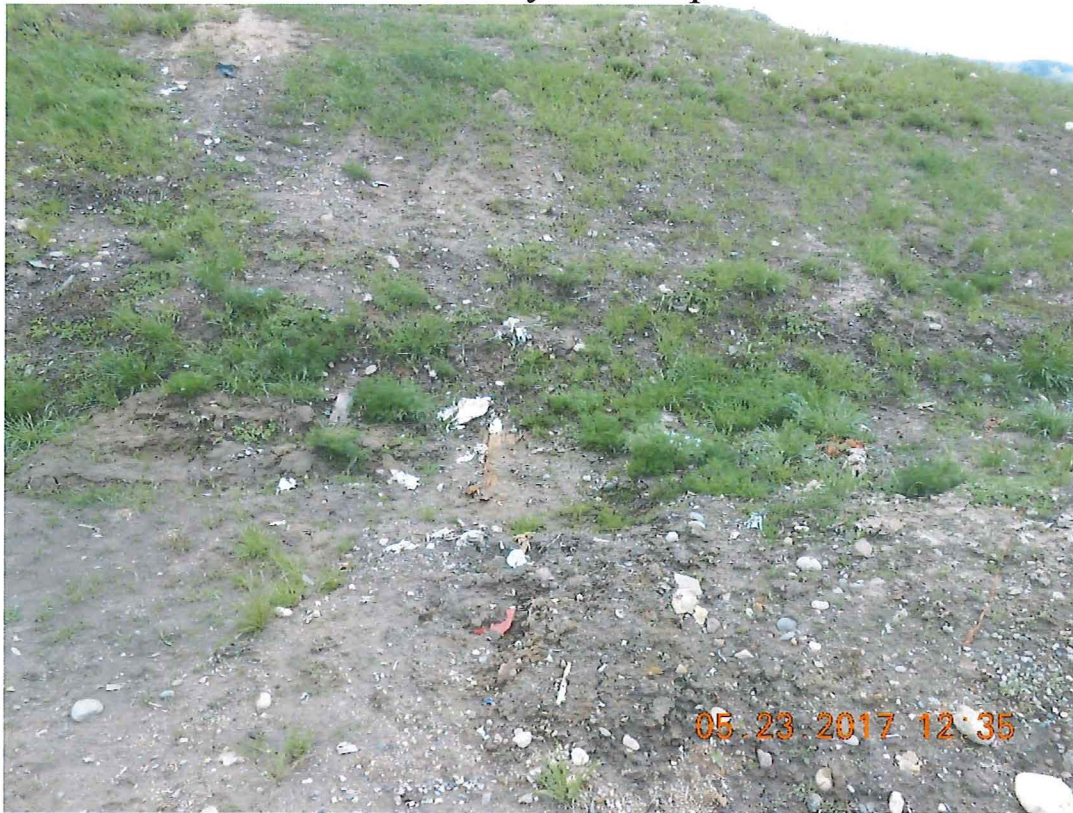
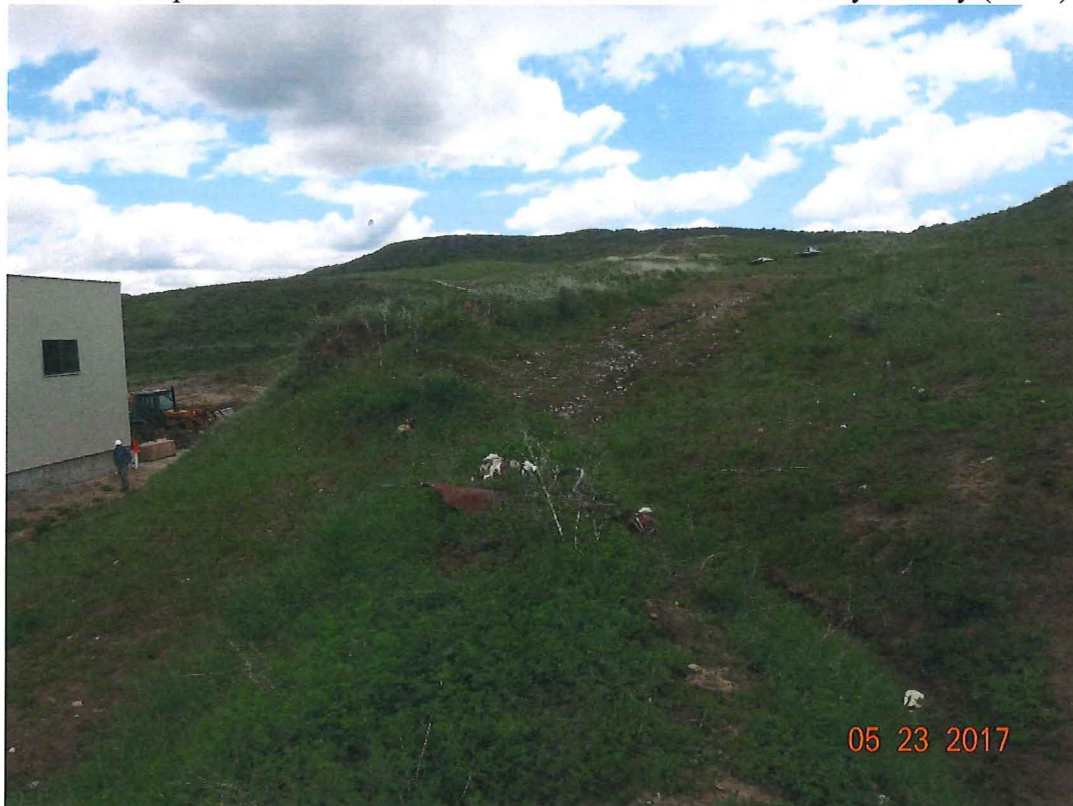
- a.) Exposed waste was noted to be present near the new MRF building where a slope had been pulled back.

The inspection group left the main landfill office on foot and headed south towards the newly completed Material Recovery Facility (MRF). The MRF building was observed as well as the slope directly to the west of the MRF building. Some exposed waste was present here where the slope had been pulled back to provide adequate room for the MRF building (see photos 1-2).

Photo 1: Exposed waste in hillside next to new Material Recovery Facility (MRF)

Photo 2: Exposed waste on hillside next to new MRF building

Requested Action 3: Immediately place required amounts of daily/intermediate/final cover in the areas noted above. Photographs documenting this placement of additional cover shall be sent to the Department within seven (7) calendar days of your receipt of this Compliance Advisory.

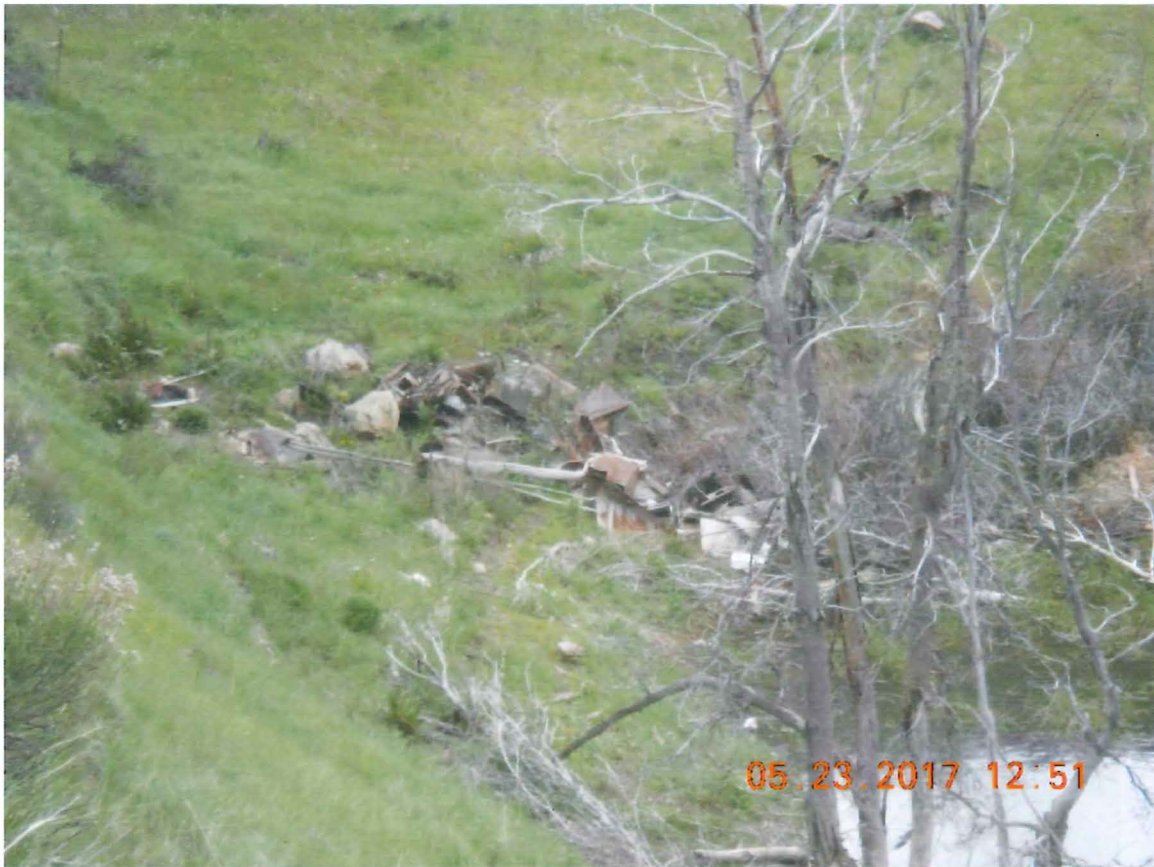
Deficiency 8: Waste was noted to be present in surface water/groundwater in the Doug's Drainage area in apparent violation of 6 CCR 1007-2, Section 3.1.9. It appeared as though a load had been historically dumped in this area, and there was a large equipment tire present in this area as well.

The inspection group proceeded to the south up the slope to the west of the MRF building. There is a drainage area in this portion of the facility that is referred to as "Doug's Drainage". Solid waste was noted to be present in the surface water in this feature (see photo 3). The area just to the north of Doug's Drainage was also examined while the group was in this area. There appeared to be a large amount of historically placed compost material in this location (see photos 4-7). Although Twin Enviro representatives indicated that the compost material was "finished" compost (i.e. it had been tested and passed both temperature holding time and pathogen reduction parameters), the compost material did not appear to have been screened, as large pieces of plastic and bone were noted to be present in the compost material. Vegetation in this area was also observed to be well established.

Photo 3: Solid waste present in surface water in “Doug’s Drainage”

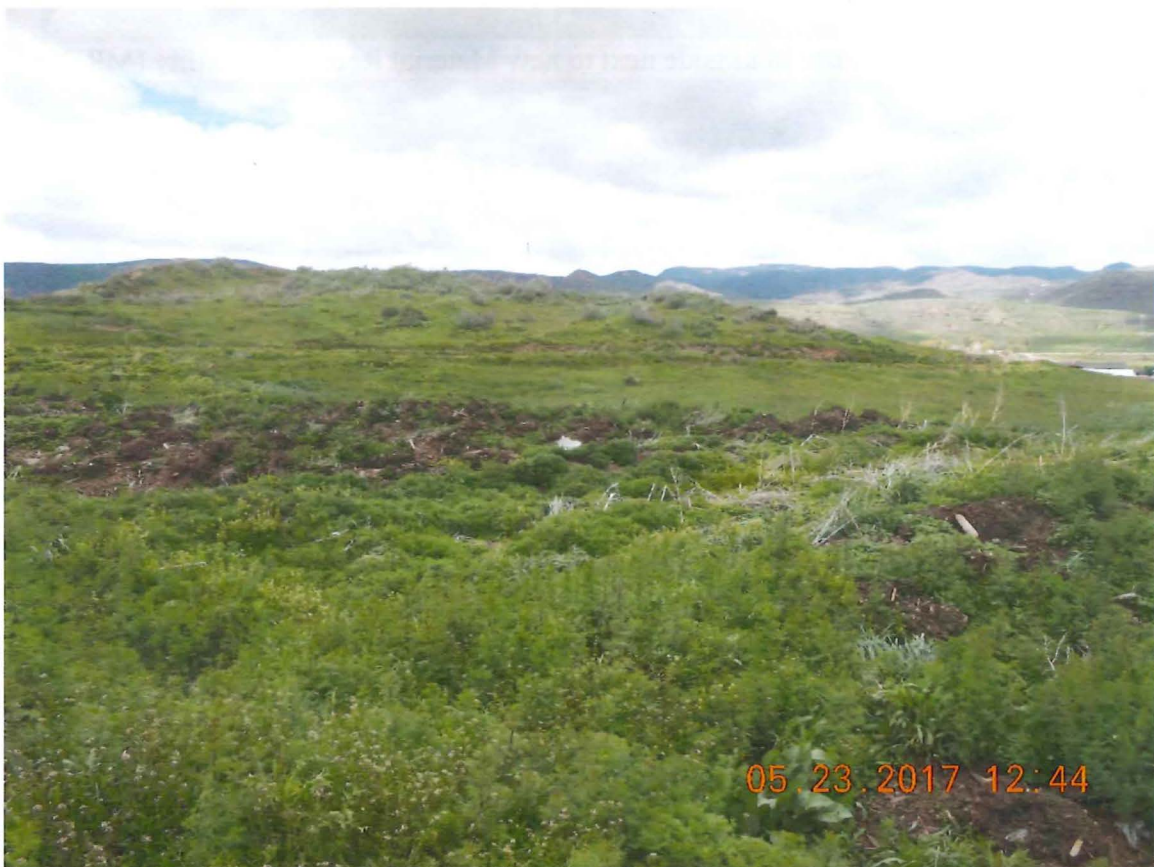
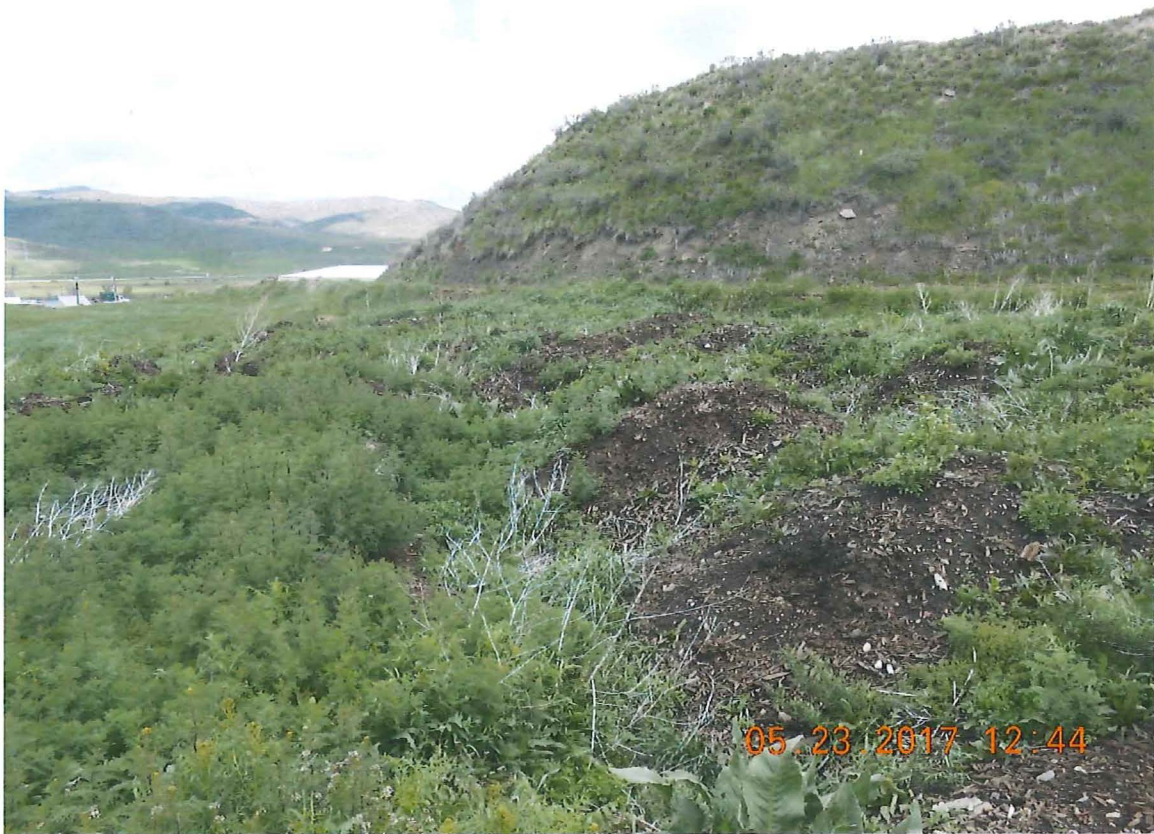
Photo 4: Unscreened compost applied in piles to area near Pit 5

Photo 5: Unscreened compost applied in piles to area near Pit 5

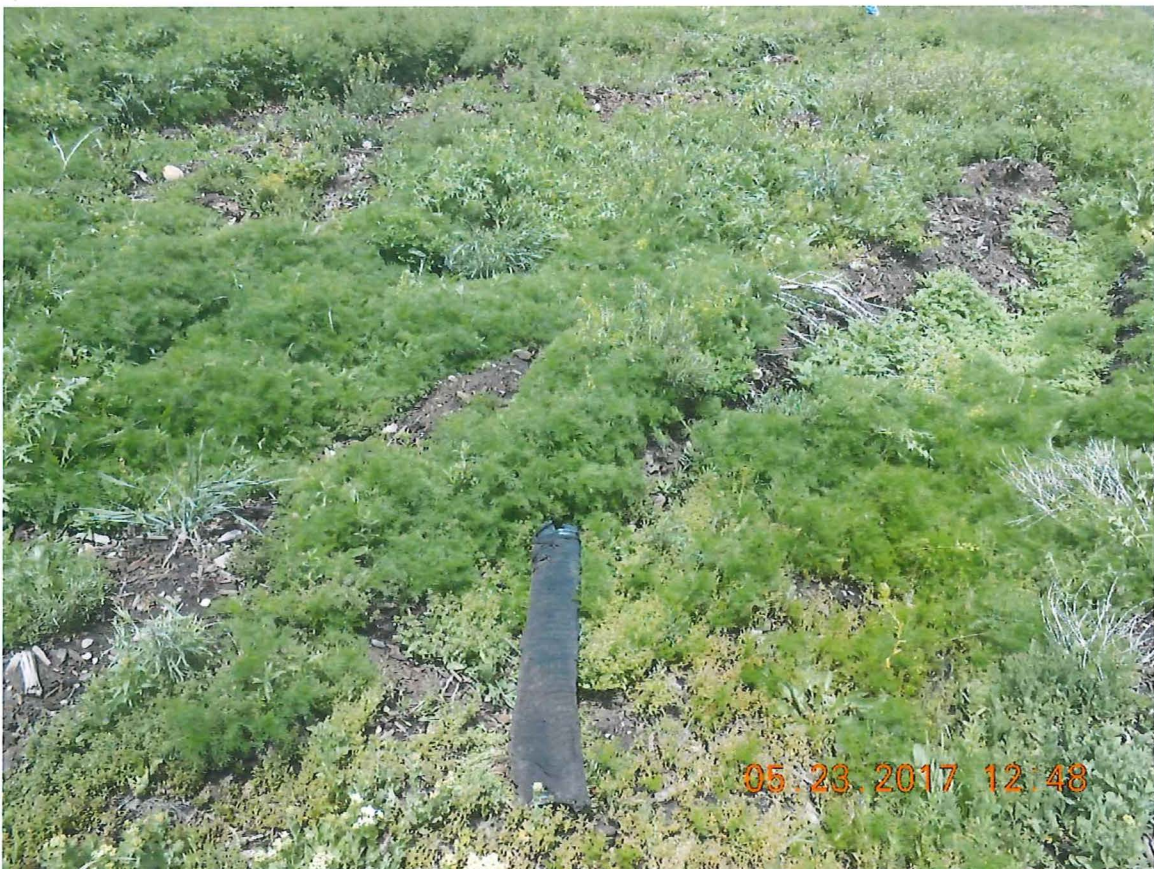
Photo 6: Plastic drainage pipe in compost near Pit 5 area

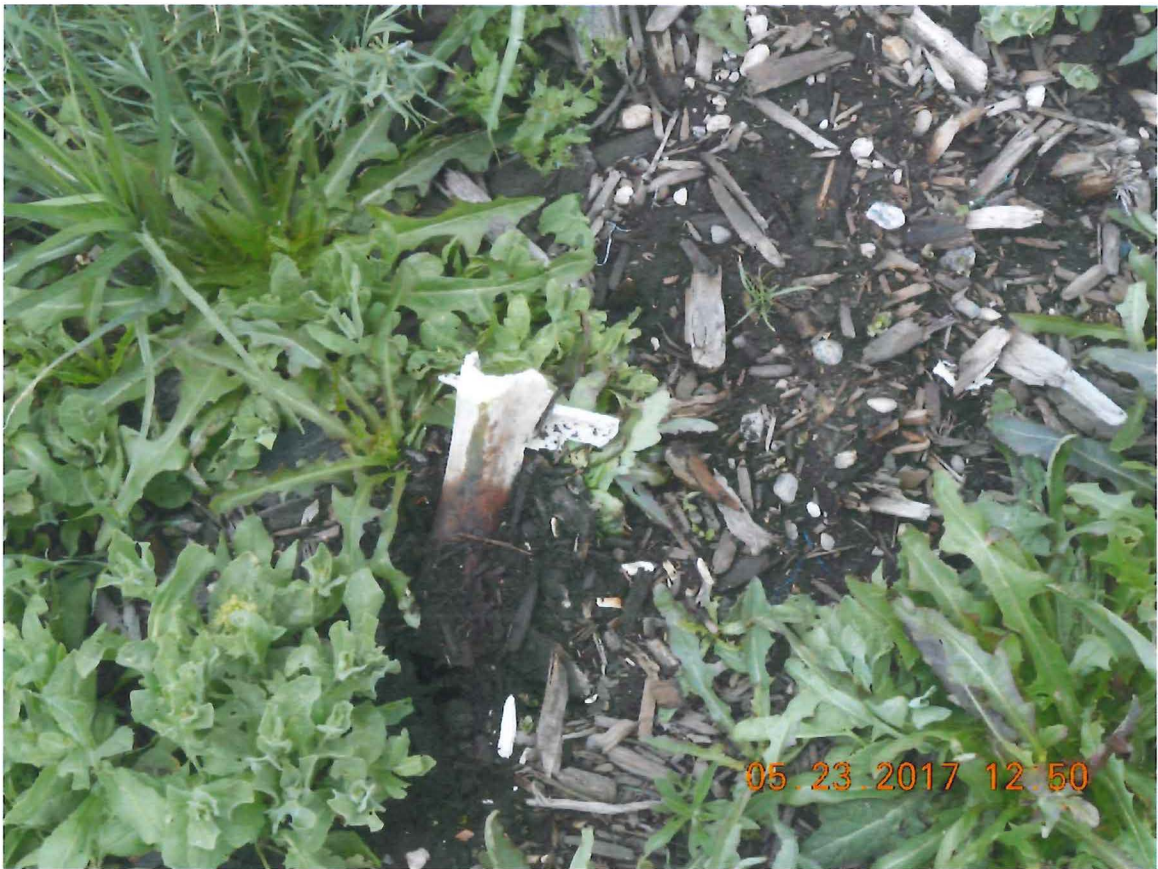
Photo 7: Bone in unscreened compost near Pit 5

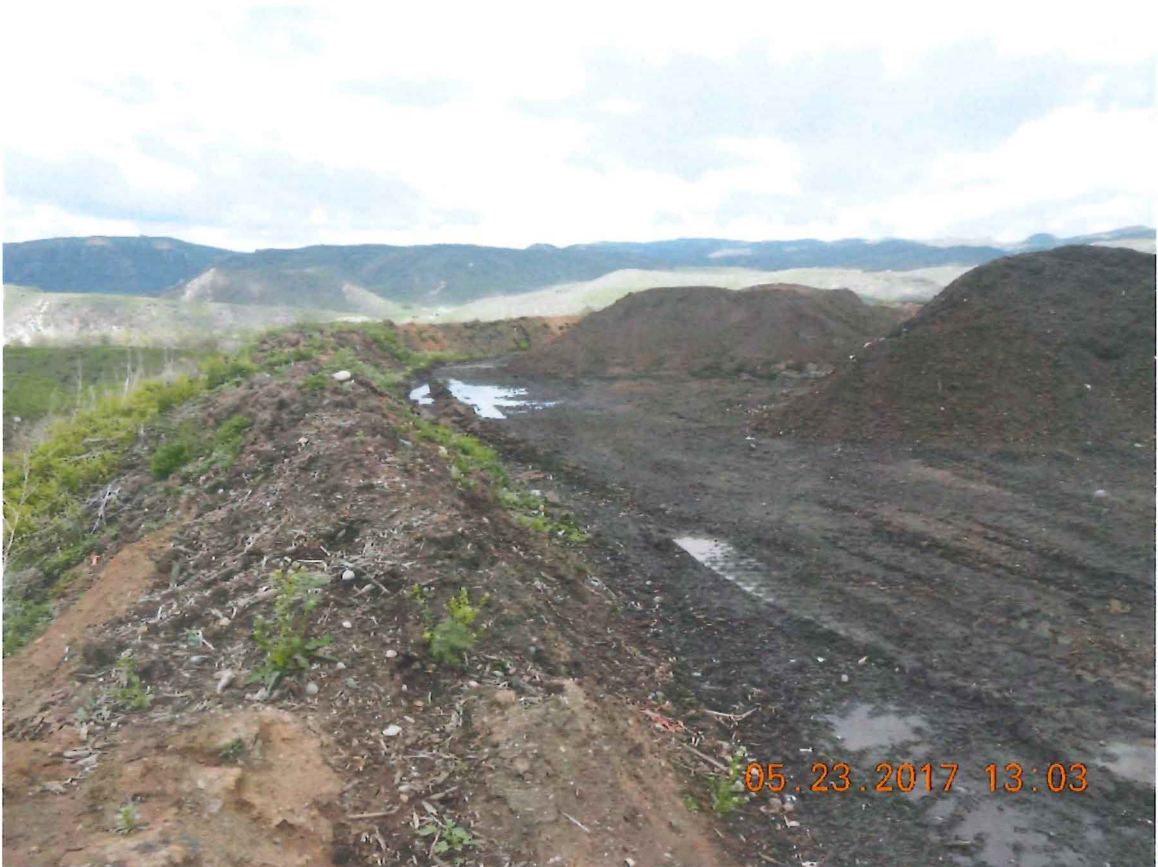
Photo 8: Newly enhanced berms around compost storage area

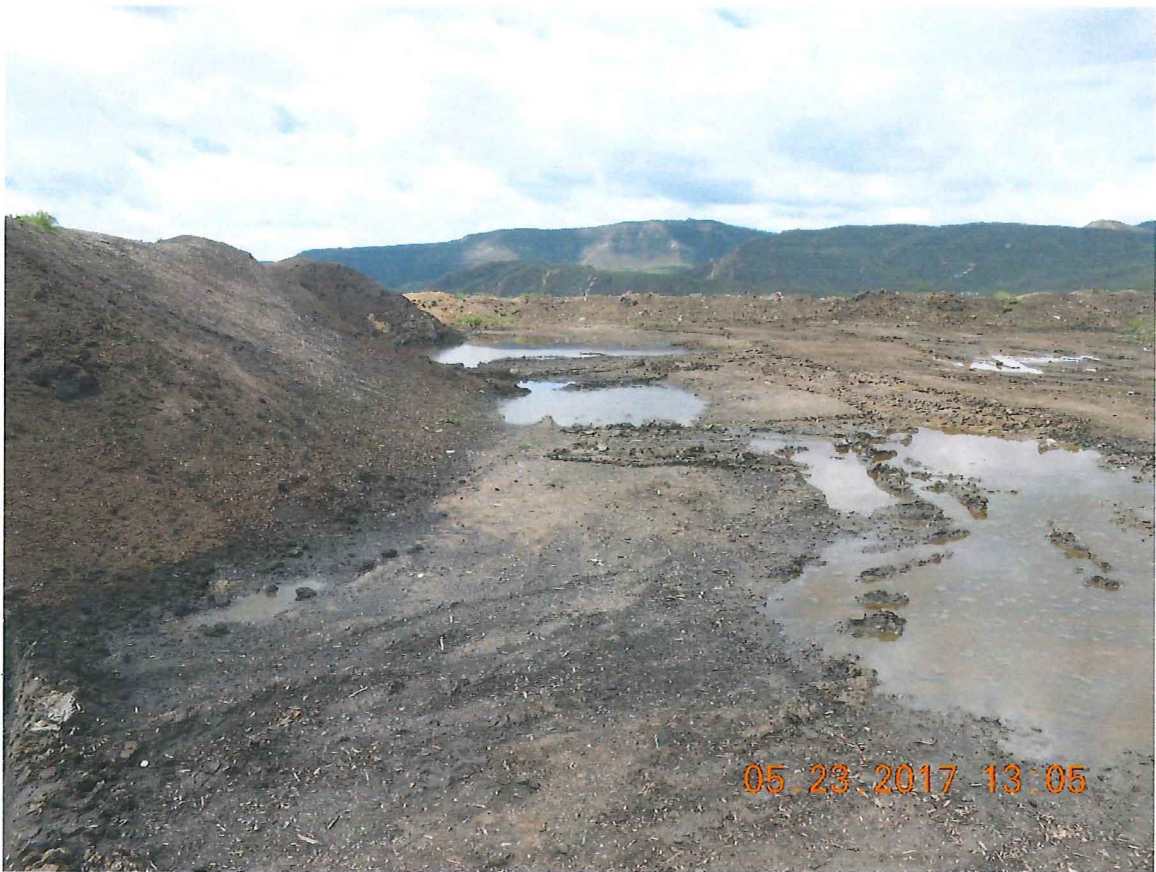
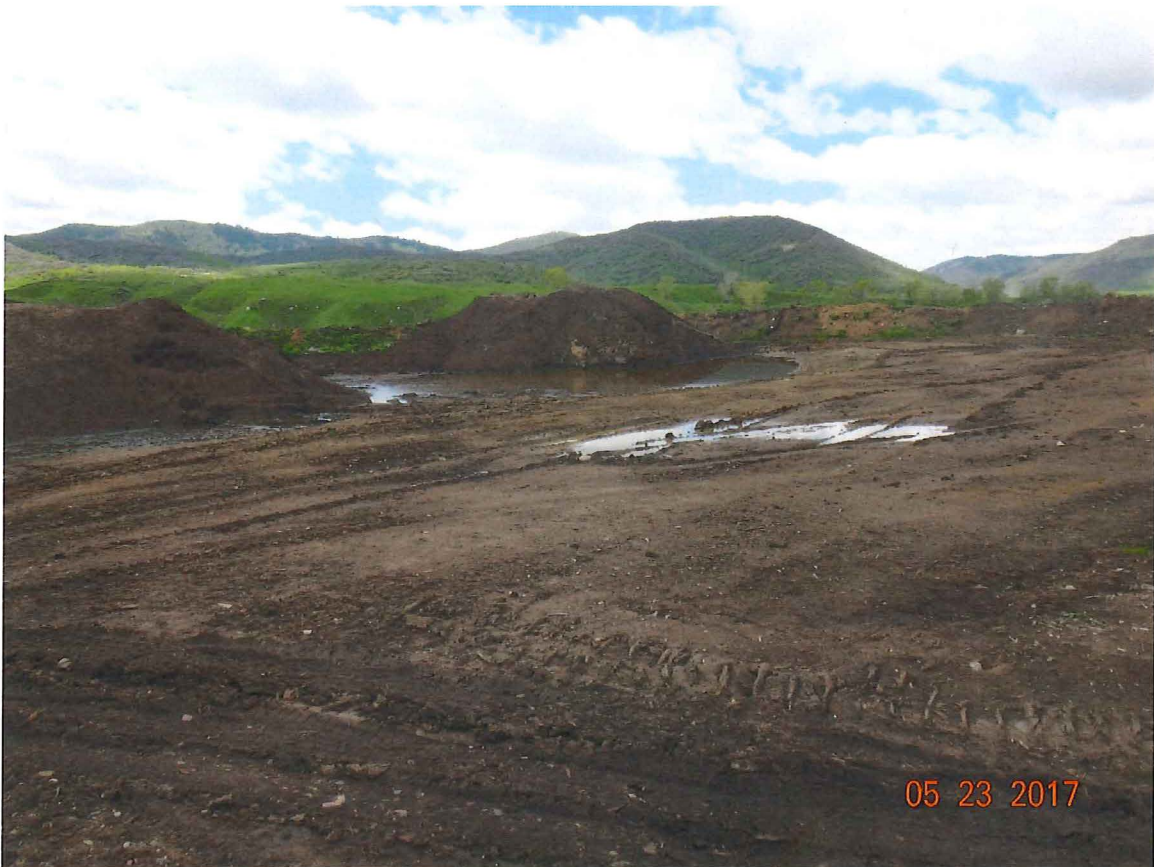
The next area of the facility that was examined was the composting operation. Minor ponding was noted to be present in the compost storage area, but the berming surrounding the area had been repaired in this area (since the previous inspection conducted on 5/12/16), and no liquids were noted to be running off from the area (see photos 8-10). The composting pad itself was also inspected and was noted to be in much better condition than it was in during the last inspection event. There was still not a wood chip operations layer on the work pad, but the work pad had been graded to drain towards the compost leachate collection pond. There were large piles of compost present on the work pad (see photos 11-12). Luke Schneider noted that these piles had not met temperature holding times, so could not technically be considered finished compost. Luke Schneider indicated that he would pursue beneficial use of this material as a soil amendment rather than using it as a finished compost product. An item of concern noted during the inspection of the work pad area was that there was storage of composting feedstock material that was occurring off of the work pad (see photos 13-14). The feedstock materials noted to be present off of the composting work pad included manure and food waste.

Photo 9: Ponding in compost storage area

Photo 10: Ponding in compost storage area

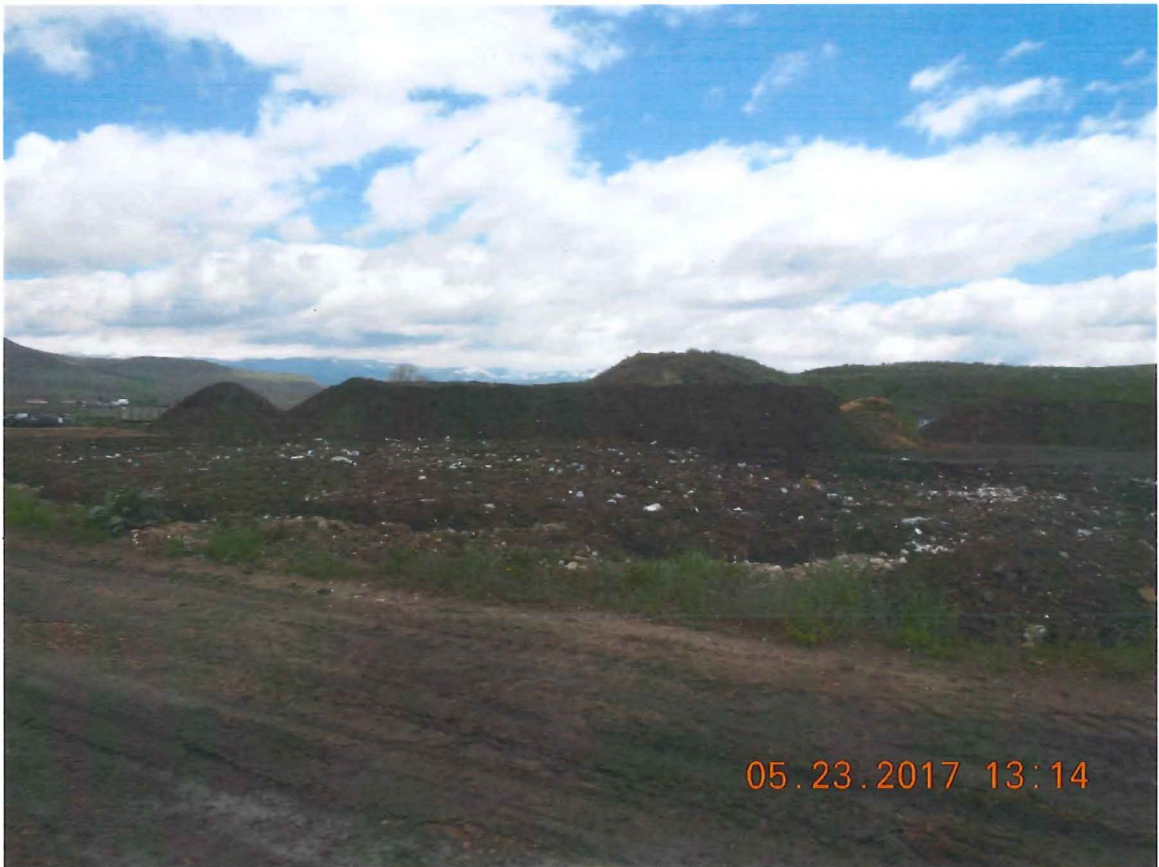
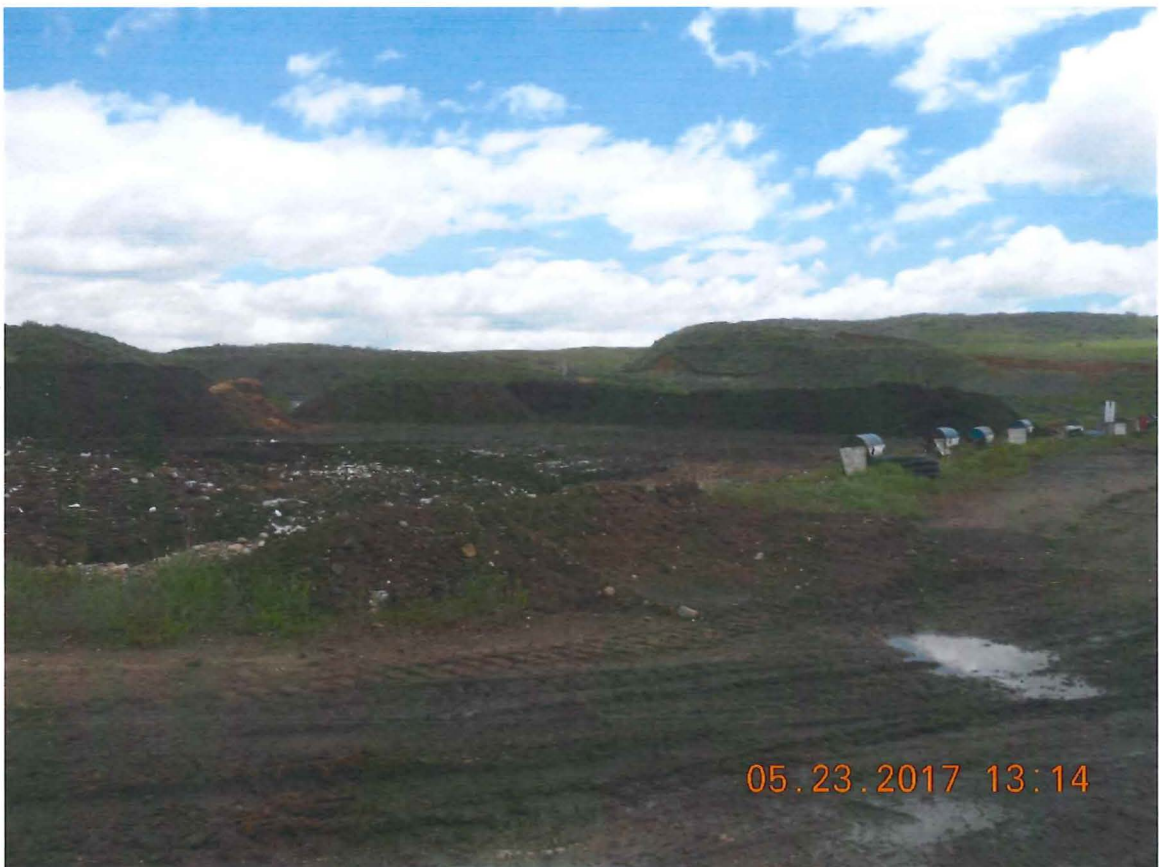
Photo 11: Piles of compost material on composting work pad that had not met “finished” standard

Photo 12: Piles of compost material on composting work pad that had not met “finished” standard

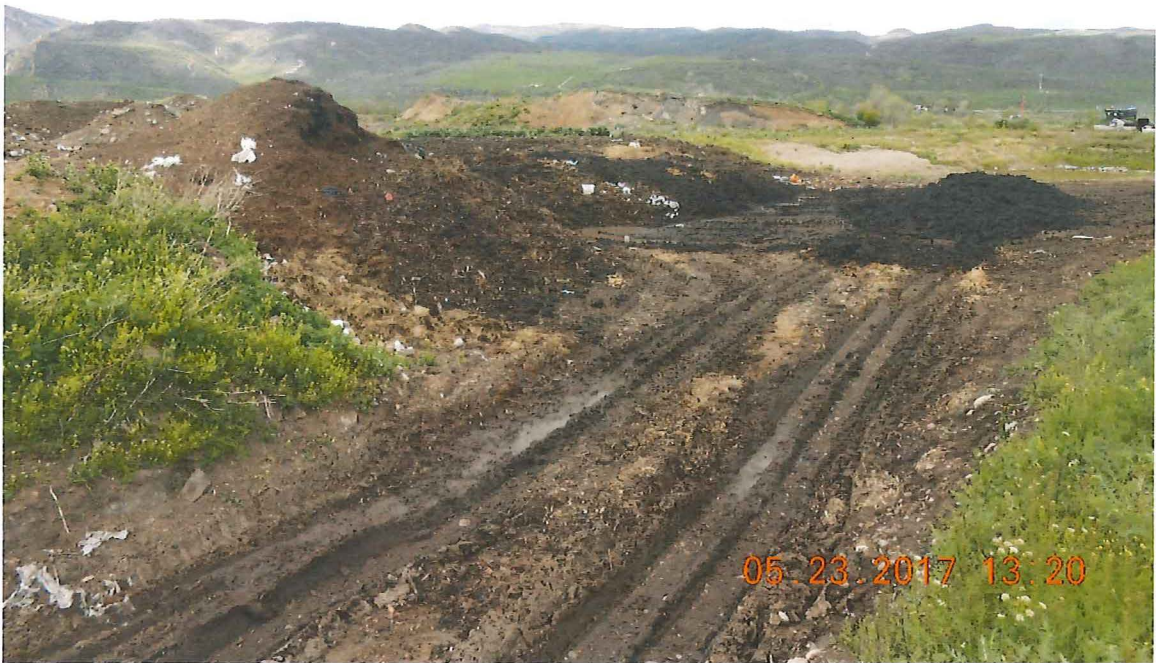
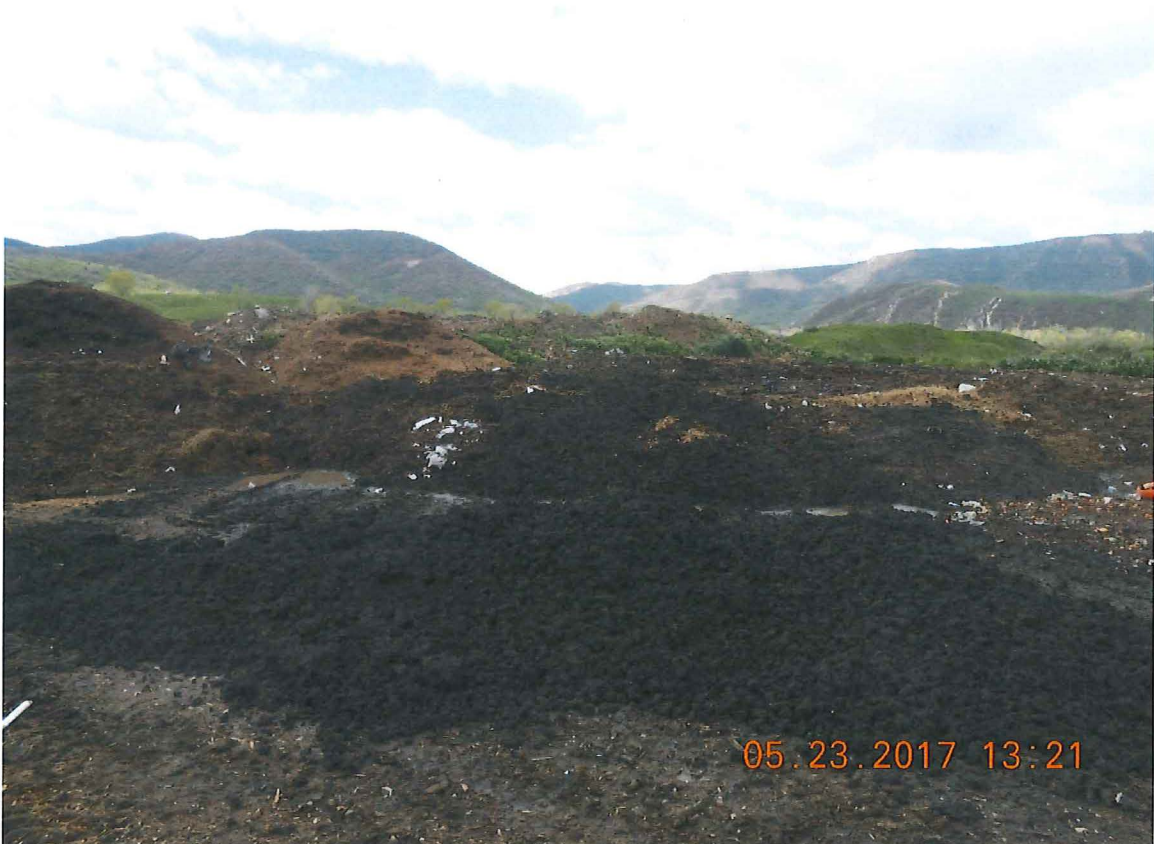
Deficiency 10: Storage of horse manure/food waste was noted to be occurring off of the working pad in the composting area in apparent violation of Section 5.5.3.1 (Description of Composting Operation) of the Milner Landfill Compost Design, Operations and Closure Plan Amendment of the approved EDOP.

Photo 13: Feedstocks (manure and food waste) stored off compost pad

Photo 14: Feedstocks (manure and food waste) stored off compost pad

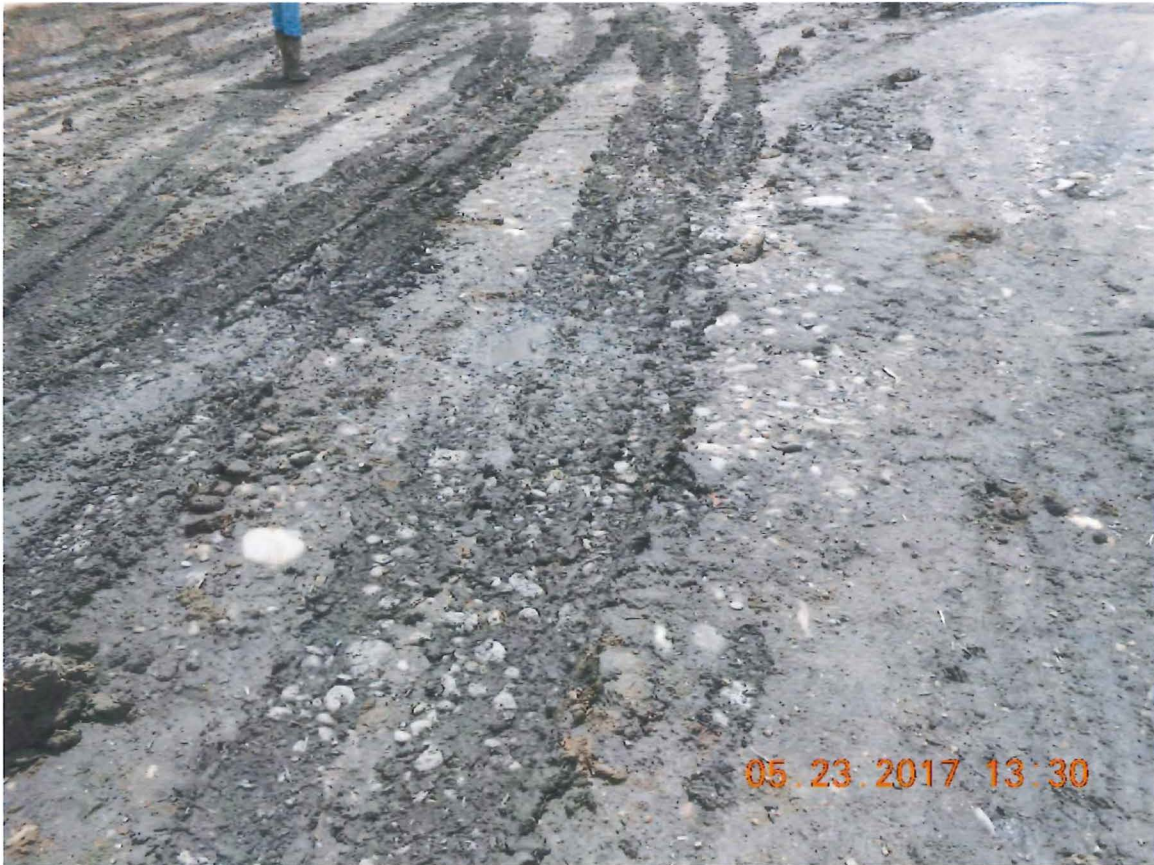
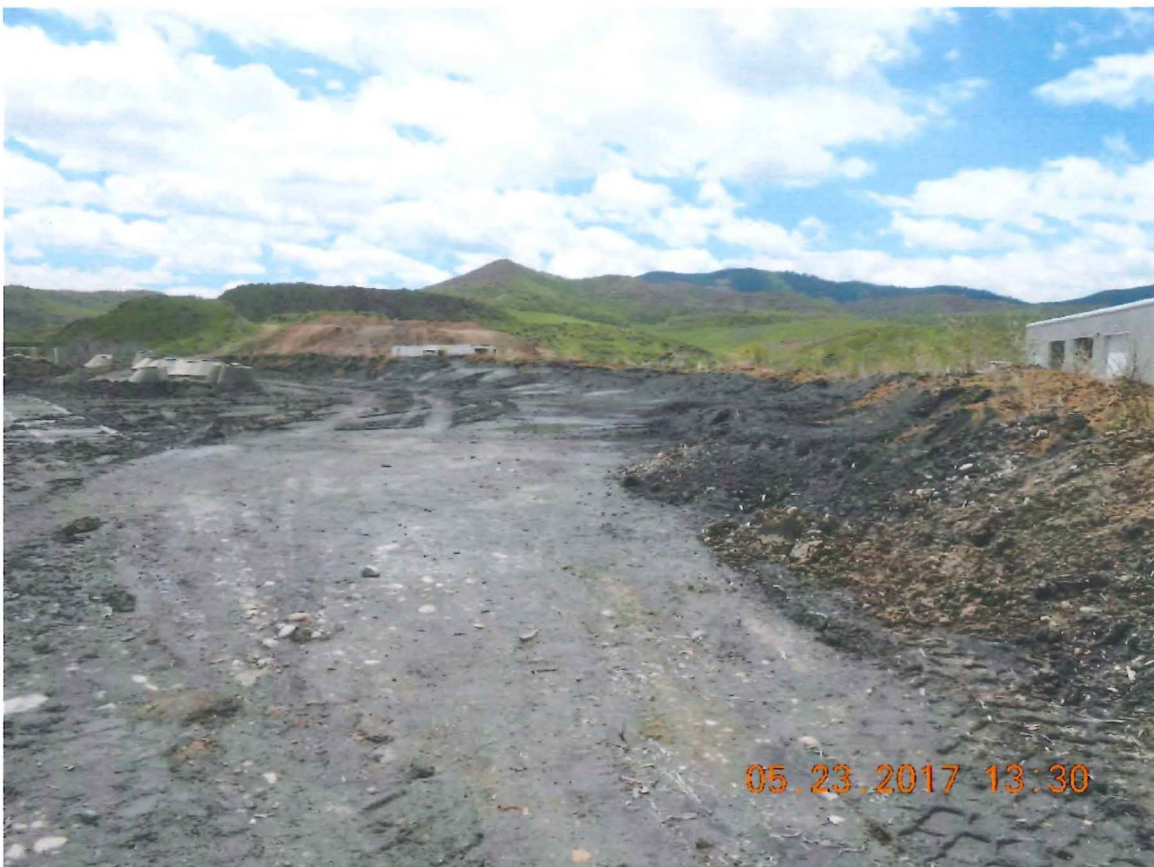
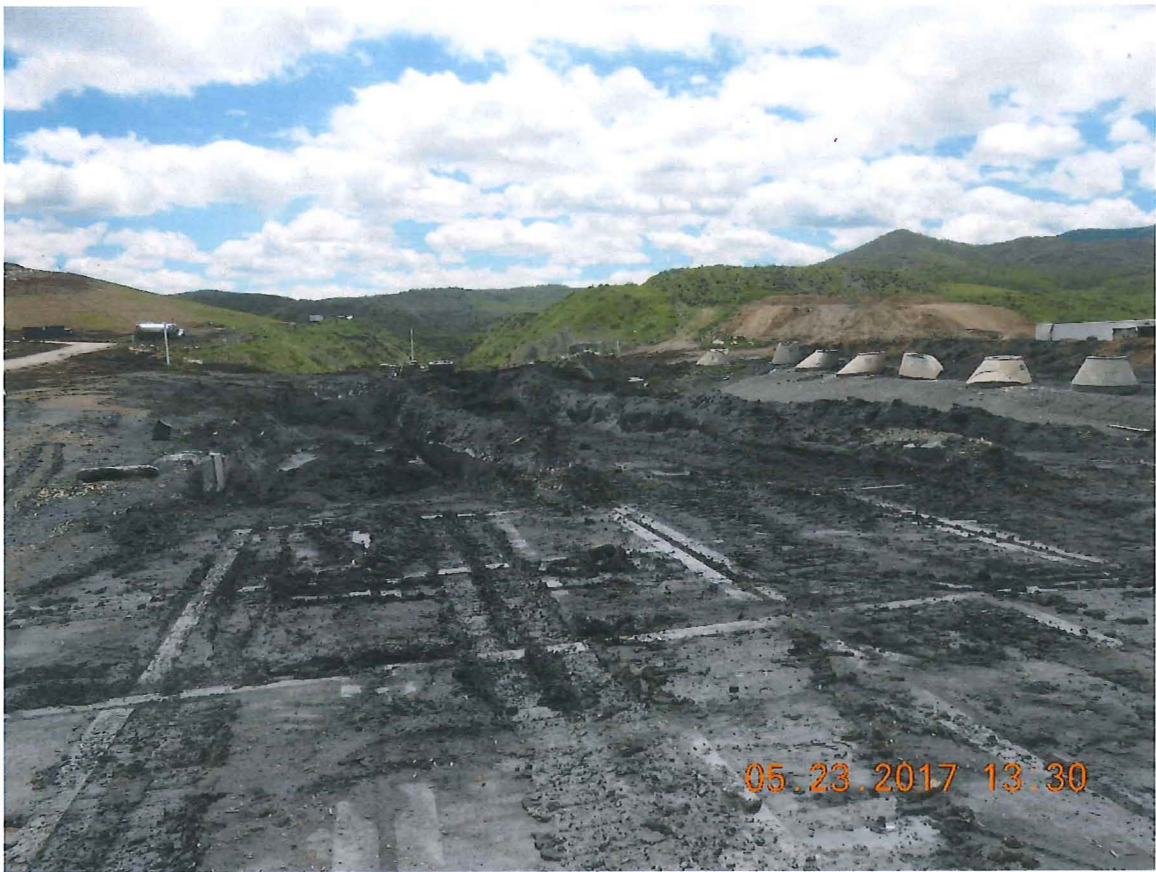
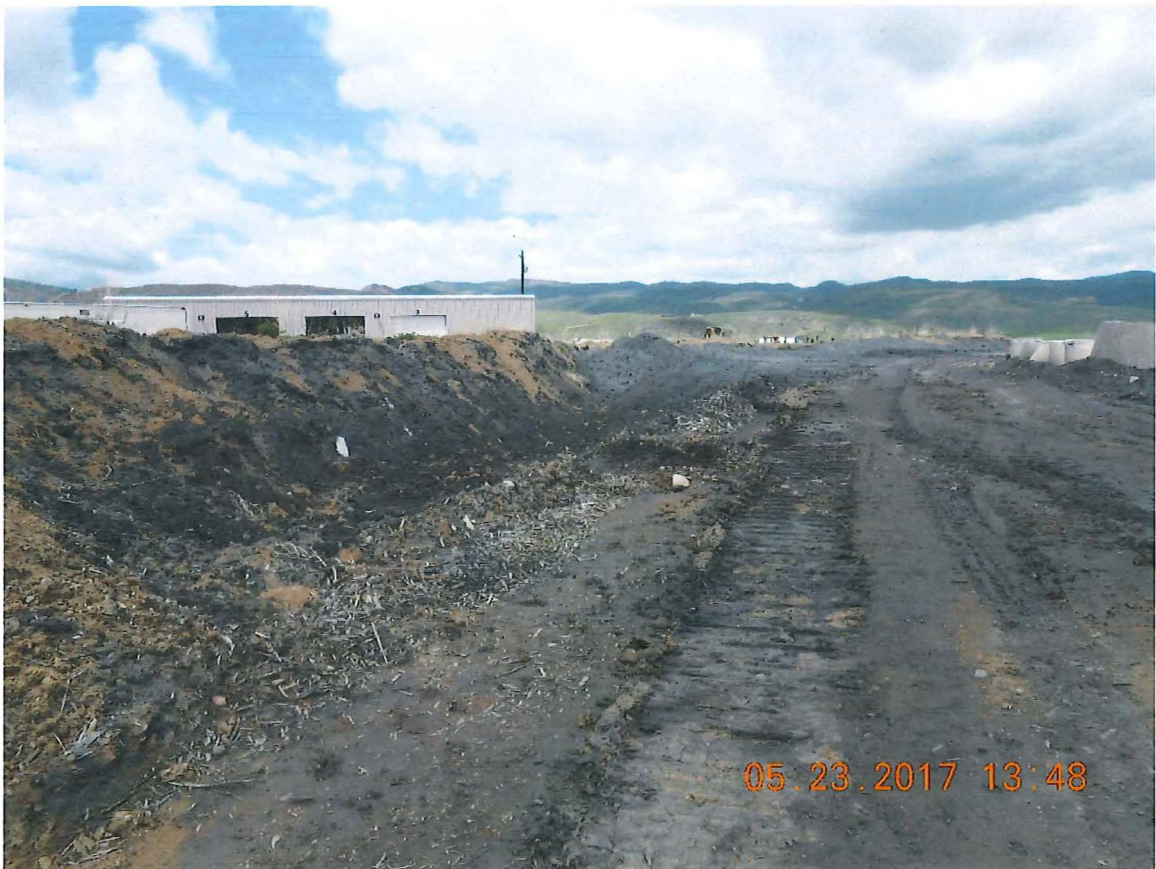
- a.) Ash was noted to be prevalent in areas surrounding the solidification basin from spillage and/or tracking, in apparent violation of Section 5.4.3.1 (Waste Flow) of the Solidification Basin Design, Operations and Closure Plan Amendment (Section 5.4 of the D&O Plan) of the approved EDOP.

The inspection group then proceeded to the solidification basin. A substantial amount of ash material was noted to be present outside of the basin area (areas surrounding the basin and on the haul roads around the basin) (see photos 15-18). This was likely due to spillage and/or tracking of

Photo 15: Ash all over ground surface around solidification basin

Photo 16: Ash all over ground surface around solidification basin

Photo 17: Ash all over ground surface around solidification basin

Photo 18: Ash tracked out of solidification basin area

- a.) Within fourteen (14) calendar days of your receipt of this Compliance Advisory ensure that all ash material is removed from the areas surrounding the solidification basin and appropriately disposed of in the working face of the landfill and submit photographs documenting this action.

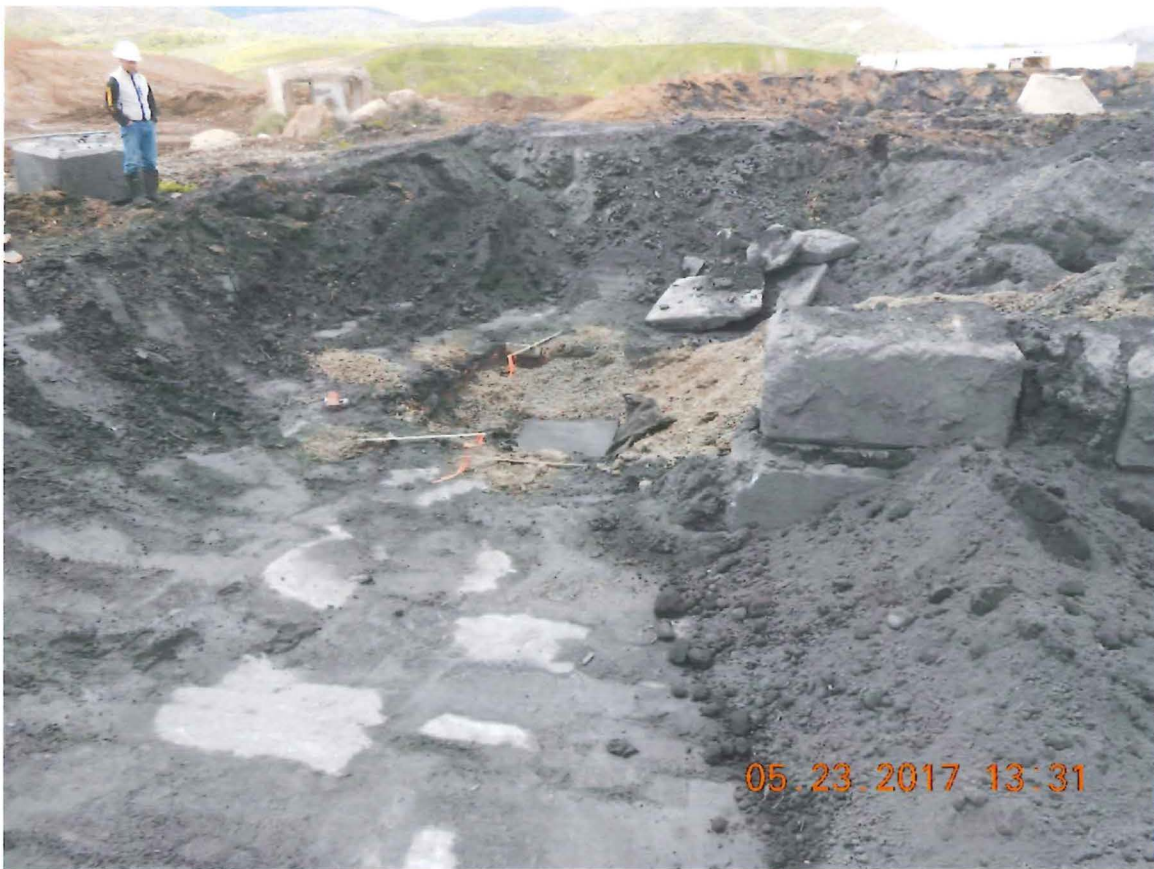
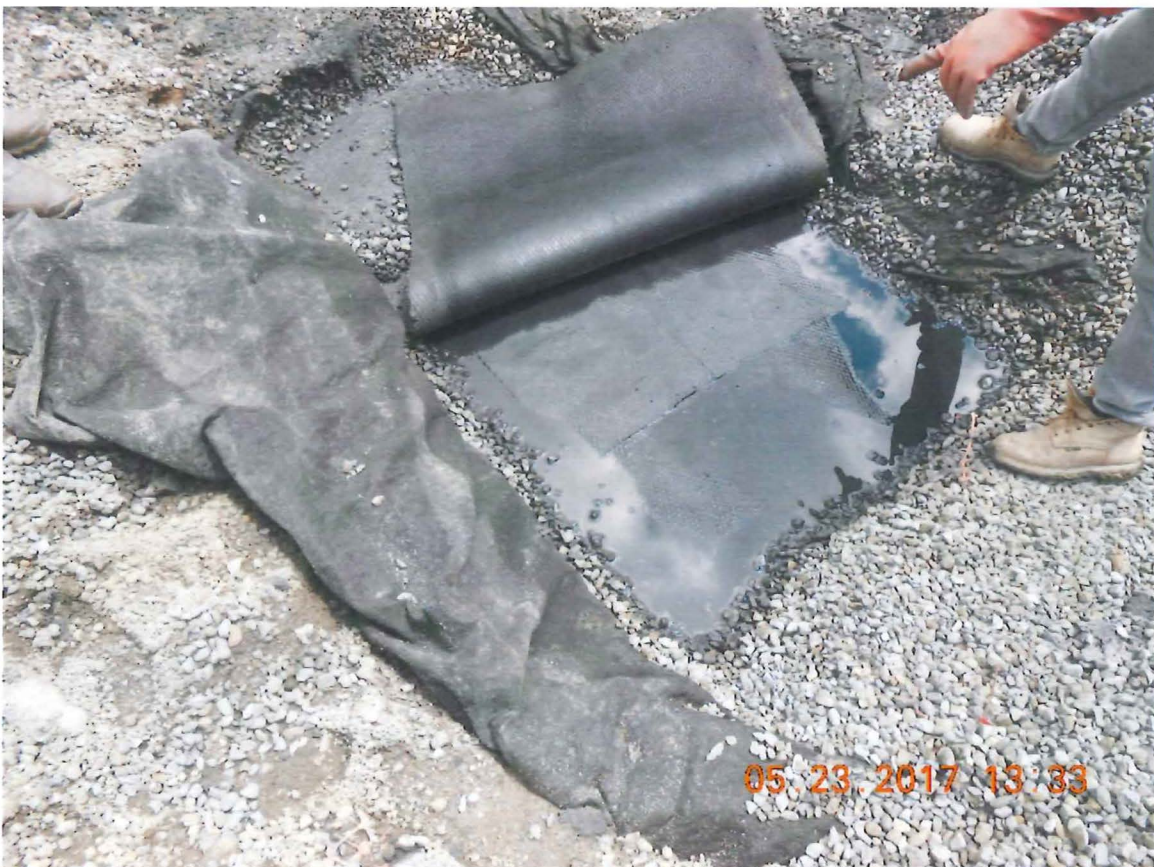
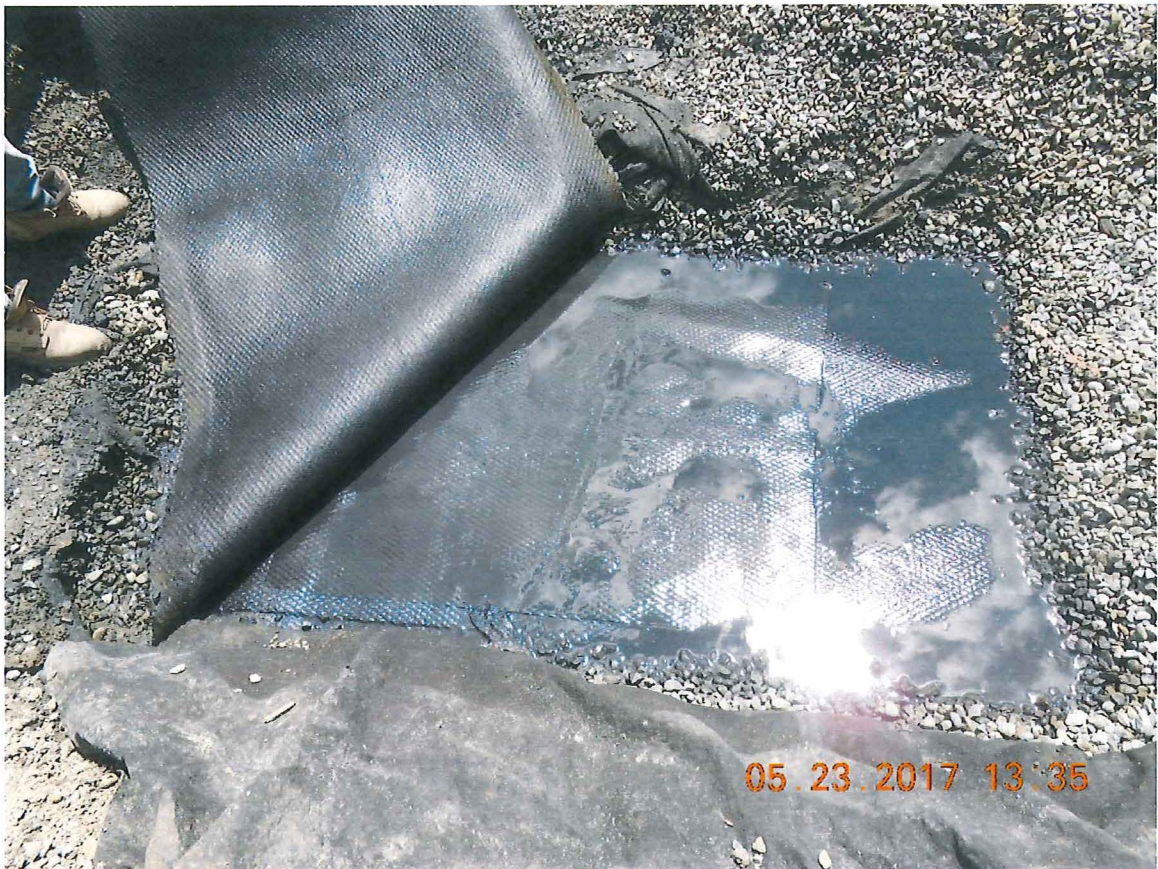
- a.) Results of prior testing events on the "coupon" installed in the solidification basin liner system could not be produced by the facility, in apparent violation of Section 5.4.3.3 of the Solidification Basin Design, Operations and Closure Plan Amendment (Section 5.4 of D&O Plan) of the approved EDOP. The coupon is much reduced from the specified installation size seeming to indicate one or two testing events have occurred in the past. As testing will require a significant portion of the coupon for each event, and based on the remaining size of the reduced coupon, it appears that the facility will be unable to comply with the requirement for 5 testing events for the liner in the solidification basin, resulting in a violation of Section 5.4.1.4 (Compatibility with the PPE Liner) of the Solidification Basin Design, Operations and Closure Plan Amendment (Section 5.4 of the D&O Plan) of the approved EDOP.

ash material out of the solidification basin. A portion of the solidification basin had been excavated just prior to the inspection event (see photos 19-21). This excavation was done to expose the coupon installed in the liner system for the purposes of destructive testing. As mentioned previously, the coupon was noted to be much smaller than was anticipated for not having completed any testing events to this point. This calls into question as to whether any previous coupon testing events have been completed at the facility, but the facility could not produce any records of any such testing having been conducted in the past. The less than anticipated quantity of the coupon will result in the facility not being in compliance with the solidification basin EDOP, as this document required 5 coupon testing events to be completed. There will not be enough coupon for 5 testing events since the destructive testing of the coupon requires a significant portion of material to be performed.

Photo 19: Excavation to expose coupon in the solidification basin

Photo 20: Exposed coupon in solidification basin

Photo 21: Exposed coupon in solidification basin
