COLORADO
Department of Public
Health & Environment

Re: Compliance Advisory for the Milner Landfill:
Twin Enviro Services
20650 County Road 205
Steamboat Springs, CO 80487
SW RTT MIL 1.6

Attachment 1 - Photo Log

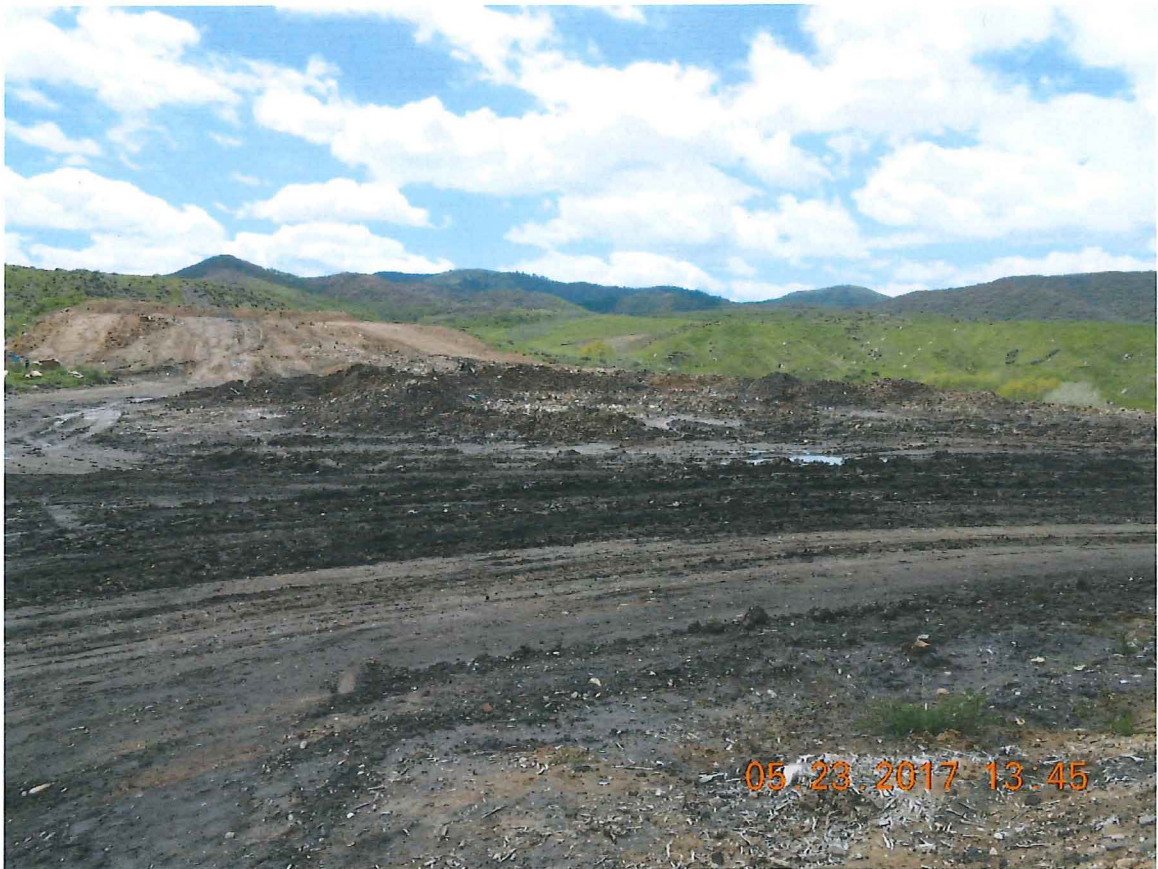
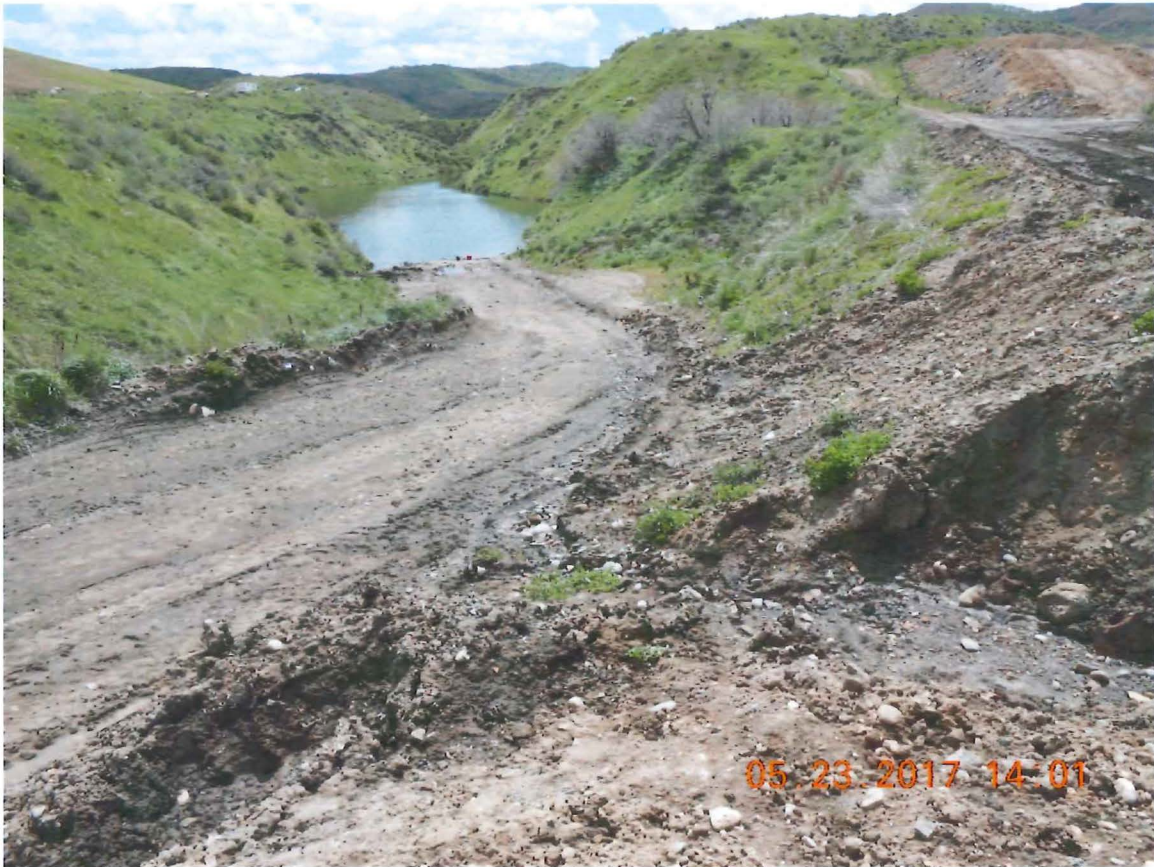
- a.) It was noted that storm water/runoff from the facility's snowmelt area was not being adequately controlled and sediment was being allowed to discharge to surface waters.
- b.) The facility did not have appropriate sediment control in place at the West borrow area.

The inspection group then moved south of the solidification basin area and observed a soil stockpile area that was also utilized this past winter/spring as the facility's snow management area. Storm water control features were noted to be absent in this area and runoff from this area was noted to making its way down a hill to a discharge point into surface water. The runoff had created channels in the area that were readily visible (see photos 22-23). The western borrow area was also observed in this area and was noted not to have appropriate sediment control measures in place.

Photo 22: Snow melt storage area

Photo 23: Runoff location from snow melt storage area

Requested Action 7: Within thirty (30) calendar days of your receipt of this Compliance Advisory repair storm water control features that require it, and implement storm water control measures in the areas listed above where they are lacking.

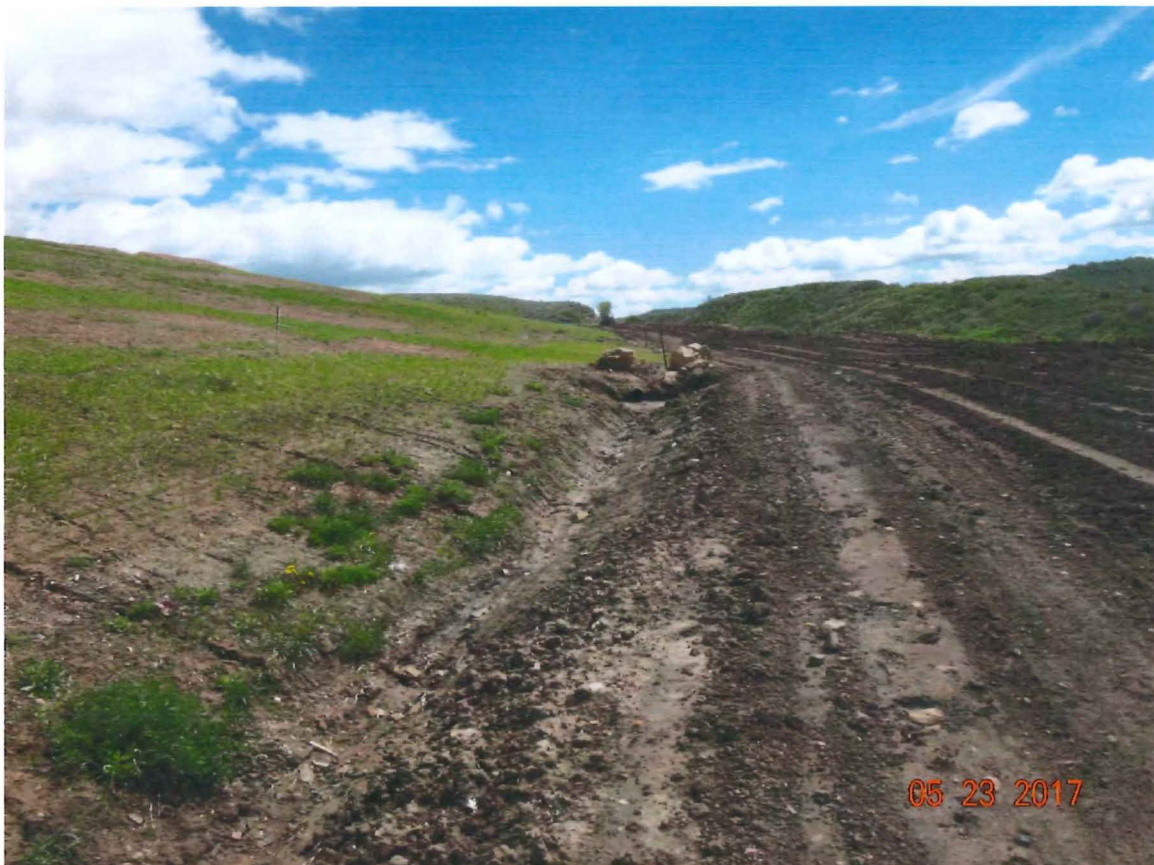
The inspection tour proceeded south along the western haul road for the facility. A couple of the storm water ditches in this area were noted to be partially filled in with sediment and likely required cleanout (see photos 24). Luke Schneider said that the facility may remove a culvert that conveys storm water from an area along the western edge of the landfill. This would be done to install a drainage ditch to eliminate sheet flow of storm water running over the buried culvert onto the western haul road of the facility.

Photo 24: Storm water ditch along W slope of active fill area (also note culvert in background which may be removed)

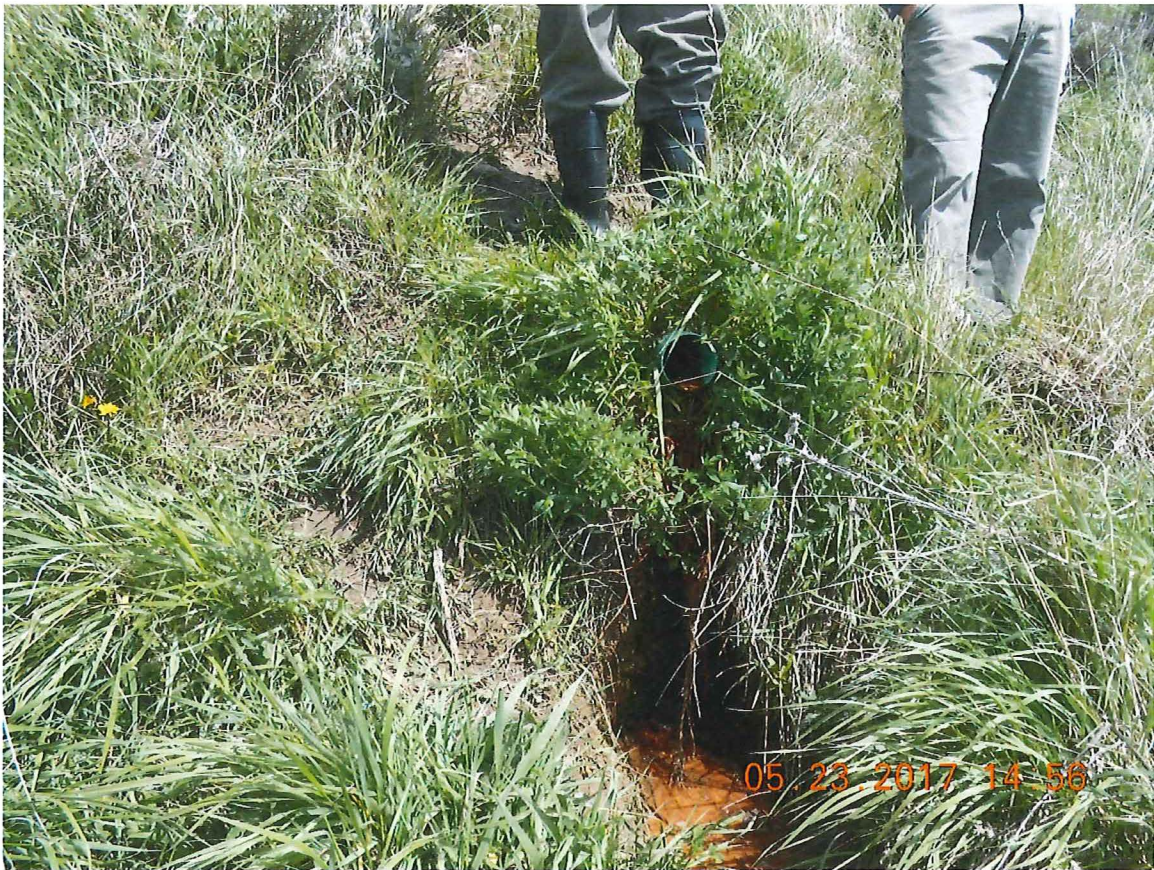
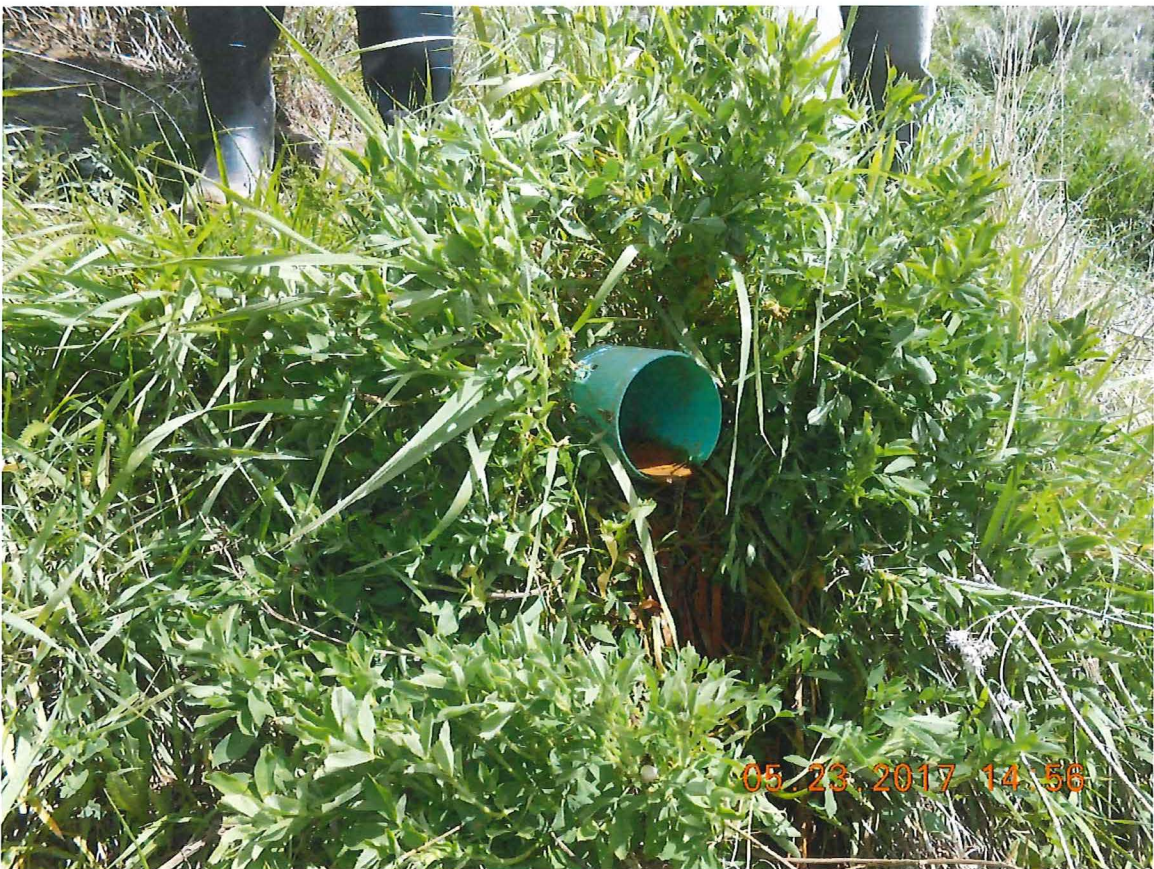
Photo 25: Original underdrain discharge point

Photo 26: Original underdrain discharge point

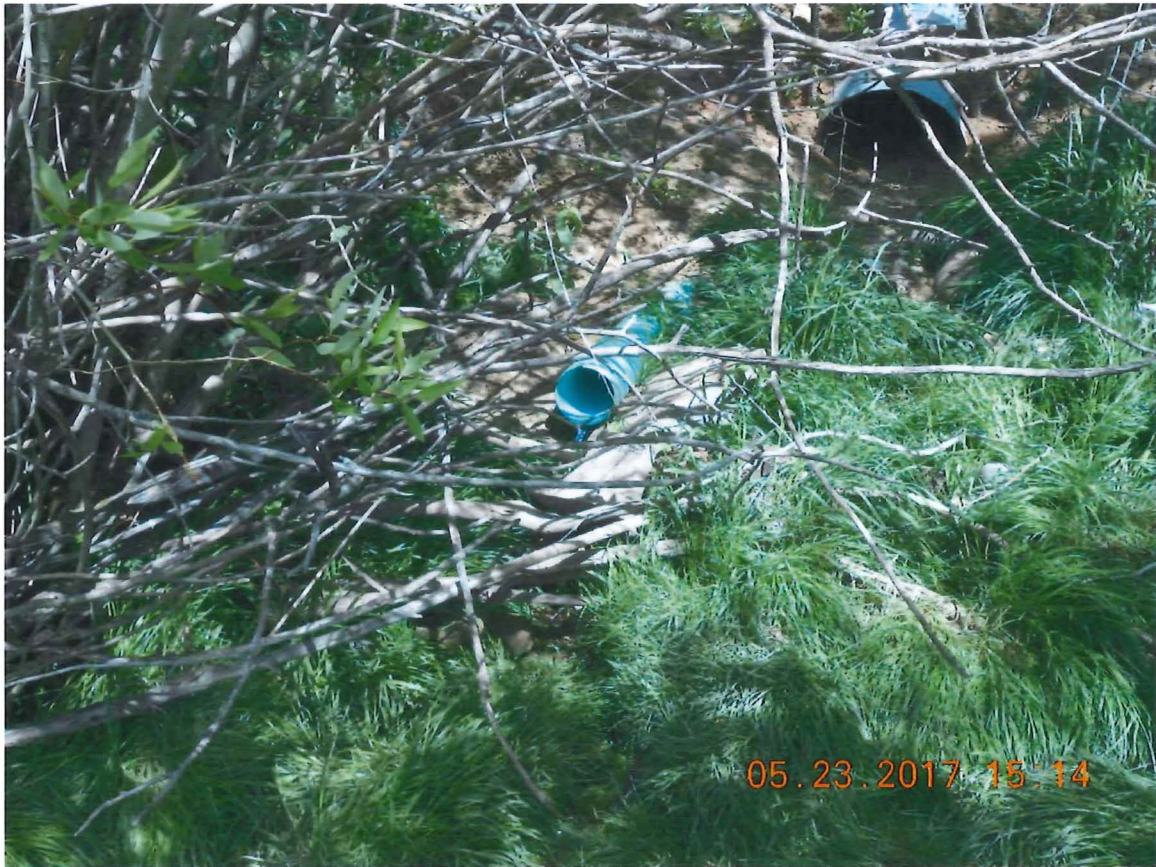
Photo 27: Newly constructed underdrain discharge point

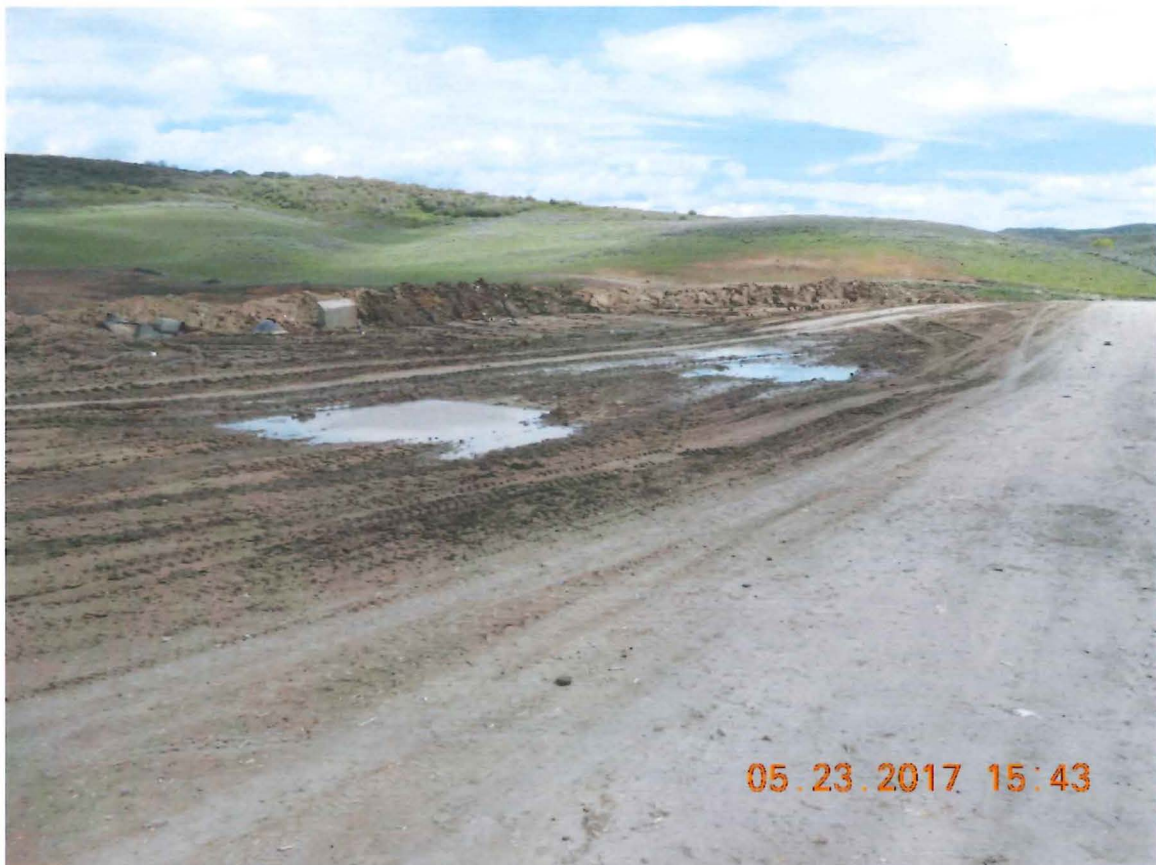
The inspection group proceeded around to the southeast and made its way to the working face of the landfill. Ponding water was noted to be present just to the south of the current working face at the landfill (see photo 28). Exposed waste was noted to be present in areas surrounding the working face of the landfill indicating insufficient daily cover had been placed in these areas (see

Photo 28: Ponding of water near working face

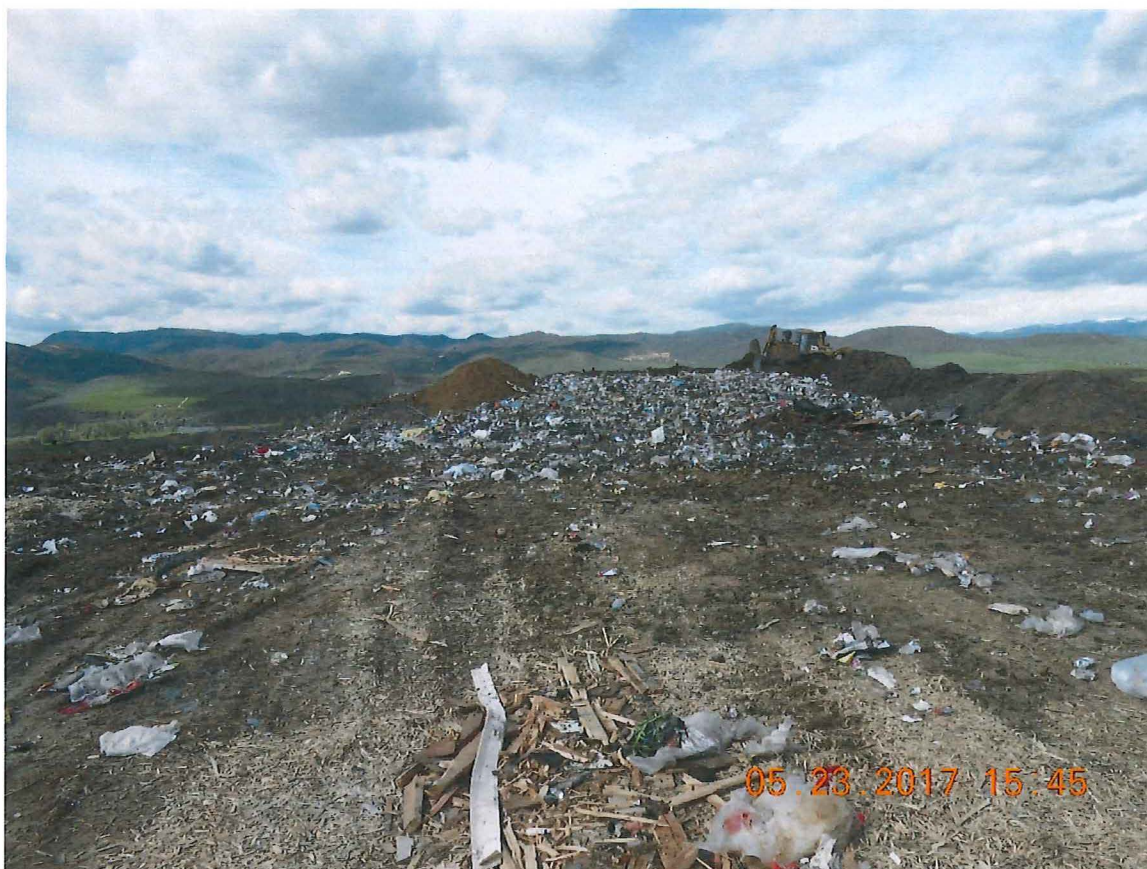
Photo 29: Active working face

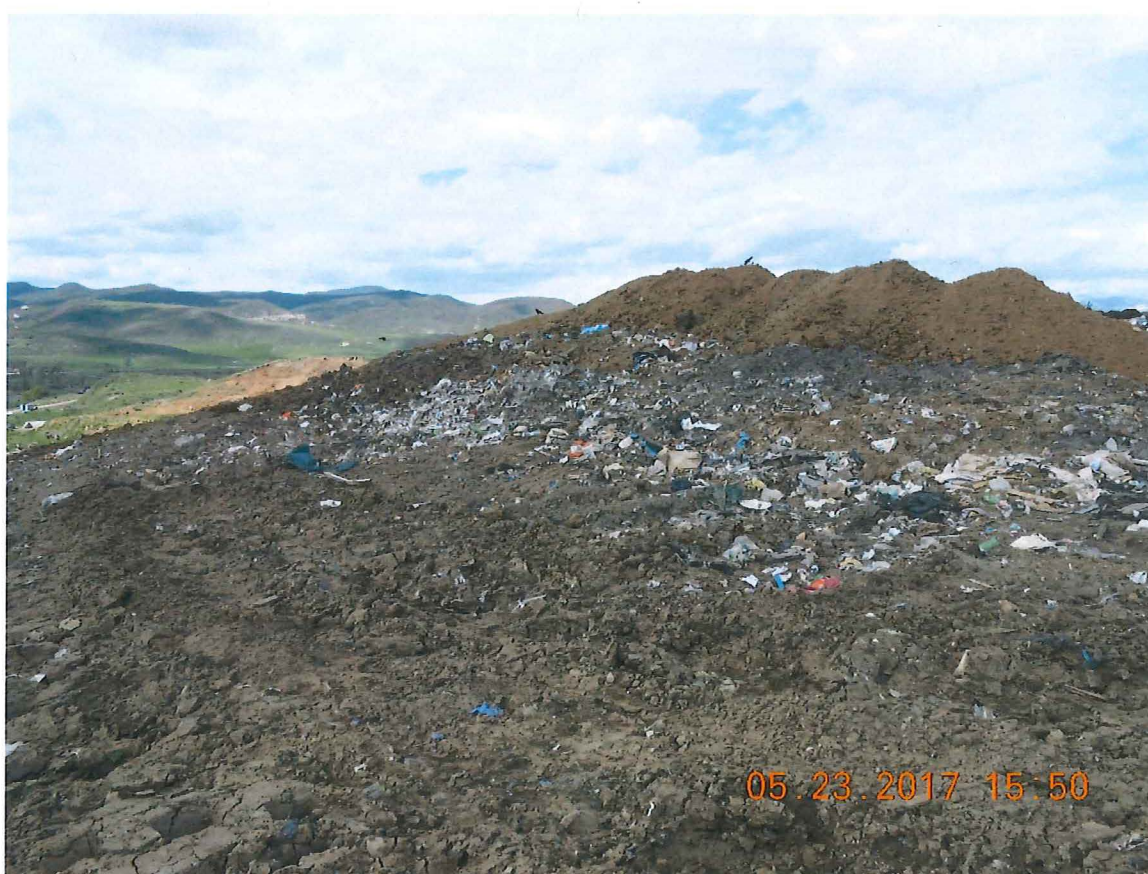
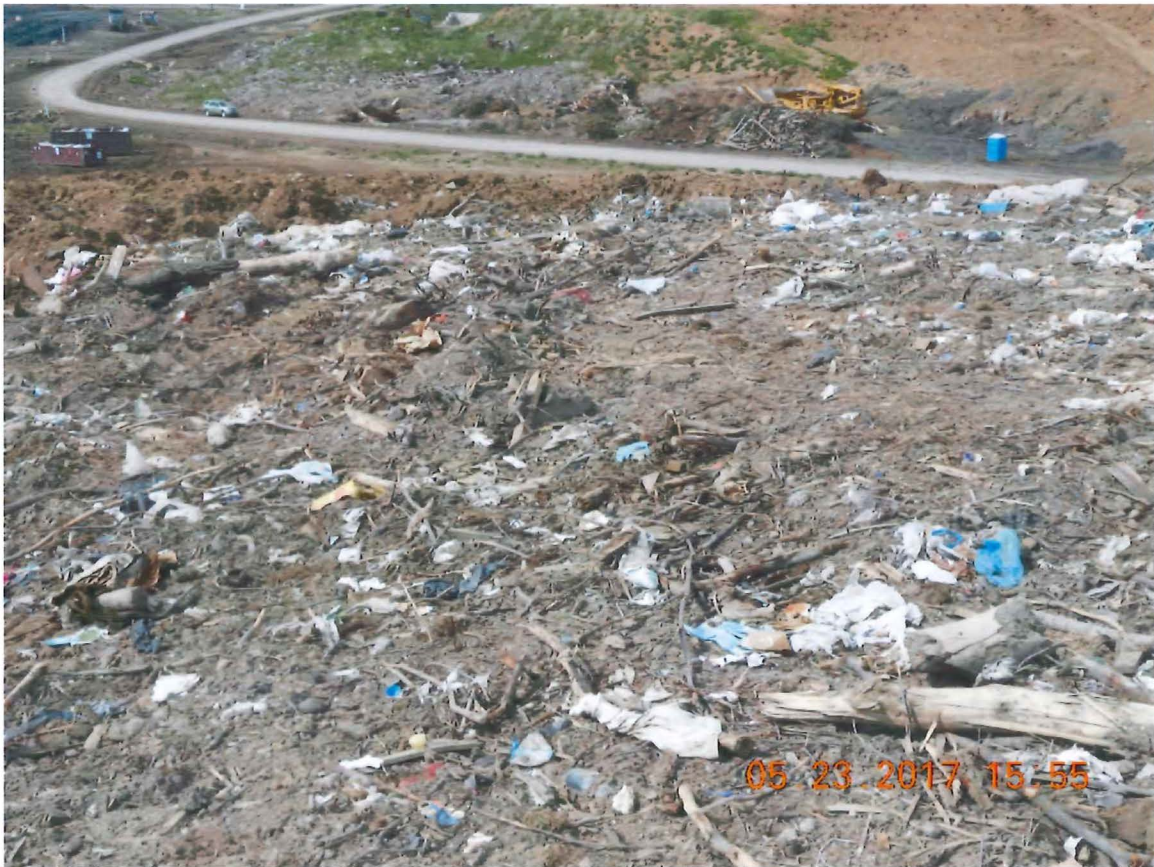
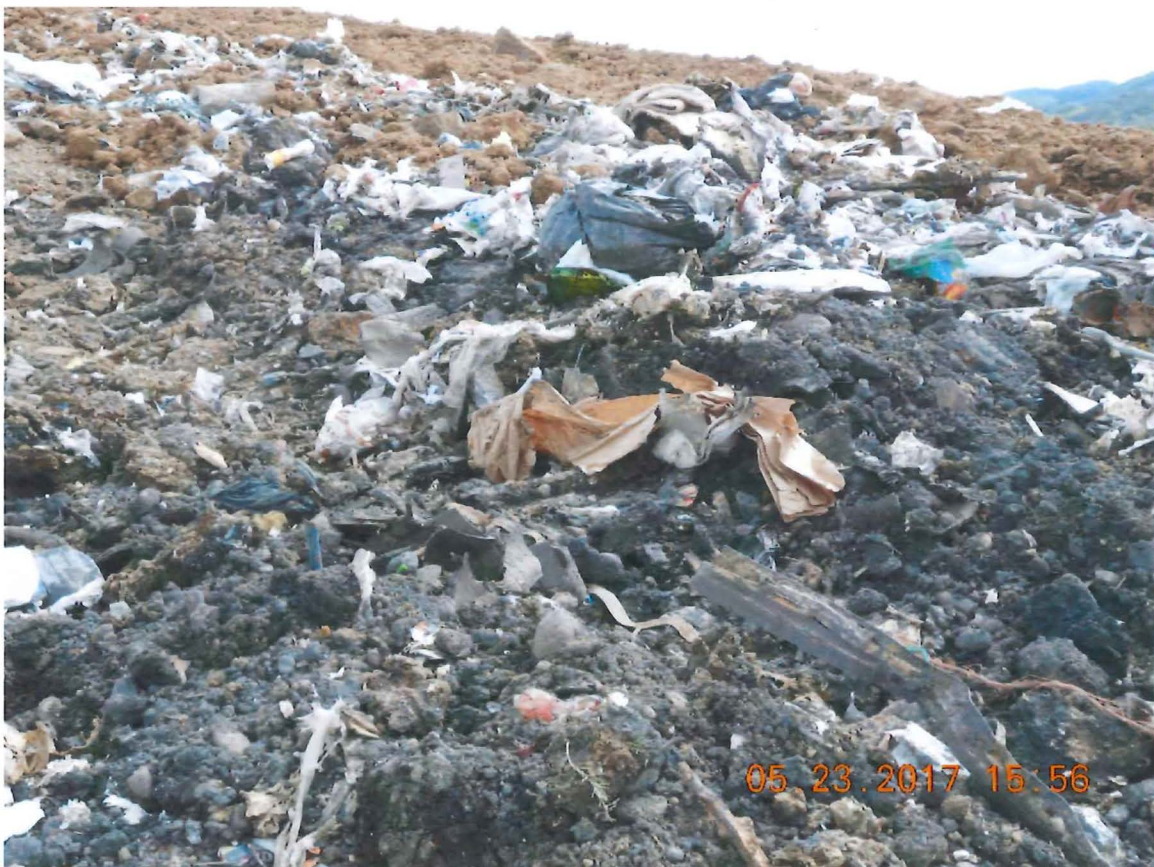
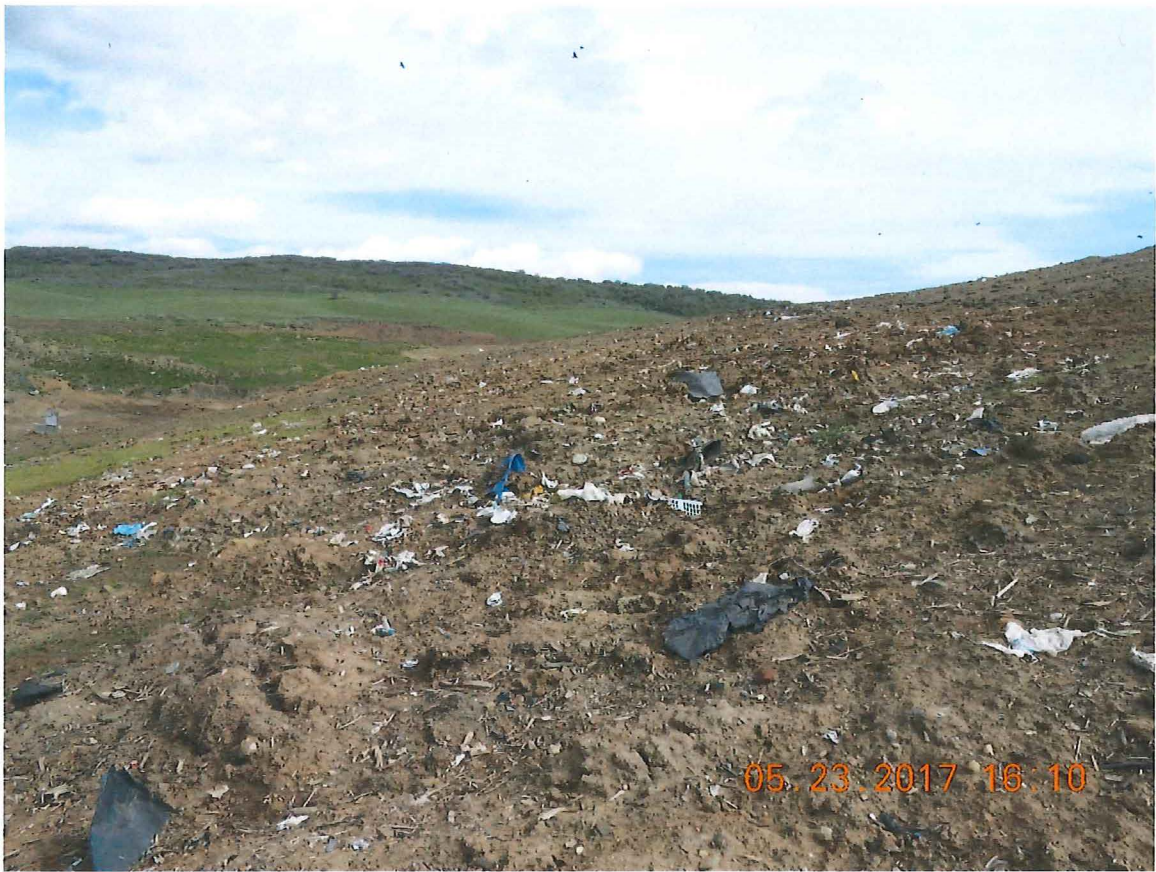
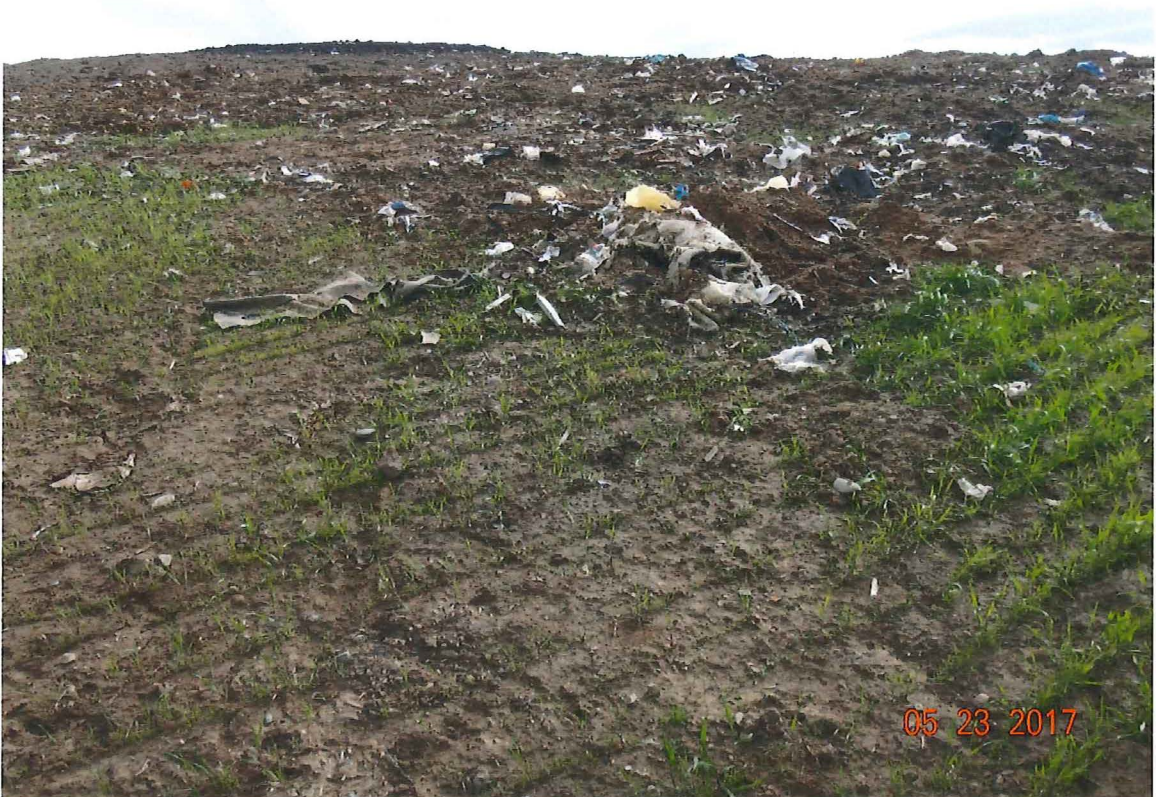
photos 29-34). At the time of the inspection it was noted that the current working face was adequately sized. However, it was noted by visual observation and also from comments from Luke Schneider that the working face had previously been too large to accommodate adequate daily cover and appropriate management. No prohibited waste streams were noted to be present at the working face at the time of the inspection.

Photo 30: Exposed waste (insufficient cover) near working face

Photo 31: Exposed waste (insufficient cover) near working face

Photo32: Exposed waste (insufficient cover) near working face

Photo 33: Exposed waste (insufficient cover) on northern slope of active fill area

Photo 34: Exposed waste (insufficient cover) on northern slope of active fill area

Requested Action 3: Immediately place required amounts of daily/intermediate/final cover in the areas noted above. Photographs documenting this placement of additional cover shall be sent to the Department within seven (7) calendar days of your receipt of this Compliance Advisory.

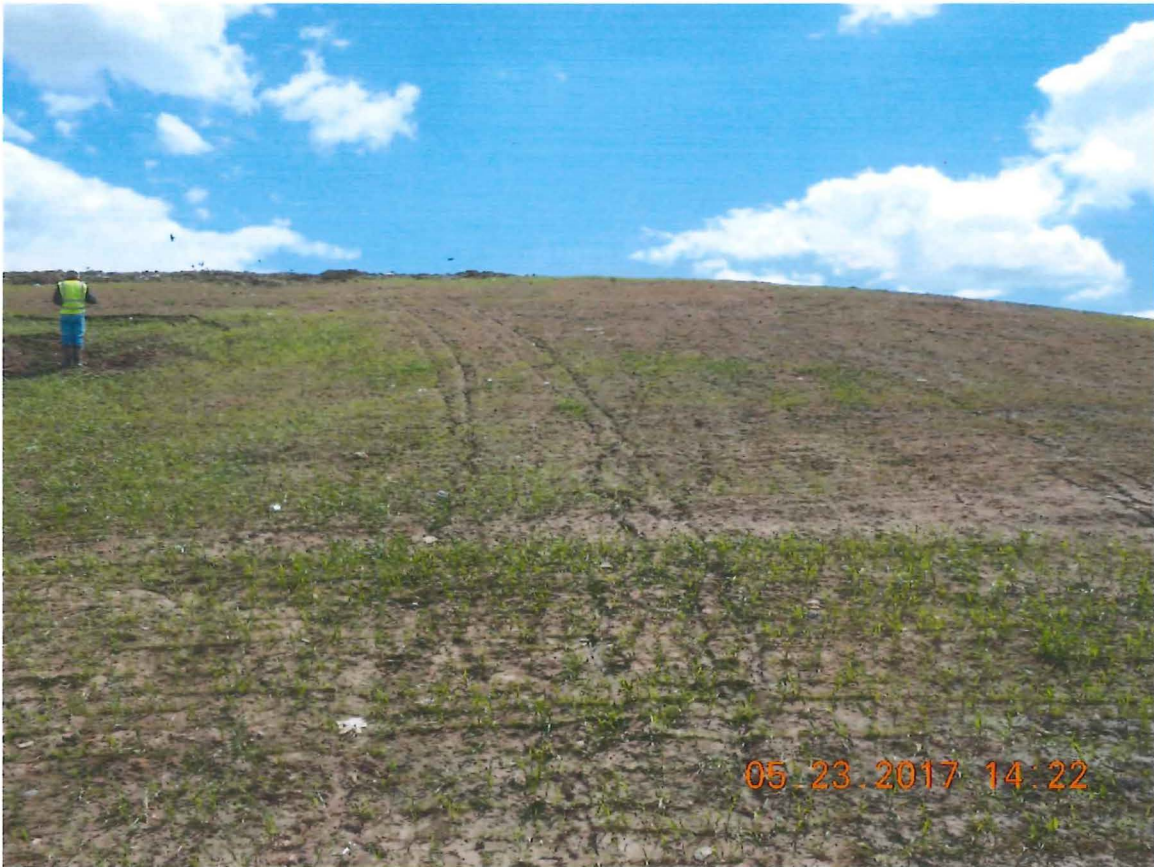
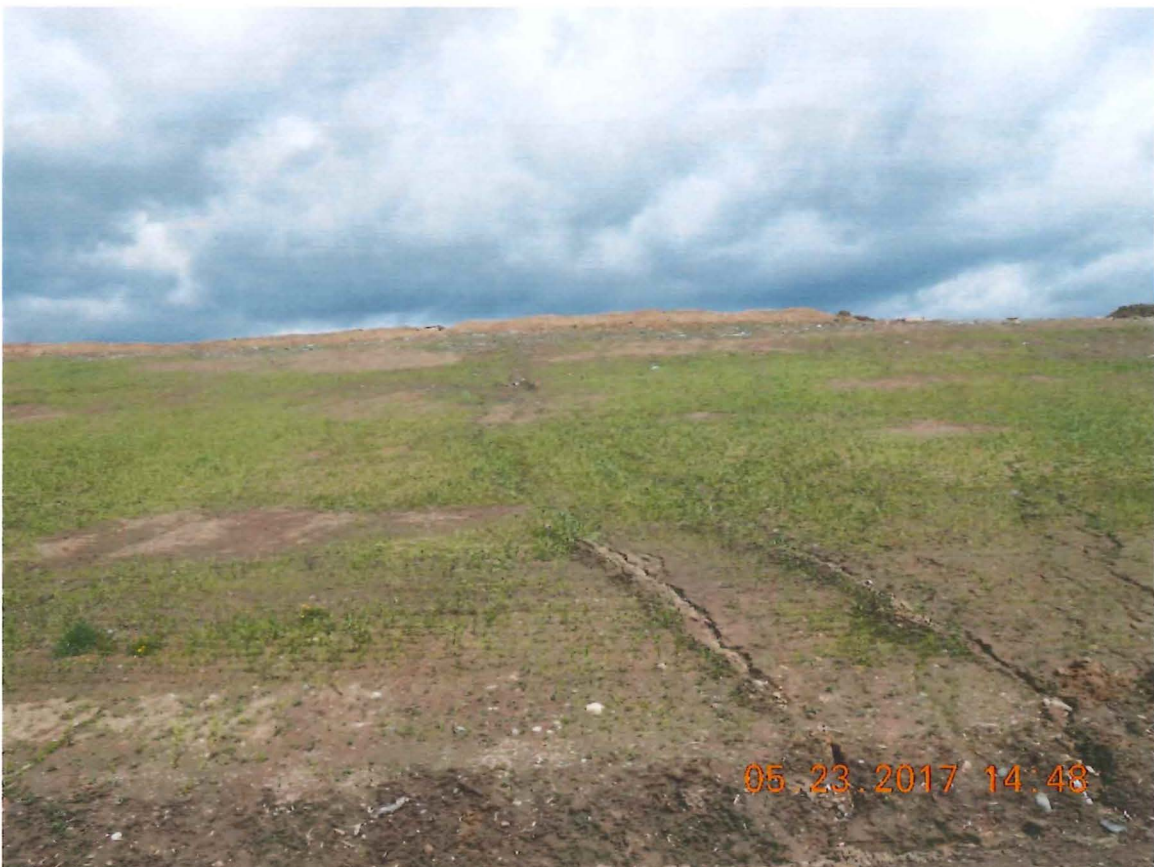
After observations of the working face of the landfill were made the inspection group moved to the north and observed the northern slope of the active landfill area where seeding had recently been performed. The vegetation in this area was noted to be filling in pretty well. However, some erosion rilling was noted to be present on this northern slope as well as on the western slope of the landfill (see photos 35-36). These slopes are at a 4:1 slope and have been seeded. The vegetation on these slopes is coming in, but is not fully established yet. This Division discussed this with Luke Schneider and indicated that this erosion would likely continue until more permanent erosion control features are installed on these slopes (these north and west slopes are in intermediate closure, but not final closure).

Photo 35: Erosion rilling on western slope of active fill area

Photo 36: Erosion rilling on western slope of active fill area

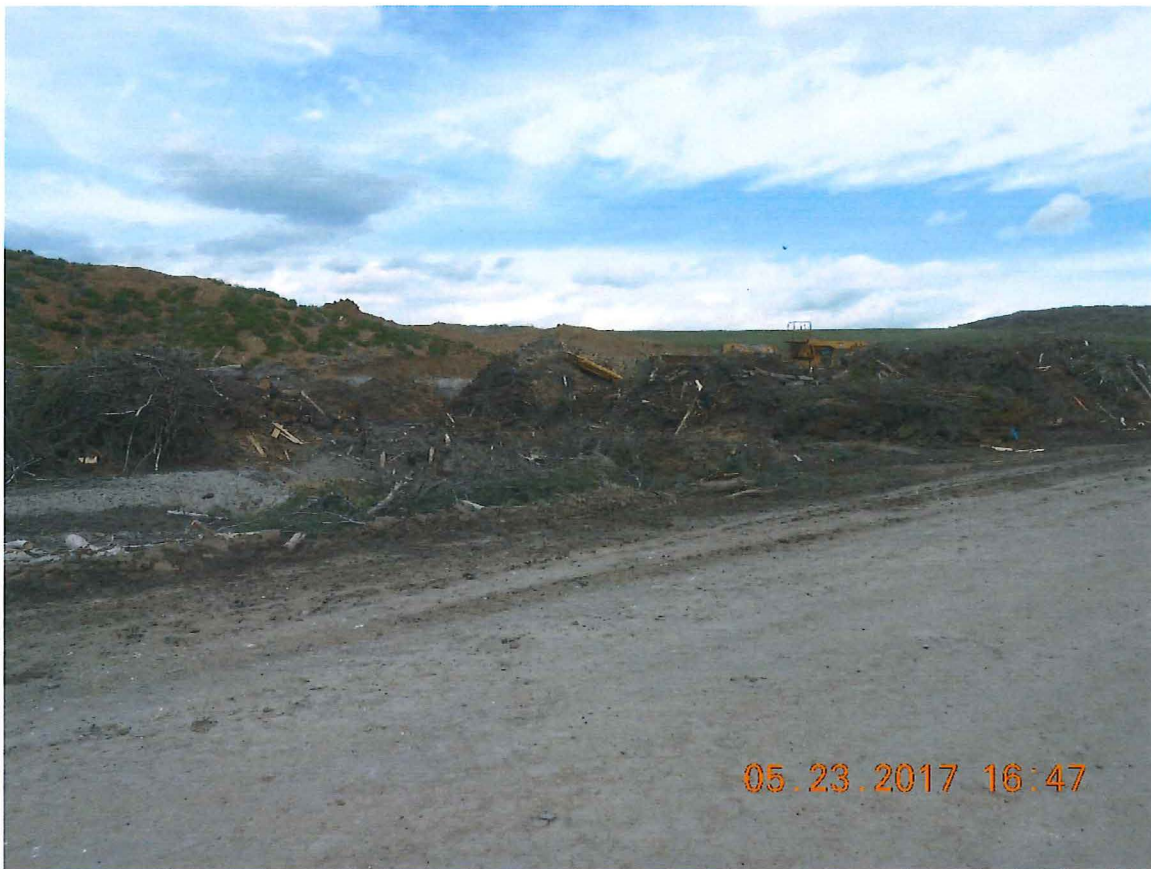
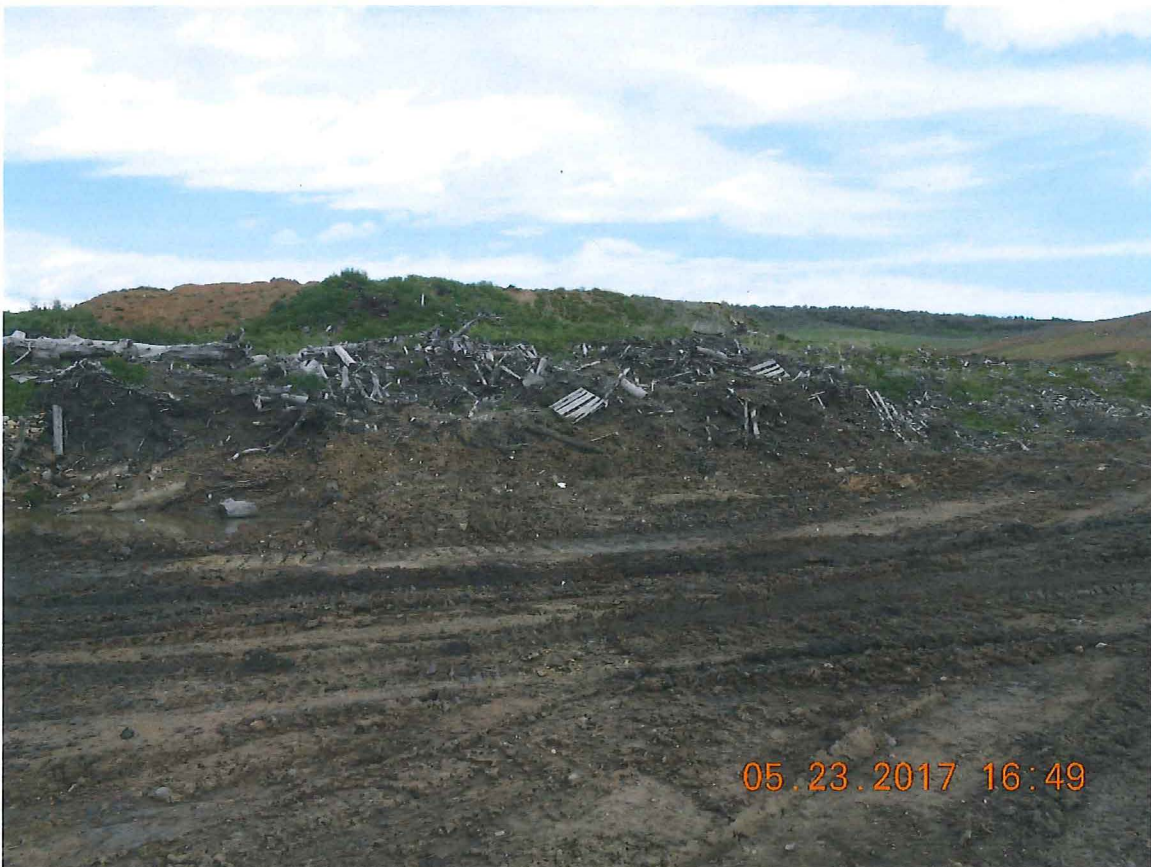
Green waste storage was noted to be present in the area north of the active portion of the landfill (see photos 37-38) similar to the findings of the 2016 inspection event. This storage of green waste is not contemplated in the facility's EDOP.

Photo 37: Green waste storage area (not contemplated in EDOP)

Photo 38: Green waste storage area (not contemplated in EDOP)

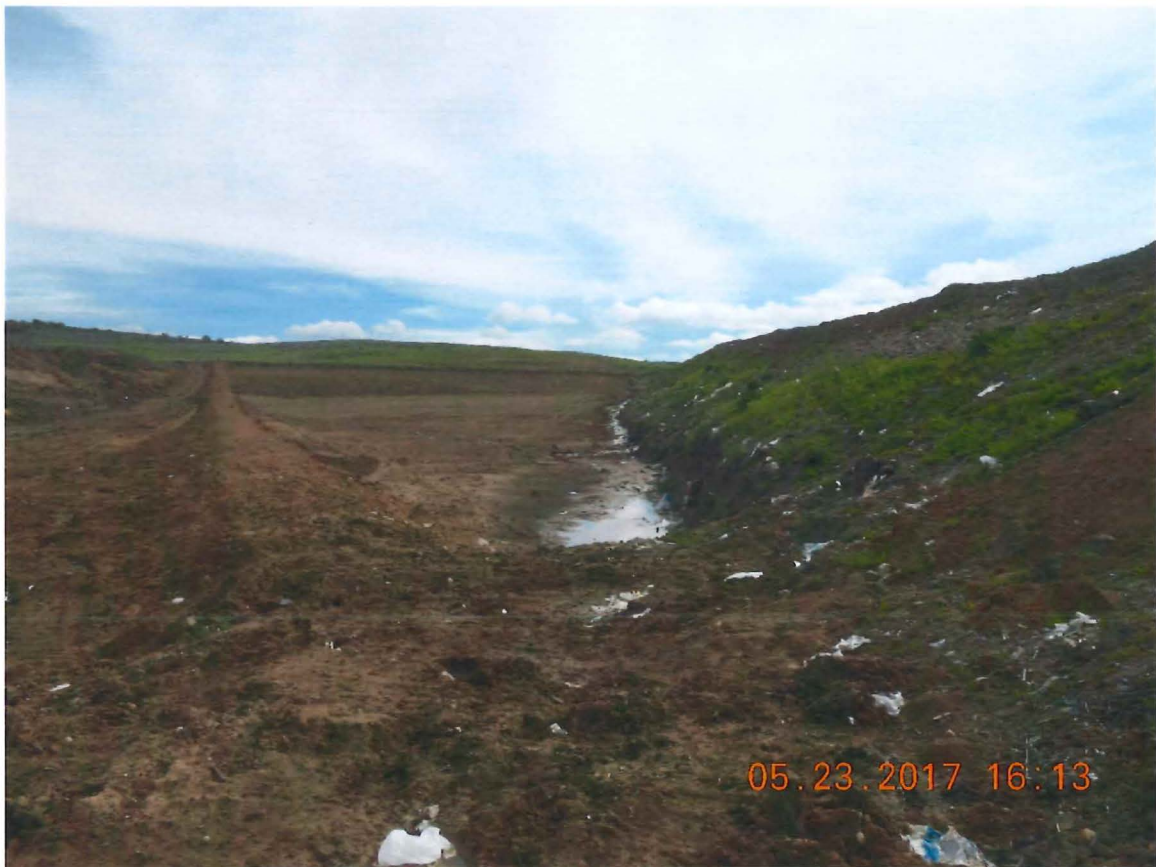
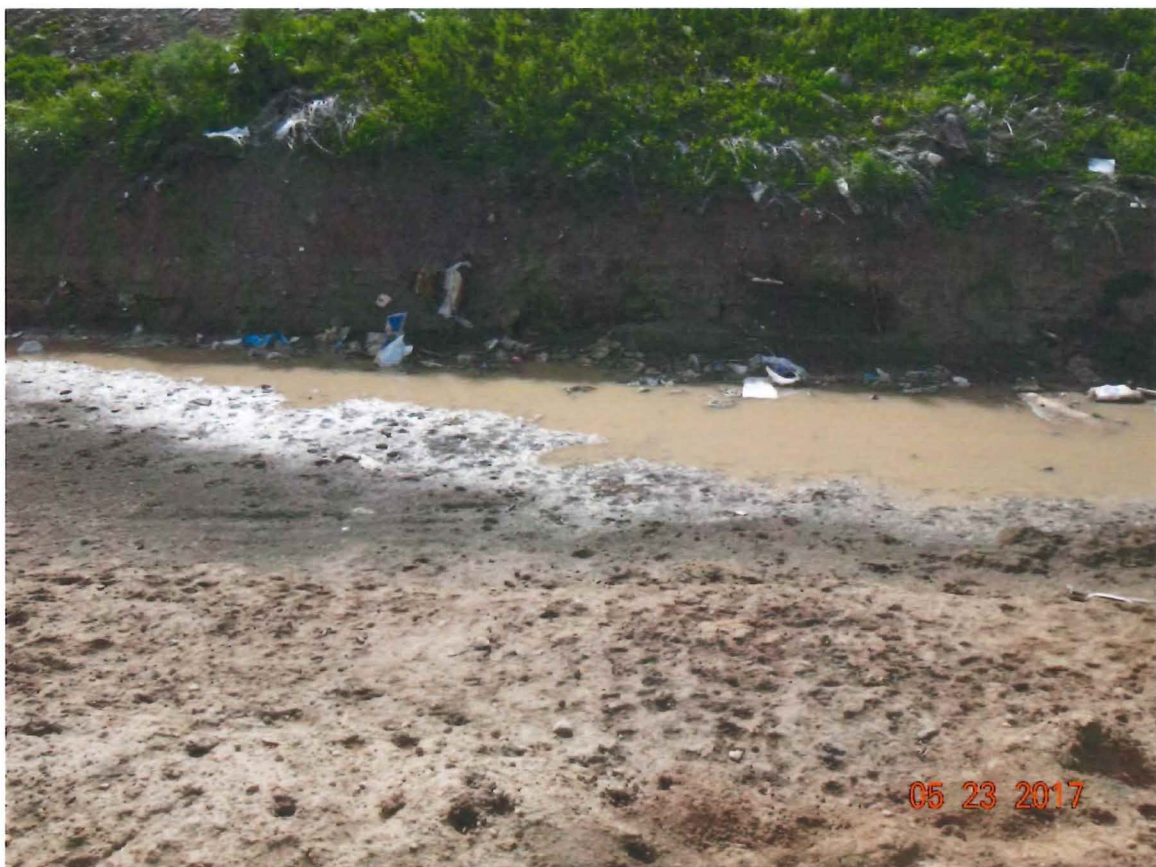
- b.) Exposed waste was noted to be present at the eastern edge of the MOD 2-3 areas where the new expansion cells 6A and 7A have been constructed. This is the area where the new liners for MODs 6A and 7A have been tied into existing liners in the MOD 2-3 area.
- c.) Exposed waste was noted on the East side of Pit 6 in multiple locations. Additionally, there was noted to be insufficient vegetation at the crest of the Pit 6 area.

The MOD 6A and 7A expansion areas were observed from the north side. Exposed waste was noted to be present at the eastern edge of the MOD 2-3 areas where the new expansion cells 6A and 7A have been constructed. Specifically, this was noted in the area the new liners for MODs 6A and 7A have been tied into existing liners in the MOD 2-3 area. This indicates inadequate intermediate cover on the MOD 2-3 cells in this area (see photos 39-40).

Photo 39: Exposed waste (insufficient cover) in MOD 6A/7A area

Photo 40: Exposed waste (insufficient cover) in MOD 6A/7A area

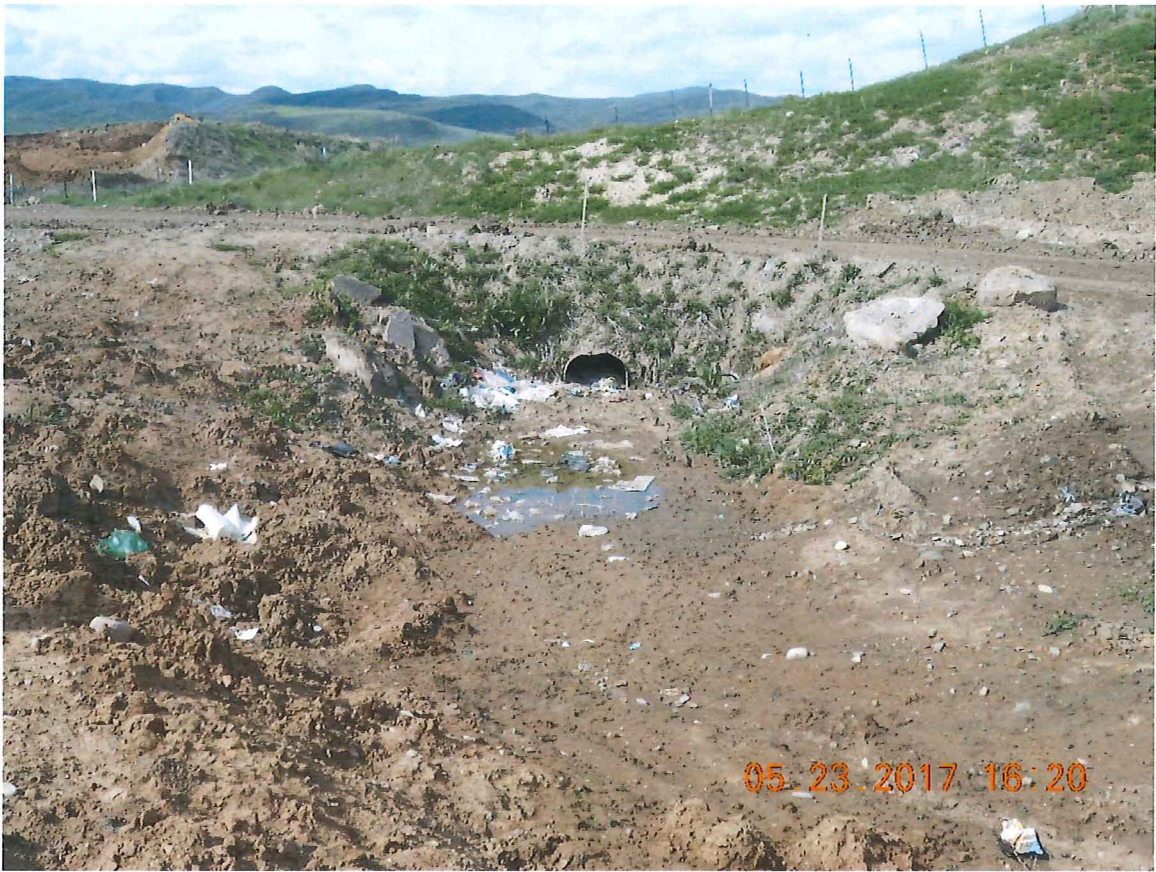
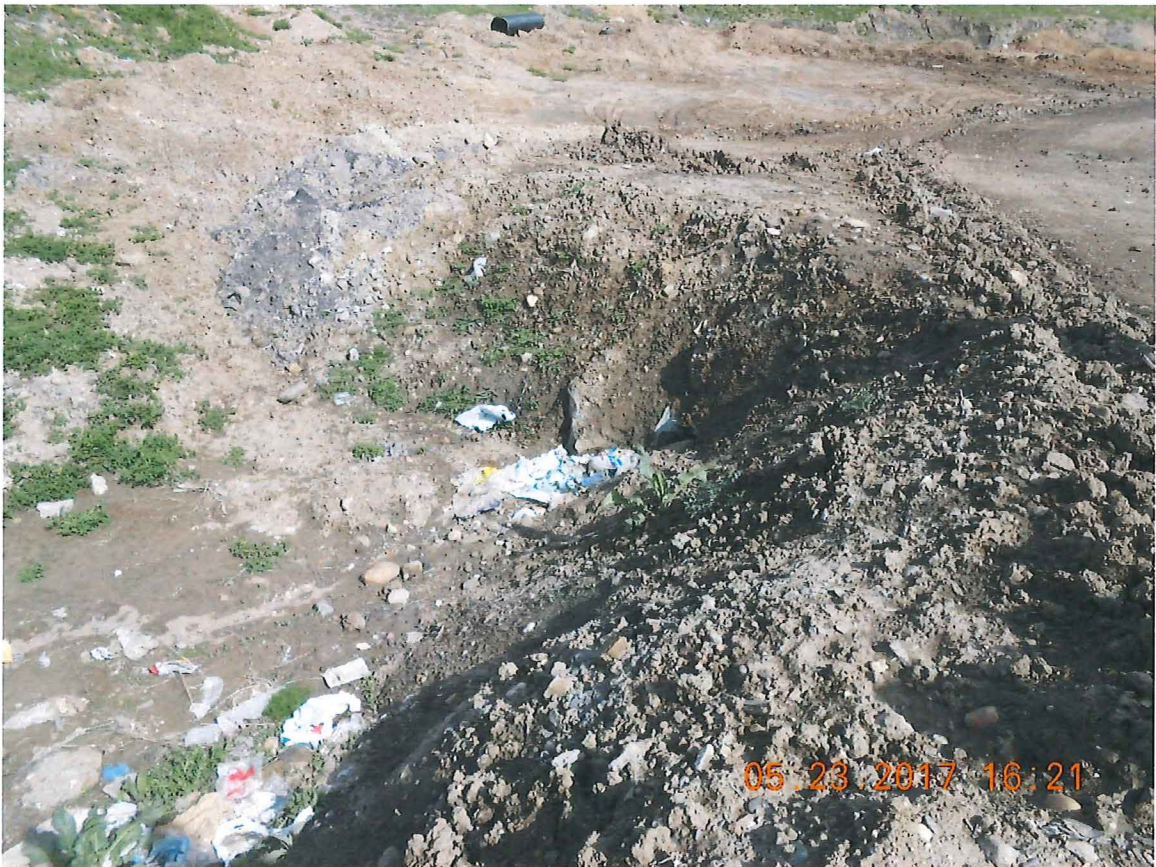
Deficiency 5: Windblown trash was noted to be prevalent at the facility during this inspection event, in apparent violation of 6 CCR 1007-2, Section 2.1.11 and Section 4.7.1 (Litter Control) of the approved EDOP. Several areas were noted to have windblown trash present including:

A significant amount of windblown trash was noted to be present in the storm water ditches at the east and west sides of the MOD 6A and 7A expansion areas as well as in the MOD 6A and 7A expansion areas themselves (see photos 41-42).

Photo 41: Windblown trash in storm water ditch near MOD 6A and 7A

Photo 42: Windblown trash near MOD 6A and 7A

Requested Action 5: Within seven (7) calendar days of your receipt of this Compliance Advisory remove windblown trash from the areas noted above and submit photographs showing your return to compliance to the Department.
