COLORADO
Department of Public
Health & Environment

Re: Compliance Advisory for the Milner Landfill:
Twin Enviro Services
20650 County Road 205
Steamboat Springs, CO 80487
SW RTT MIL 1.6

Attachment 1 - Photo Log

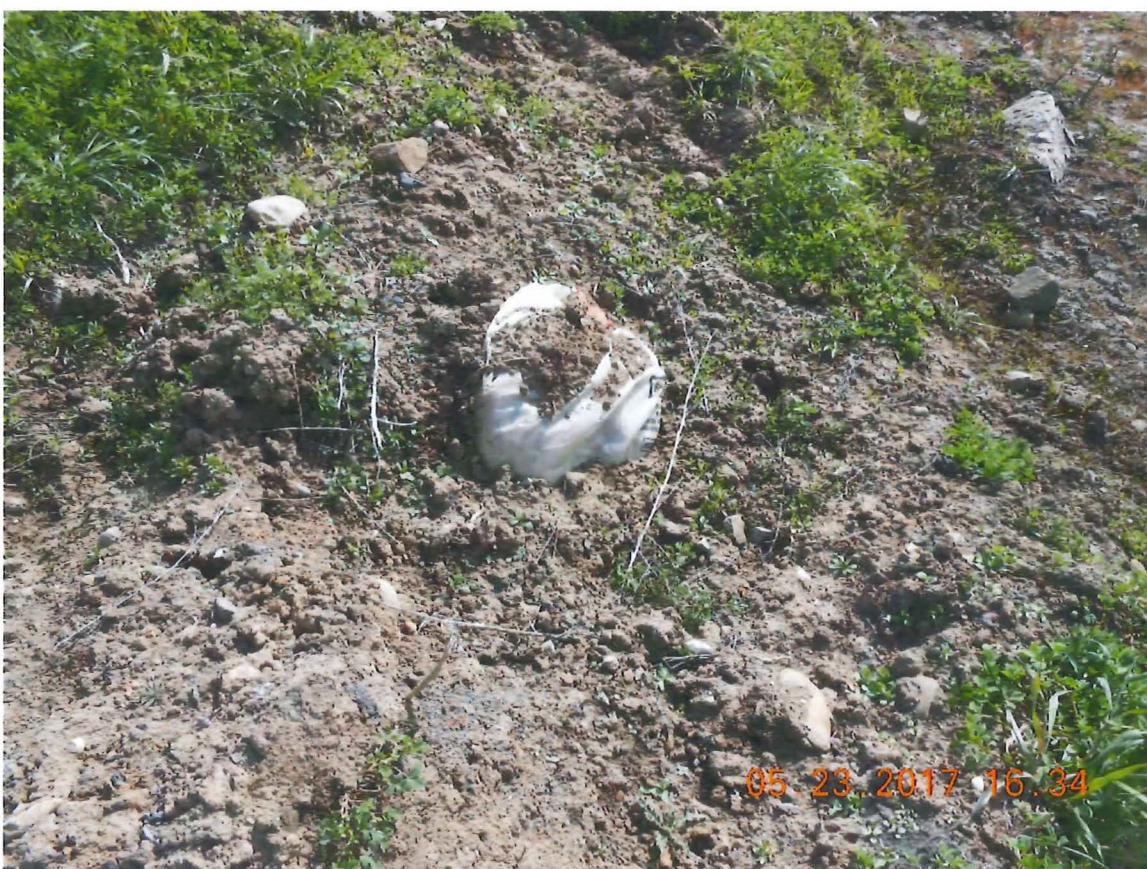
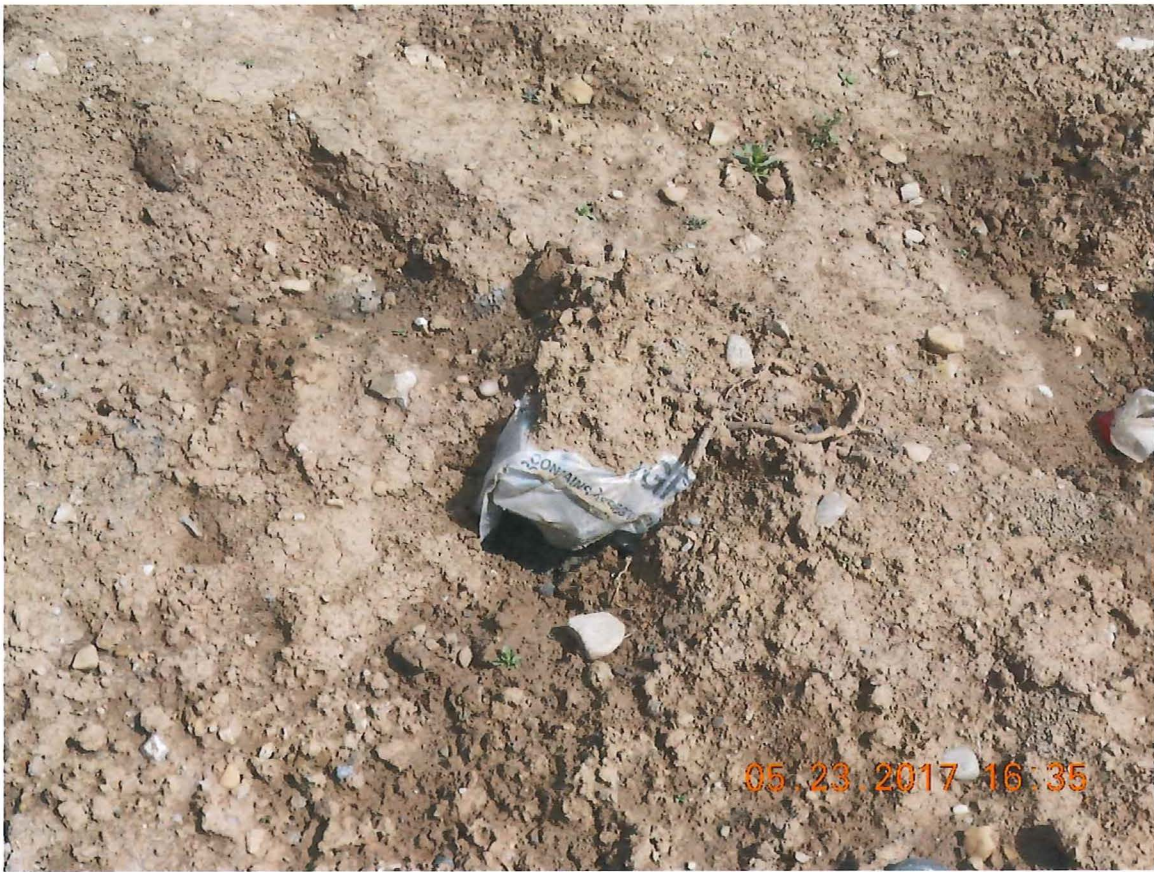
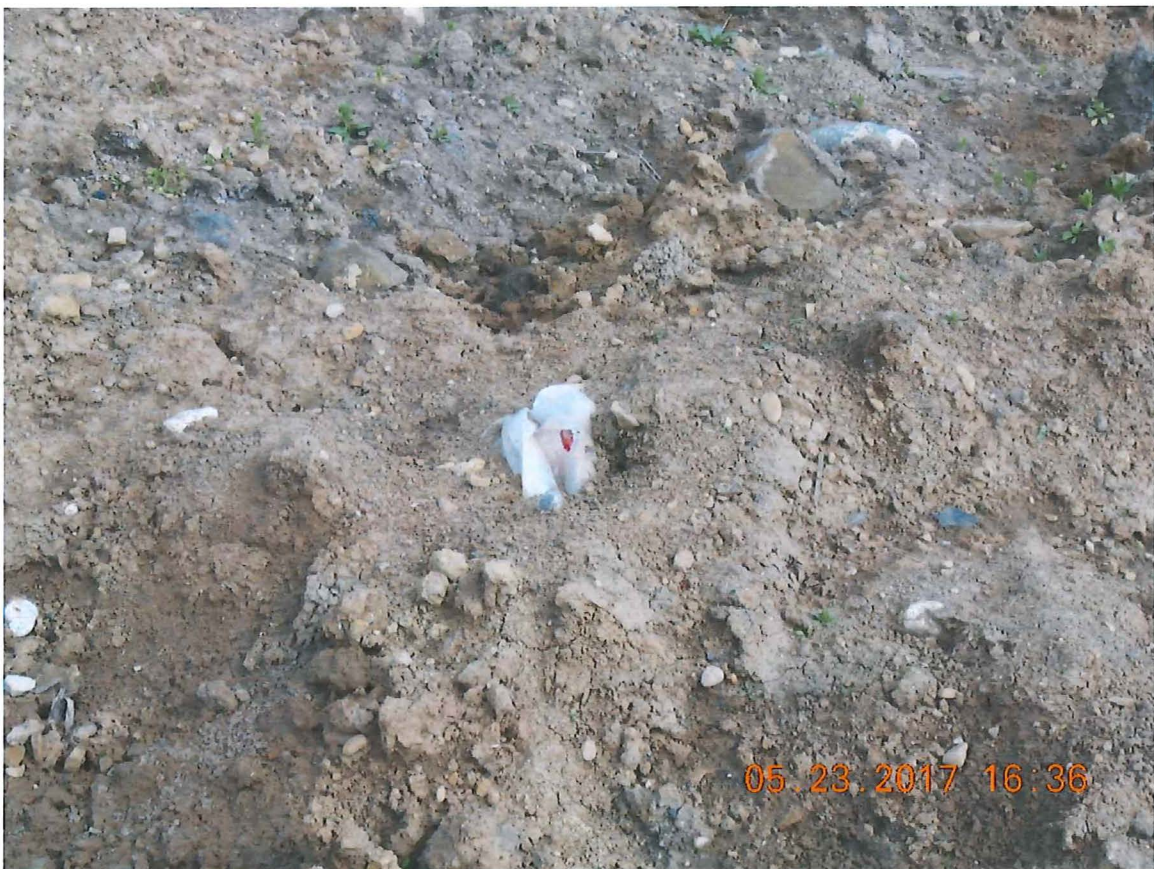
Deficiency 4: The facility failed to place adequate cover in the friable asbestos disposal area, in apparent violation of 6 CCR 1007-2, Section 5.3.7. Two waste bags were visible at the ground surface within the asbestos area indicating insufficient cover has been placed.

Observations of the friable asbestos disposal area revealed that insufficient cover had been placed over asbestos waste in this area. Two separate locations had asbestos waste packaging visible at the ground surface with no cover (see photos 44-46). Although insufficient cover was noted to be less widespread than it was during the 2016 inspection event, any exposed asbestos waste is still a significant departure from regulatory requirements.

Photo 44: Uncovered asbestos waste

Photo 45: Uncovered asbestos waste

Photo 46: Uncovered asbestos waste

Requested Action 4: Immediately place required amounts of cover in the friable asbestos disposal area over all areas where asbestos waste were noted to be present on the ground surface. Pictures documenting this placement of additional cover shall be sent to the Department within seven (7) calendar days of your receipt of this Compliance Advisory.
