February 23, 2022

Job Number: 20-11636

Subject: On-Site Wastewater Treatment System  
Observations, Donham-Burgess Residence, 27875  
US Highway 40, Routt County, Colorado.

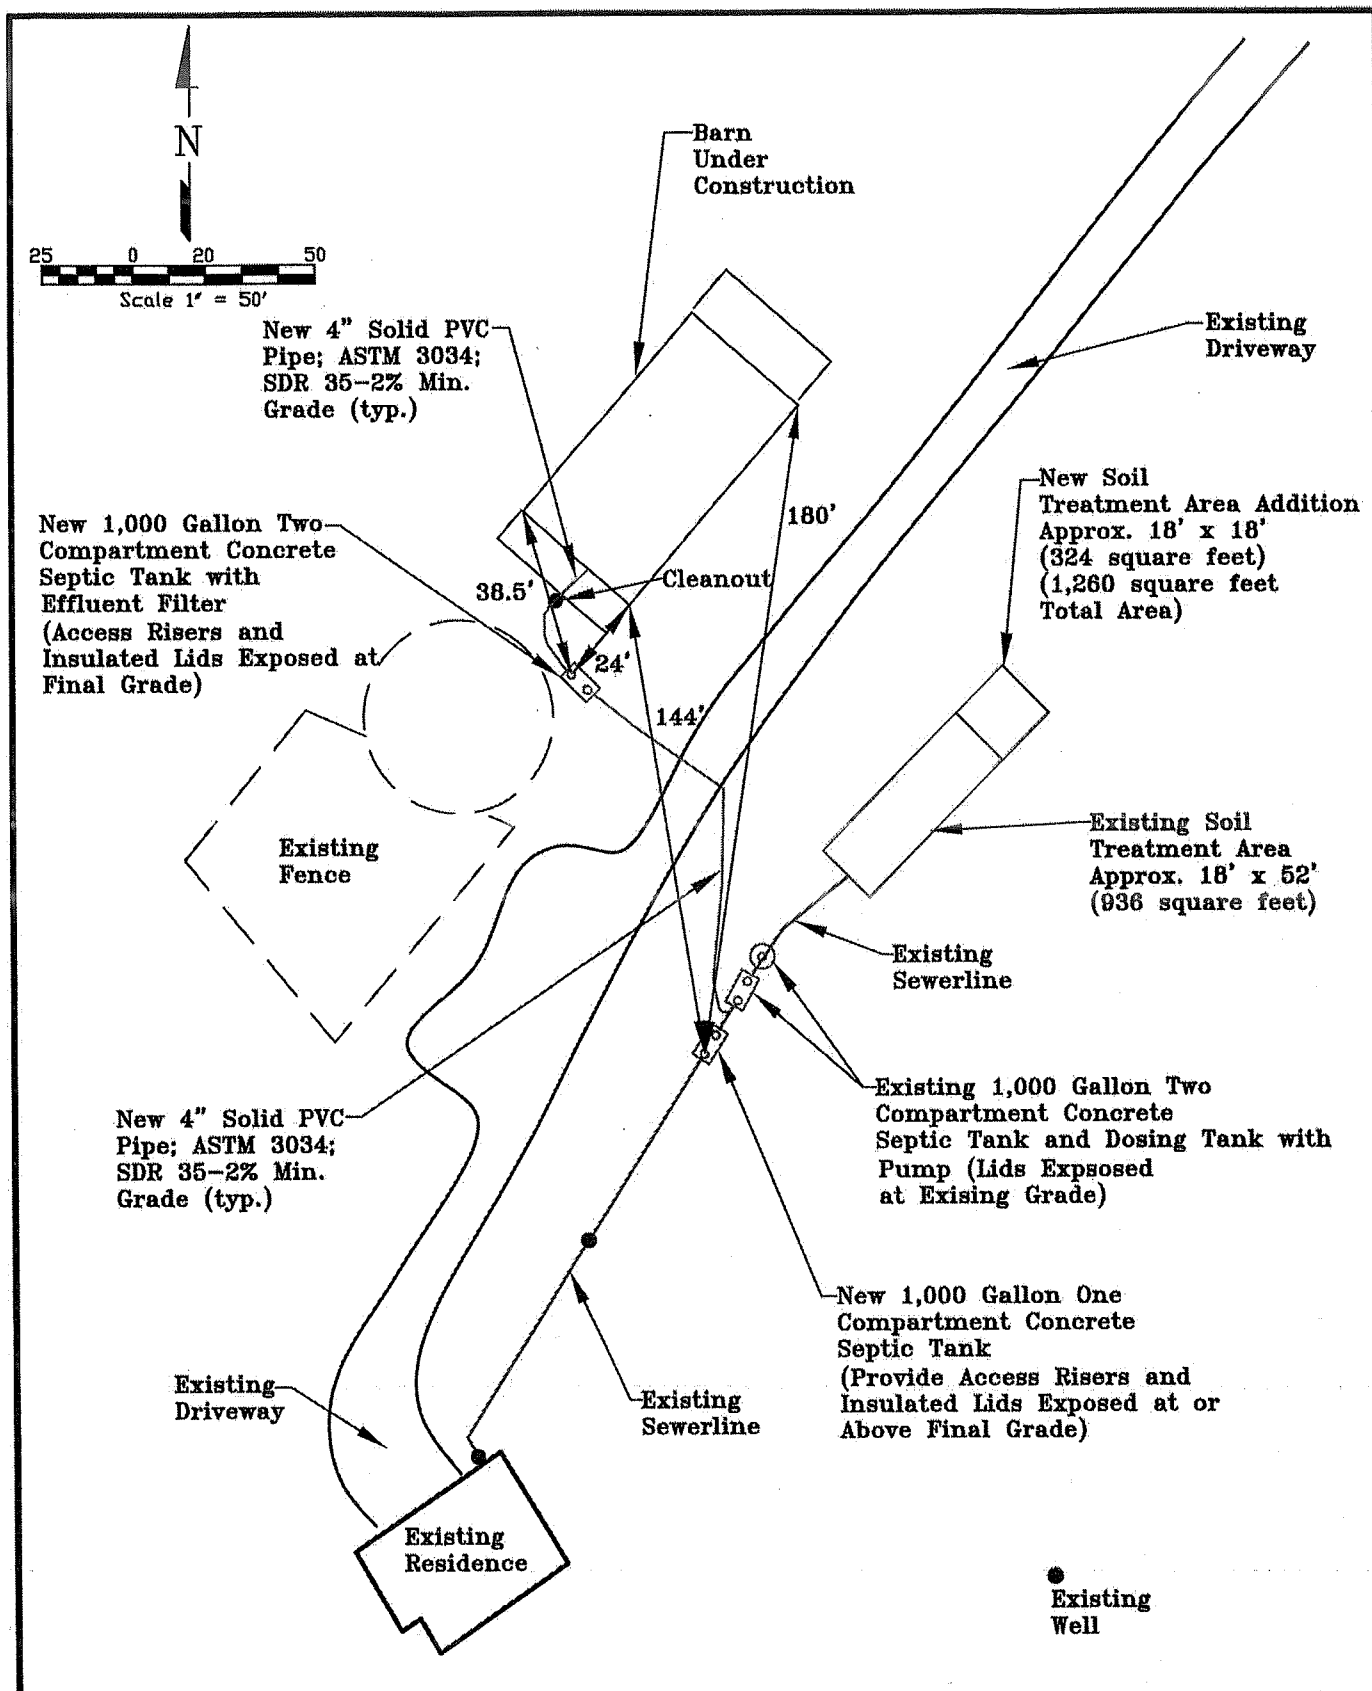
At the time of our site visit on November 10, 2020, the OWTS had been backfilled. It appeared that sufficient cover had been placed over the piping, tanks and soil treatment area. The lids for the septic and dosing tanks were accessible at the finished ground surface. An as-built drawing taken from field measurements of the system is presented in Figure #1.
