Re: Geotechnical Exploration and Geologic Hazard Evaluation  
Proposed Tailwaters at Stagecoach Subdivision  
Routt County, Colorado  
Western Slope Geotech Project No. 23-1076

Geotechnical Exploration & Geologic Hazard Evaluation  
Proposed Tailwaters at Stagecoach Subdivision  
Routt County, Colorado  
WSG Project # 23-1076

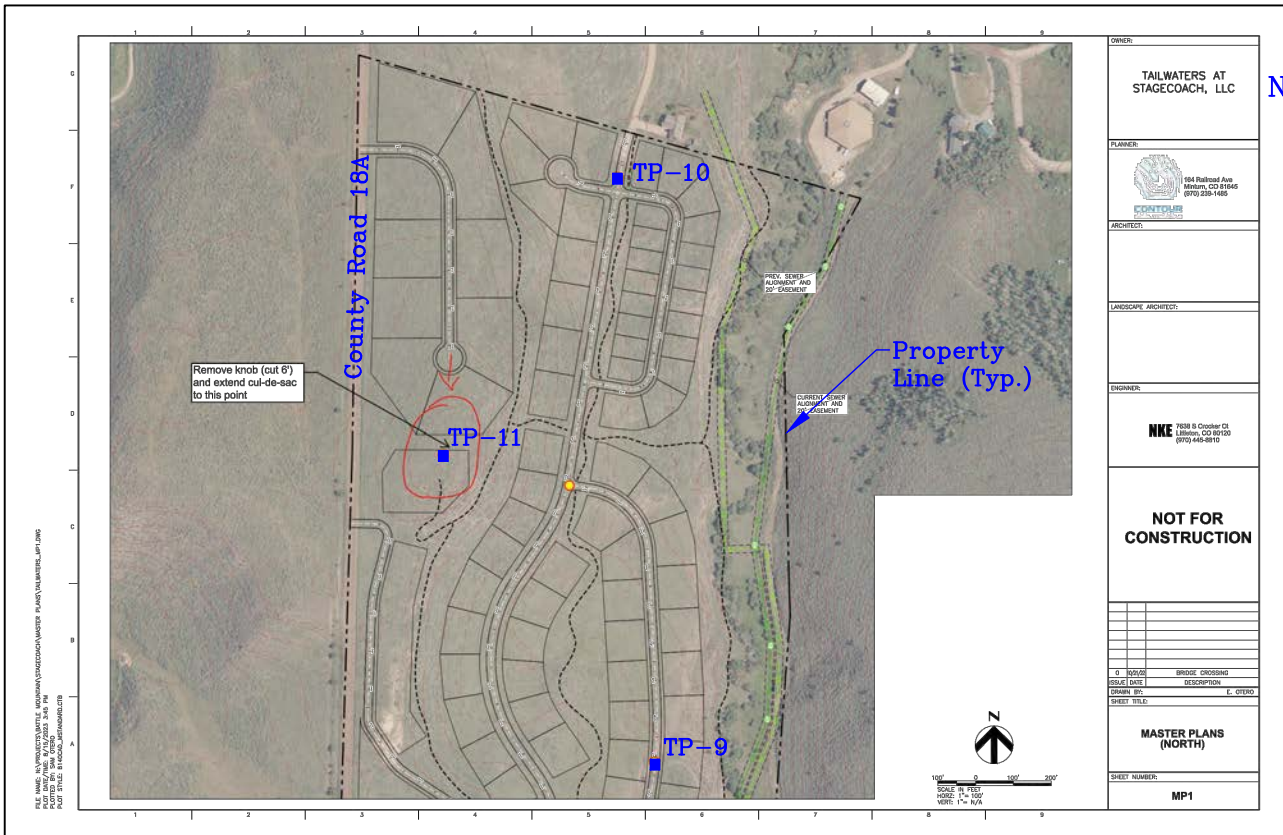
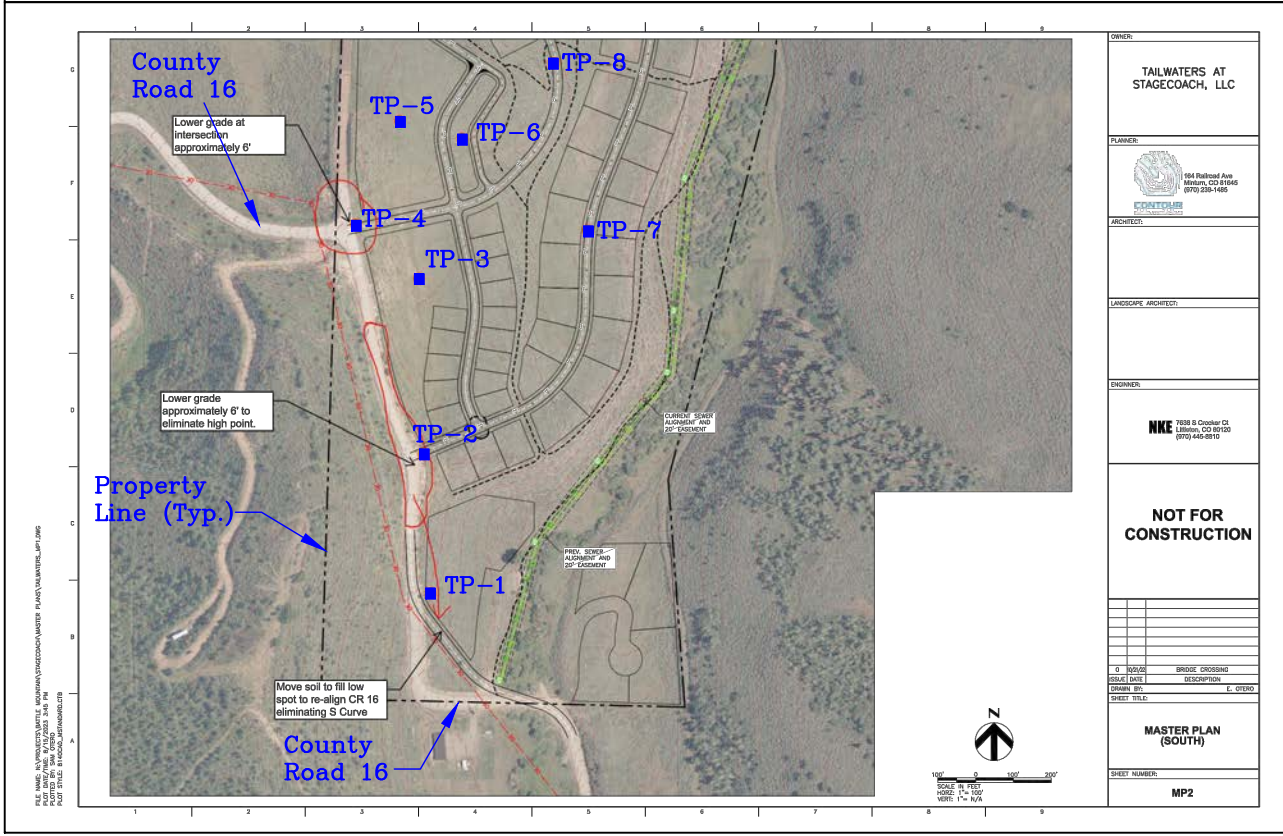
Date: 10/26/23 Figure No.: 1

WSG's field exploration program consisted of the observation of eleven (11) exploratory test pits generally located along proposed roadway alignments. The test pits were advanced to obtain information about the subsurface profile, groundwater conditions and obtain material samples for laboratory testing. Approximate test pit locations are shown on Figure 1.

SITE PLAN/LOCATION OF TEST PITS

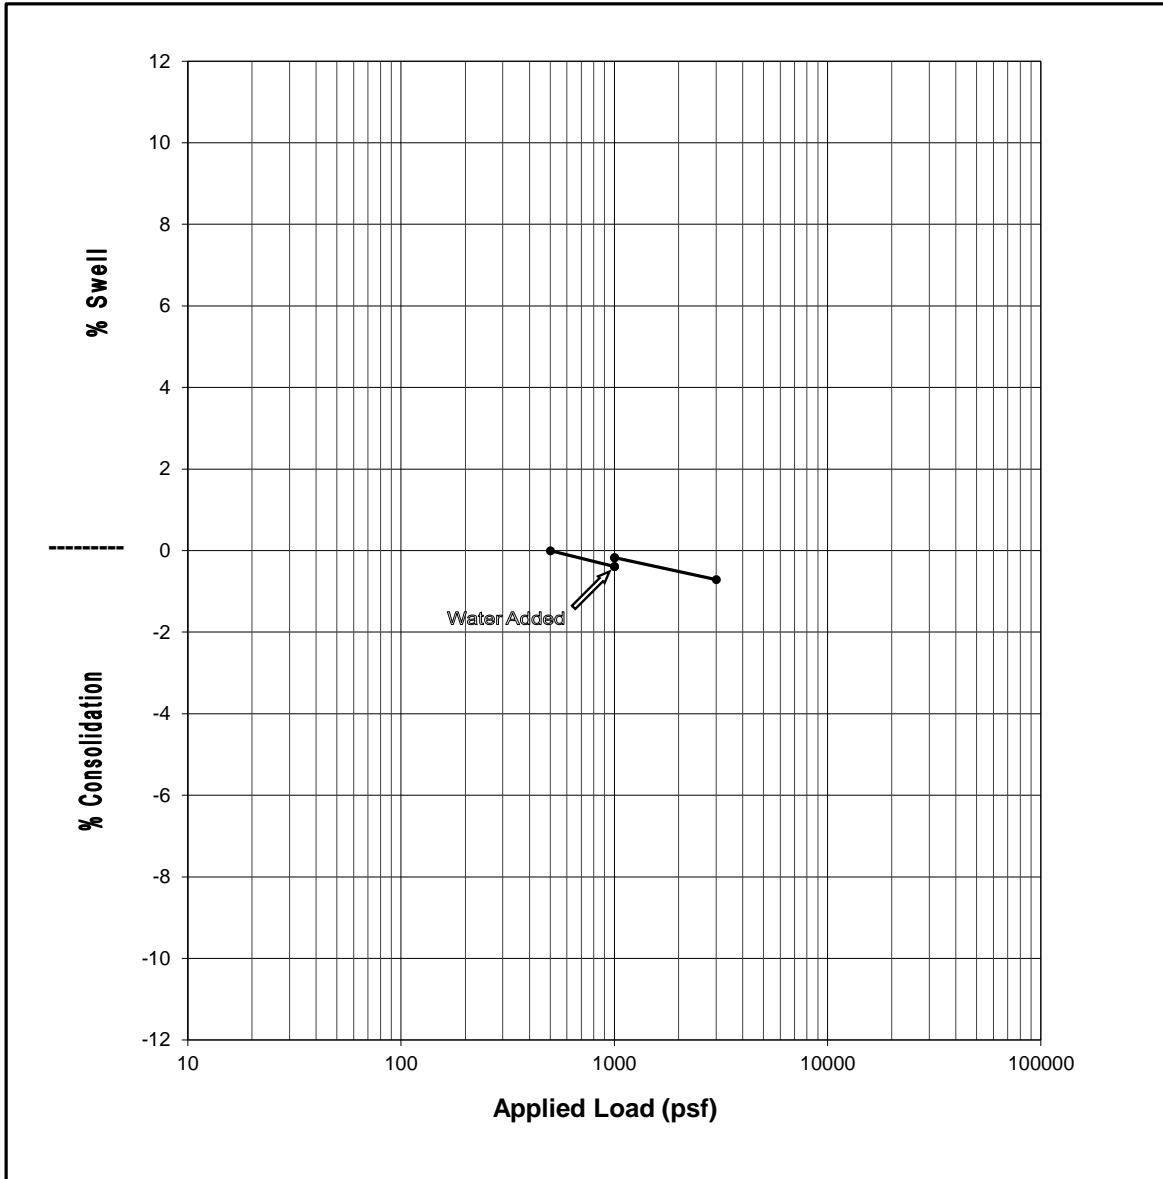
Project Name: Tailwaters at Stagecoach	Project No.: 23-1076
Location: Routt County, CO	Date: 10/24/23
Drawn/Checked: HS/HS	Figure No. : 5

<b>Sample ID: TP-2 @ 7'</b>			
<b>Sample Description: Sandstone (SM)</b>			
Initial Moisture	15.9%	Liquid Limit	NV
Final Moisture	30.6%	Plasticity Index	NP
% Swell @ 1000 psf	0.2%	% Passing #200	38.2%
Swell Pressure	1,500 psf	Dry Density	82.9 pcf

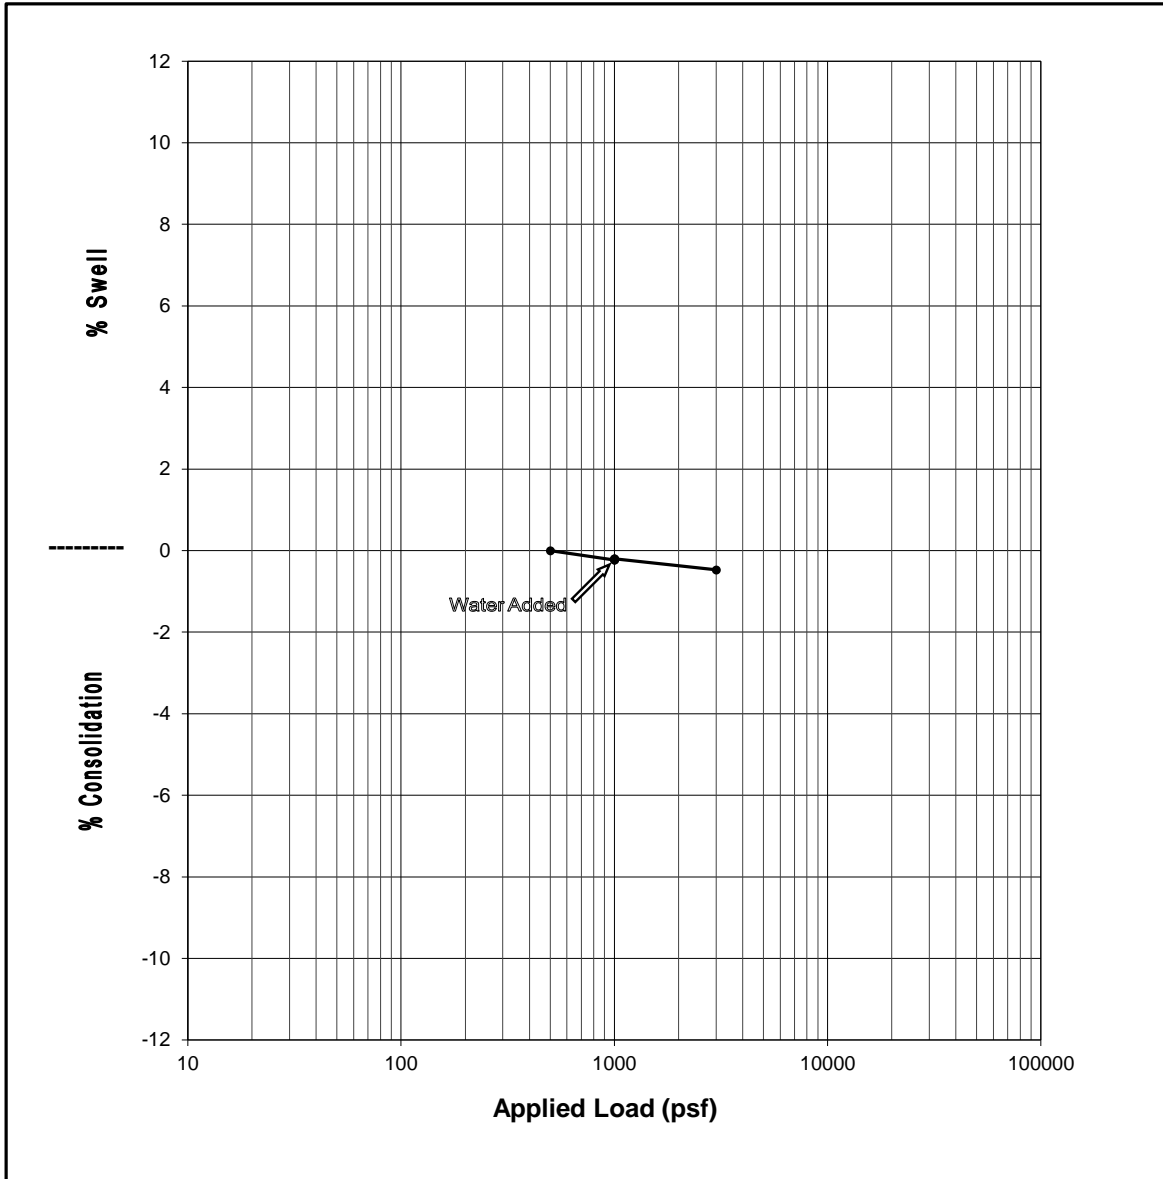
Project Name: Tailwaters at Stagecoach	Project No.: 23-1076
Location: Routt County, CO	Date: 10/24/23
Drawn/Checked: HS/HS	Figure No. : 6

<b>Sample ID: TP-3 @ 9 1/2'</b>			
<b>Sample Description: Sandstone (SM)</b>			
Initial Moisture	10.5%	Liquid Limit	NV
Final Moisture	24.7%	Plasticity Index	NP
% Swell @ 1000 psf	0.0%	% Passing #200	34.8%
Swell Pressure	<1,000 psf	Dry Density	94.5 pcf

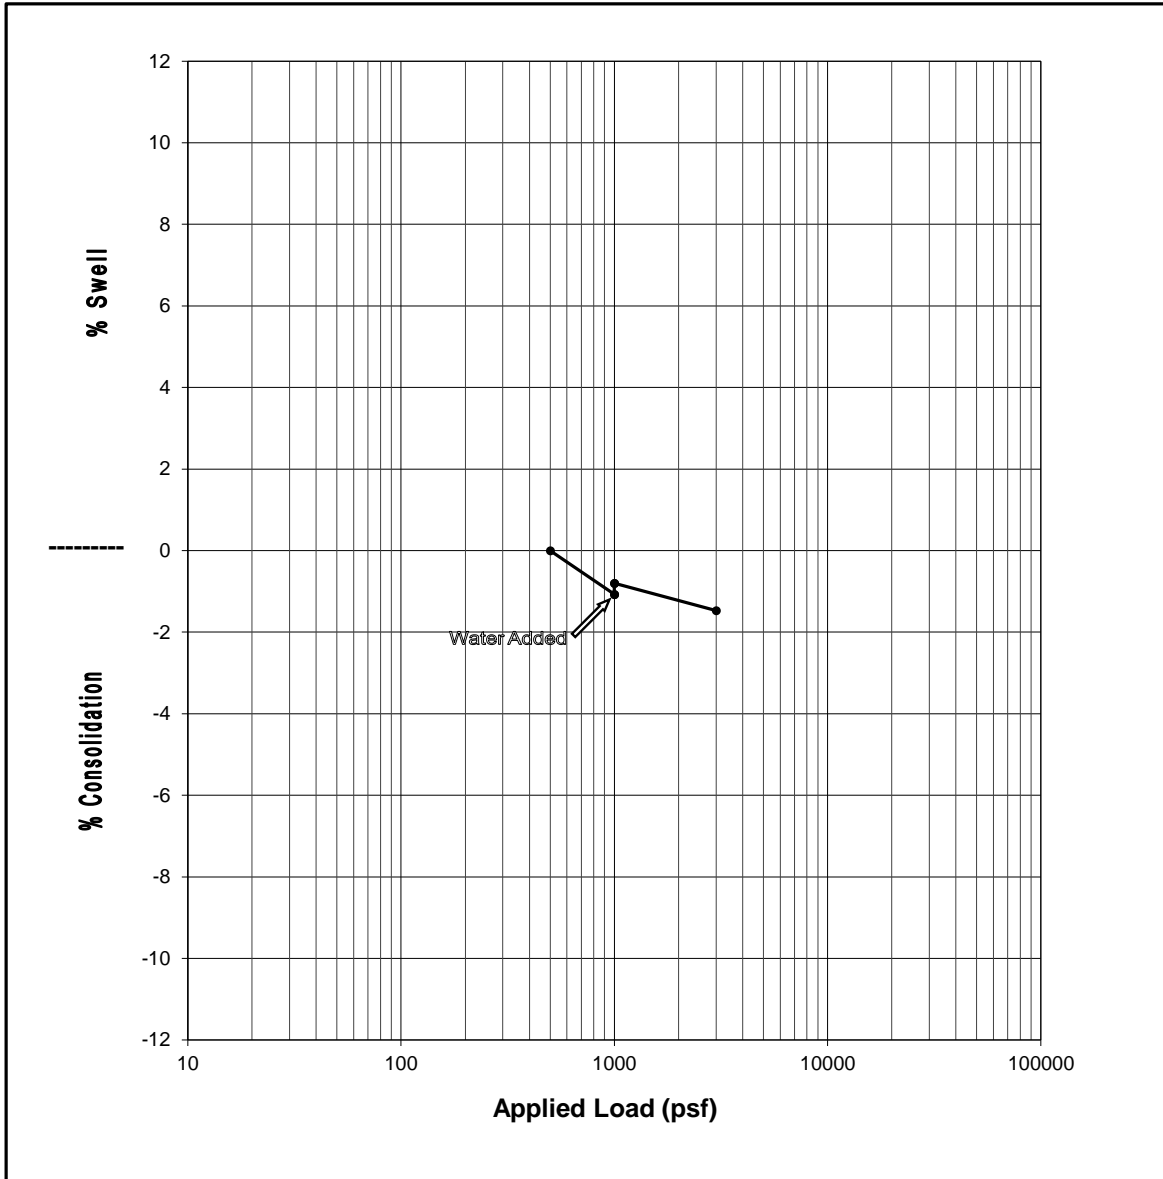
Project Name: Tailwaters at Stagecoach	Project No.: 23-1076
Location: Routt County, CO	Date: 10/24/23
Drawn/Checked: HS/HS	Figure No. : 7

<b>Sample ID: TP-8 @ 6'</b>			
<b>Sample Description: Very Sandy Clay (CL)</b>			
Initial Moisture	22.7%	Liquid Limit	26
Final Moisture	20.5%	Plasticity Index	8
% Swell @ 1000 psf	0.3%	% Passing #200	61.6%
Swell Pressure	1,500 psf	Dry Density	99.5 pcf

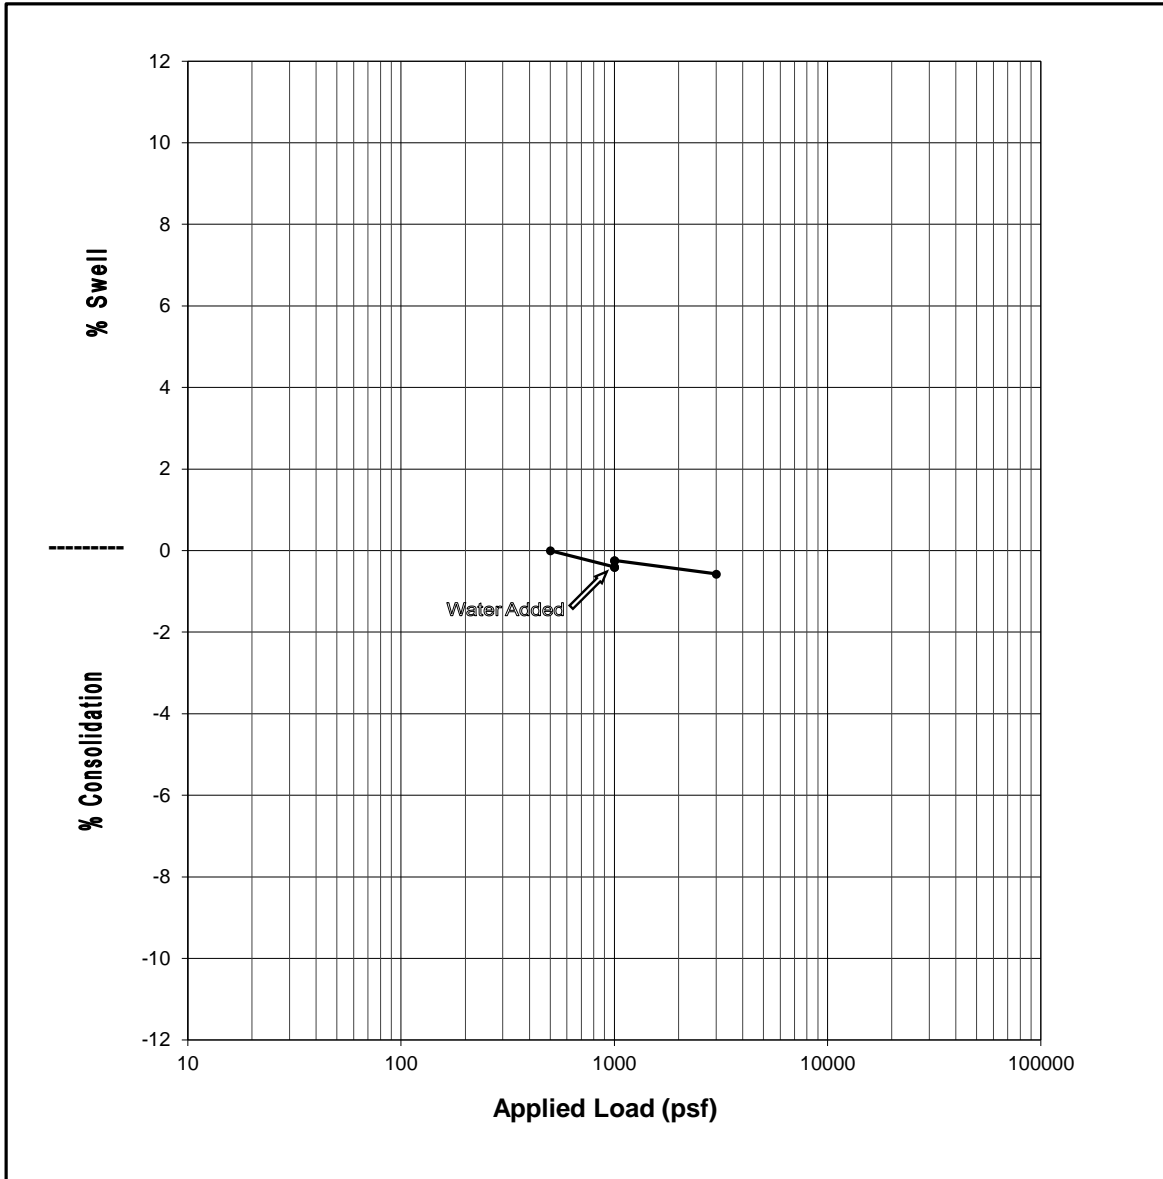
Project Name: Tailwaters at Stagecoach	Project No.: 23-1076
Location: Routt County, CO	Date: 10/24/23
Drawn/Checked: HS/HS	Figure No. : 8

<b>Sample ID: TP-10 @ 8'</b>			
<b>Sample Description: Sandy Clay (CL)</b>			
Initial Moisture	16.5%	Liquid Limit	26
Final Moisture	29.8%	Plasticity Index	5
% Swell @ 1000 psf	0.2%	% Passing #200	73.7%
Swell Pressure	1,800 psf	Dry Density	84.8 pcf
