Date: 15 November 2023
Revised 20 September 2024, 11 October 2024, and 21 November 2024

Re: Desktop Review and Geologic Study
Stagecoach Mountain Resort
Routt County, Colorado
Langan Project No.: 620044701

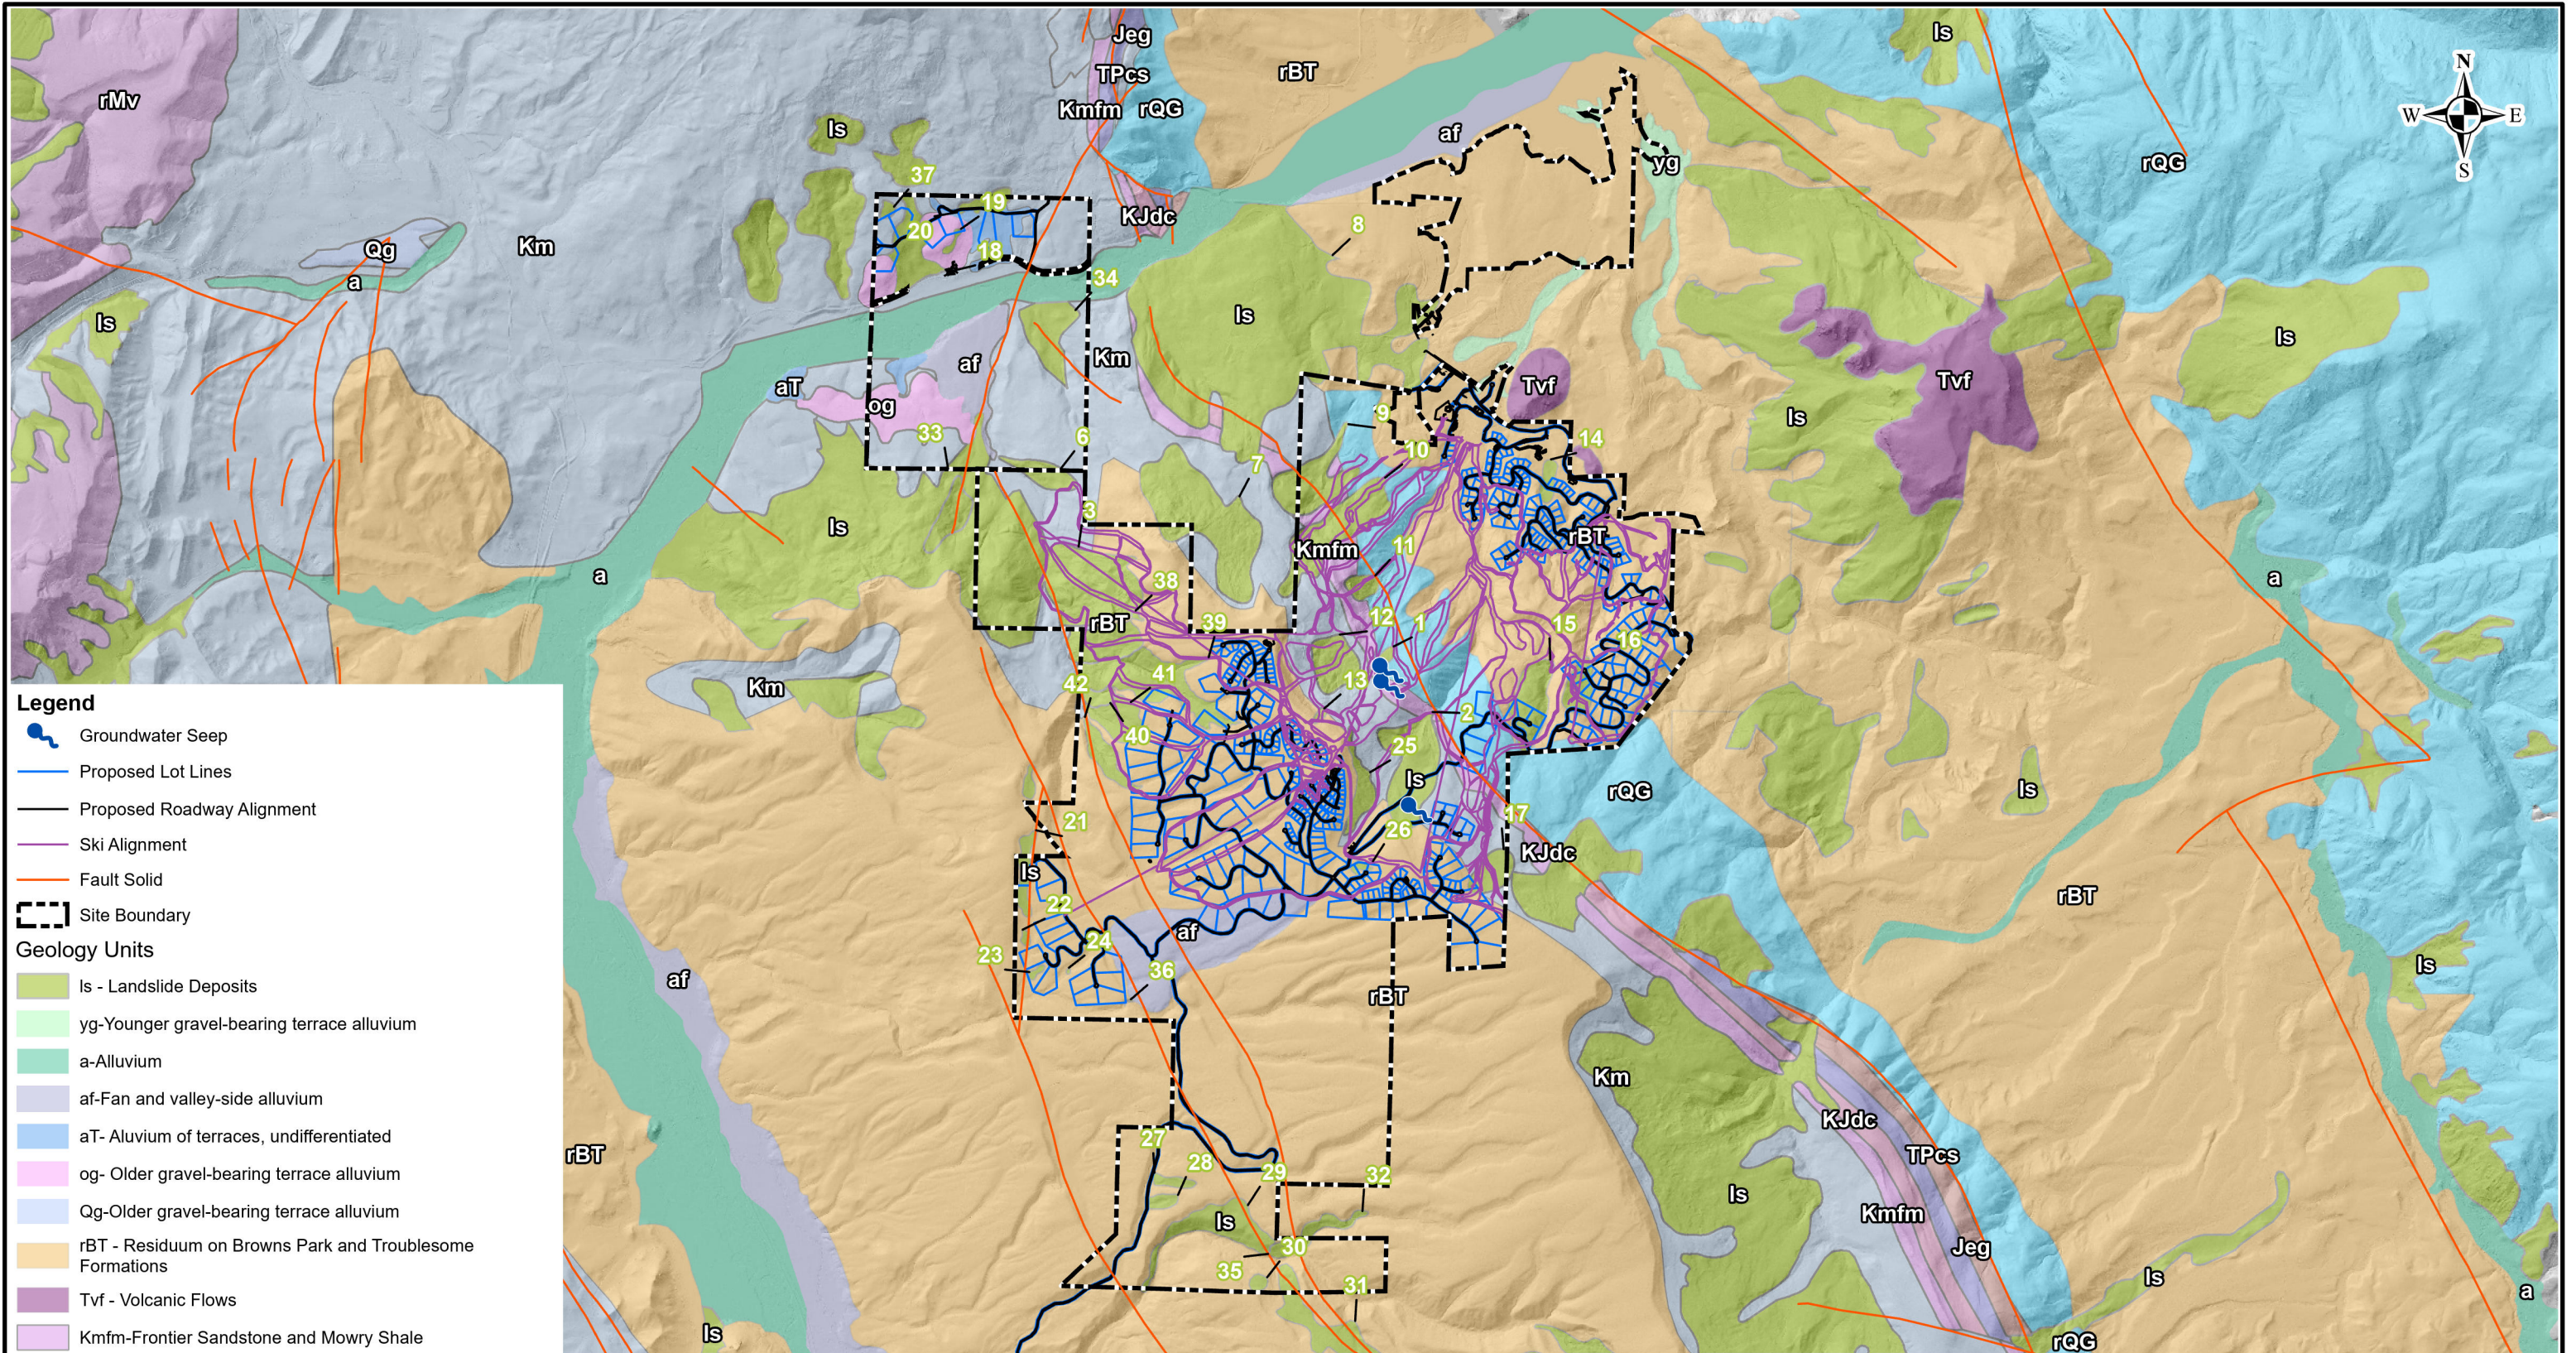
We performed field geologic mapping of the site to identify geologic hazards potentially affecting the proposed development. Mapping was performed to delineate bedrock and surficial deposits, and identify previous slope movements, faults, and other geologic features where accessible. A summary of identified geologic units is provided below, and our site-specific geologic map incorporating our findings is presented in Figures 3a and 3b.

Areas with steep slopes (grades 30% or greater) are delineated and shown on Figures 4a and 4b. Detailed slope stability analyses will be necessary where development will encroach upon the steep slope areas. We observed 33 landslides (both shallow and potentially deep-seated) derived from unconsolidated residuum on steep slopes; see Figures 3a and 3b.

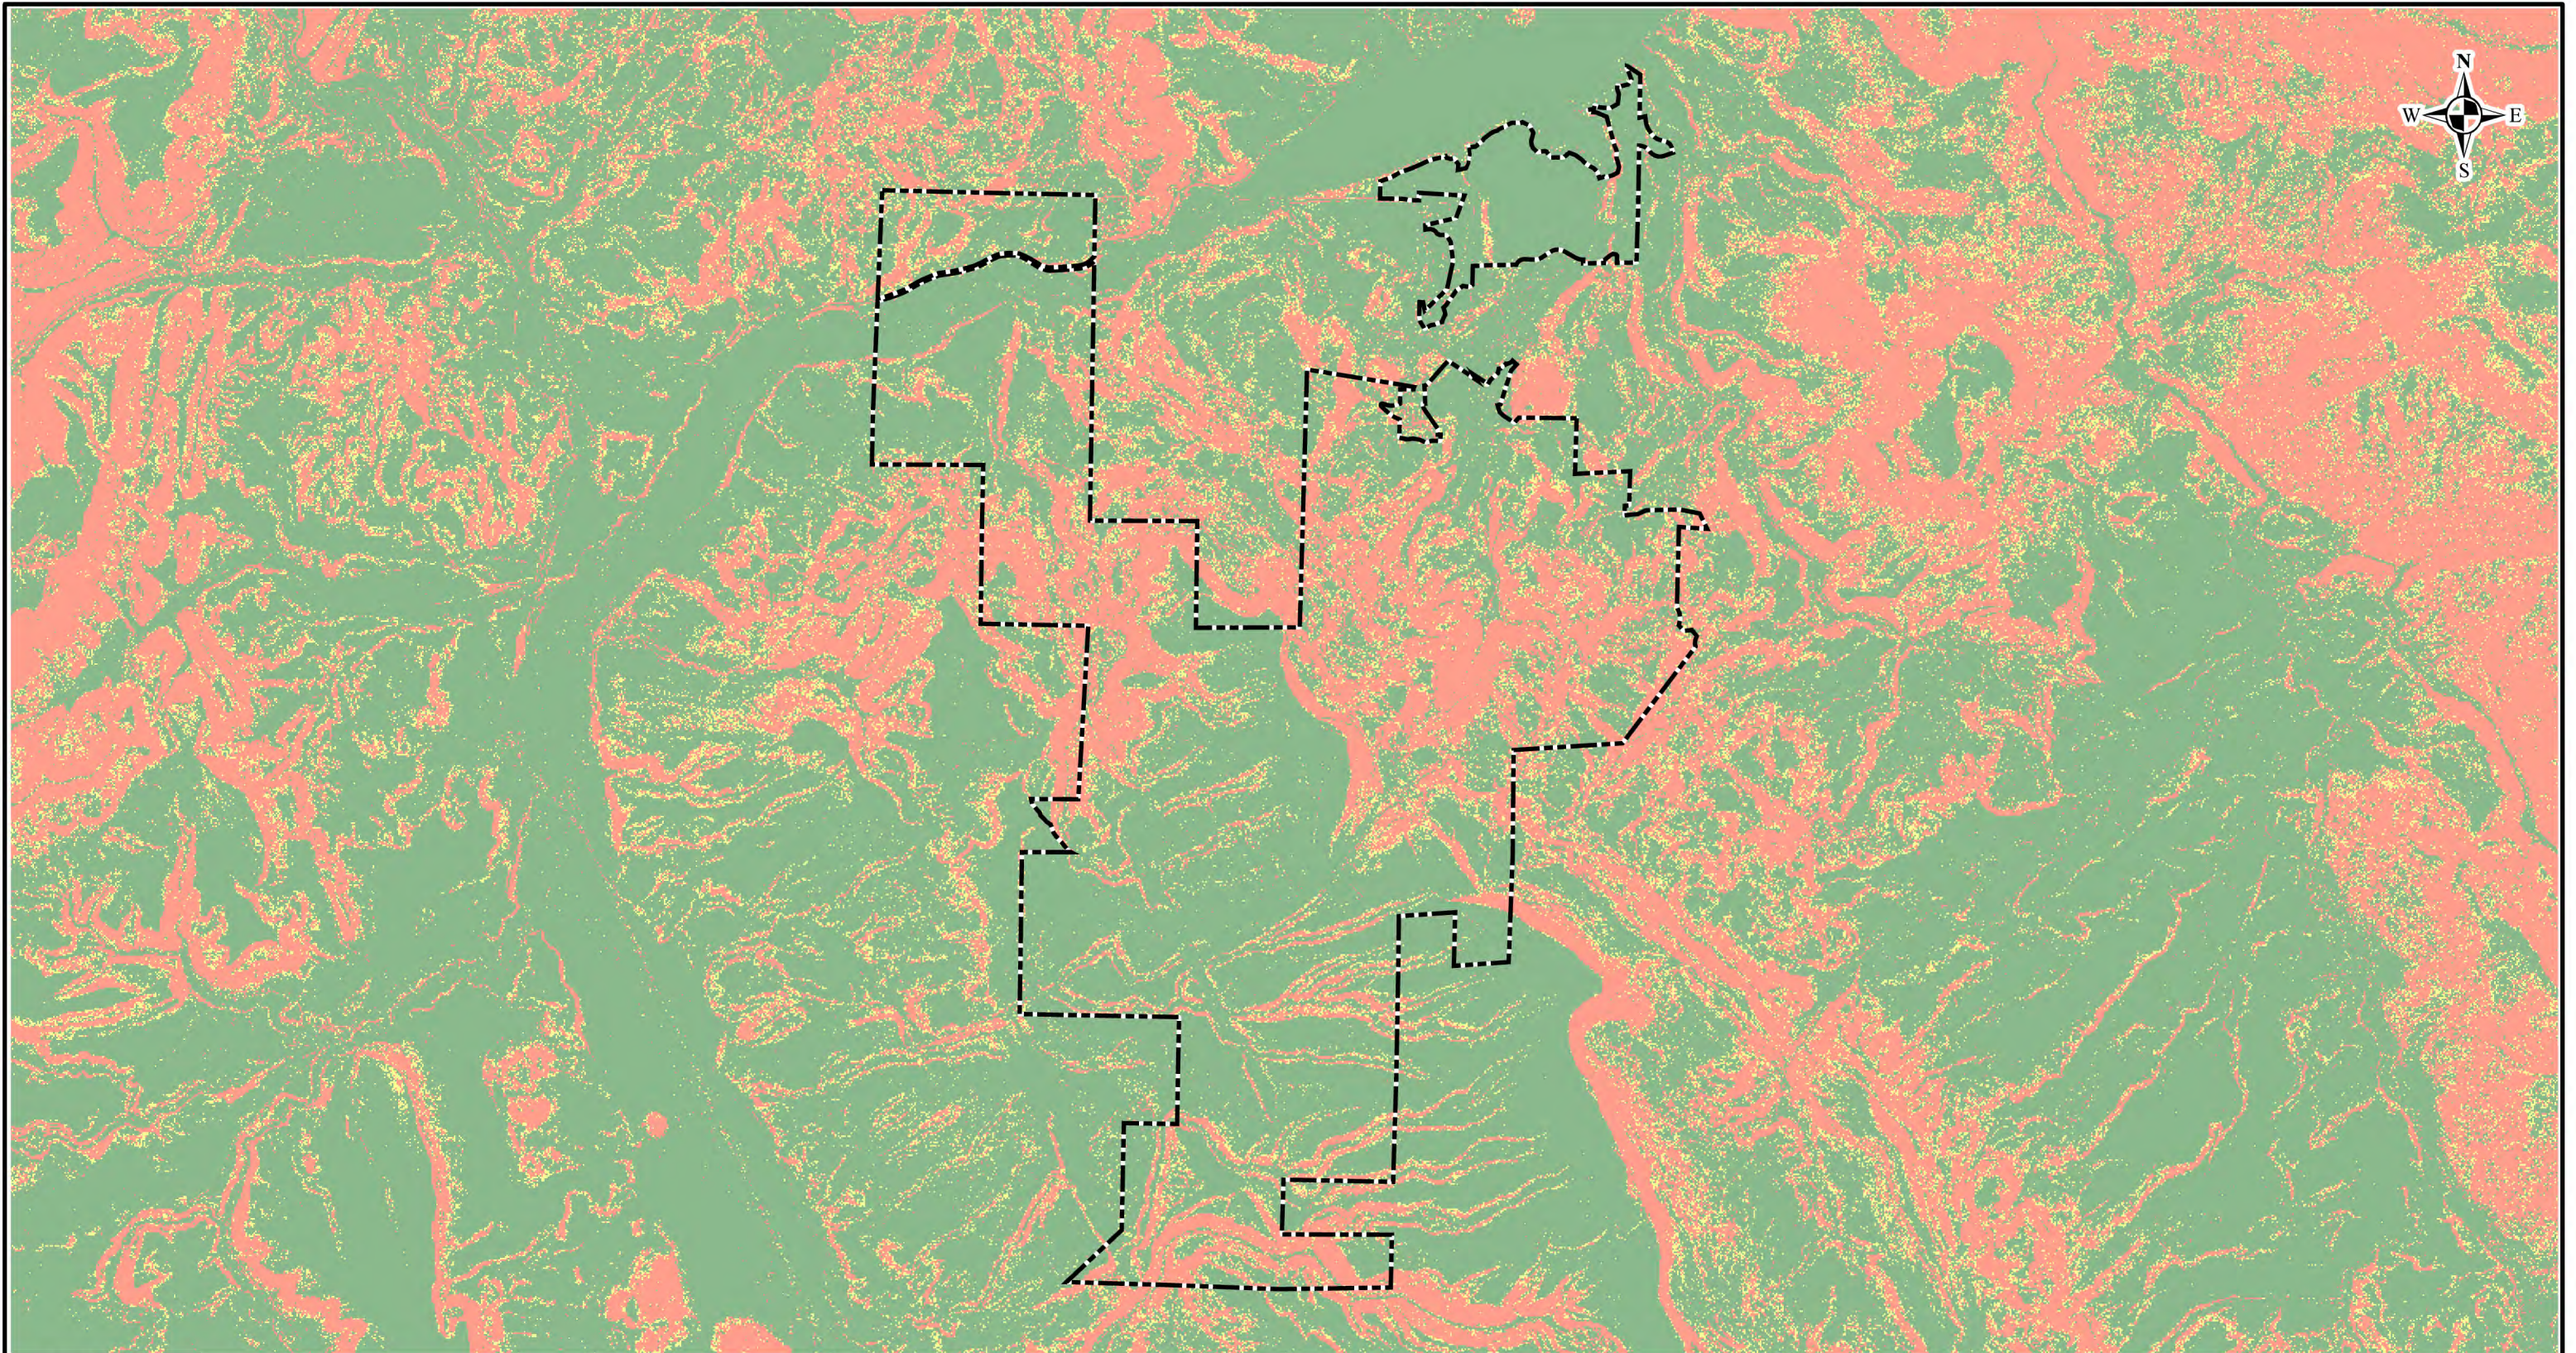
<table><tr> <td>Project No.</td> <td>620044701</td> <td rowspan="4">Figure</td> </tr><tr> <td colspan="2" style="text-align: center;">4a</td> <td></td> </tr></table>

Slopes with grades of 30% or greater encountered in surficial deposits or soils (residuum and/or alluvial and colluvial deposits) will be more prone to instability and development in these areas may be limited or require slope stabilization. Preliminarily, cuts steeper than 2H:1V (horizontal to vertical, typical) at the site will require detailed slope stability analysis to determine maximum cut angles and development buffers, if required. As mentioned previously, groundwater seeps can weaken slope materials and cause slope failures on shallow to moderately steep slopes. We understand some drainage solutions have been implemented adjacent to current developments; we can provide recommendations for drainage solutions for both existing and proposed developments, where required.
