To: Madeline Song / Discovery Land Company

Date: 15 November 2023
Revised 20 September 2024, 11 October 2024, and 21 November 2024

Re: Desktop Review and Geologic Study
Stagecoach Mountain Resort
Routt County, Colorado
Langan Project No.: 620044701

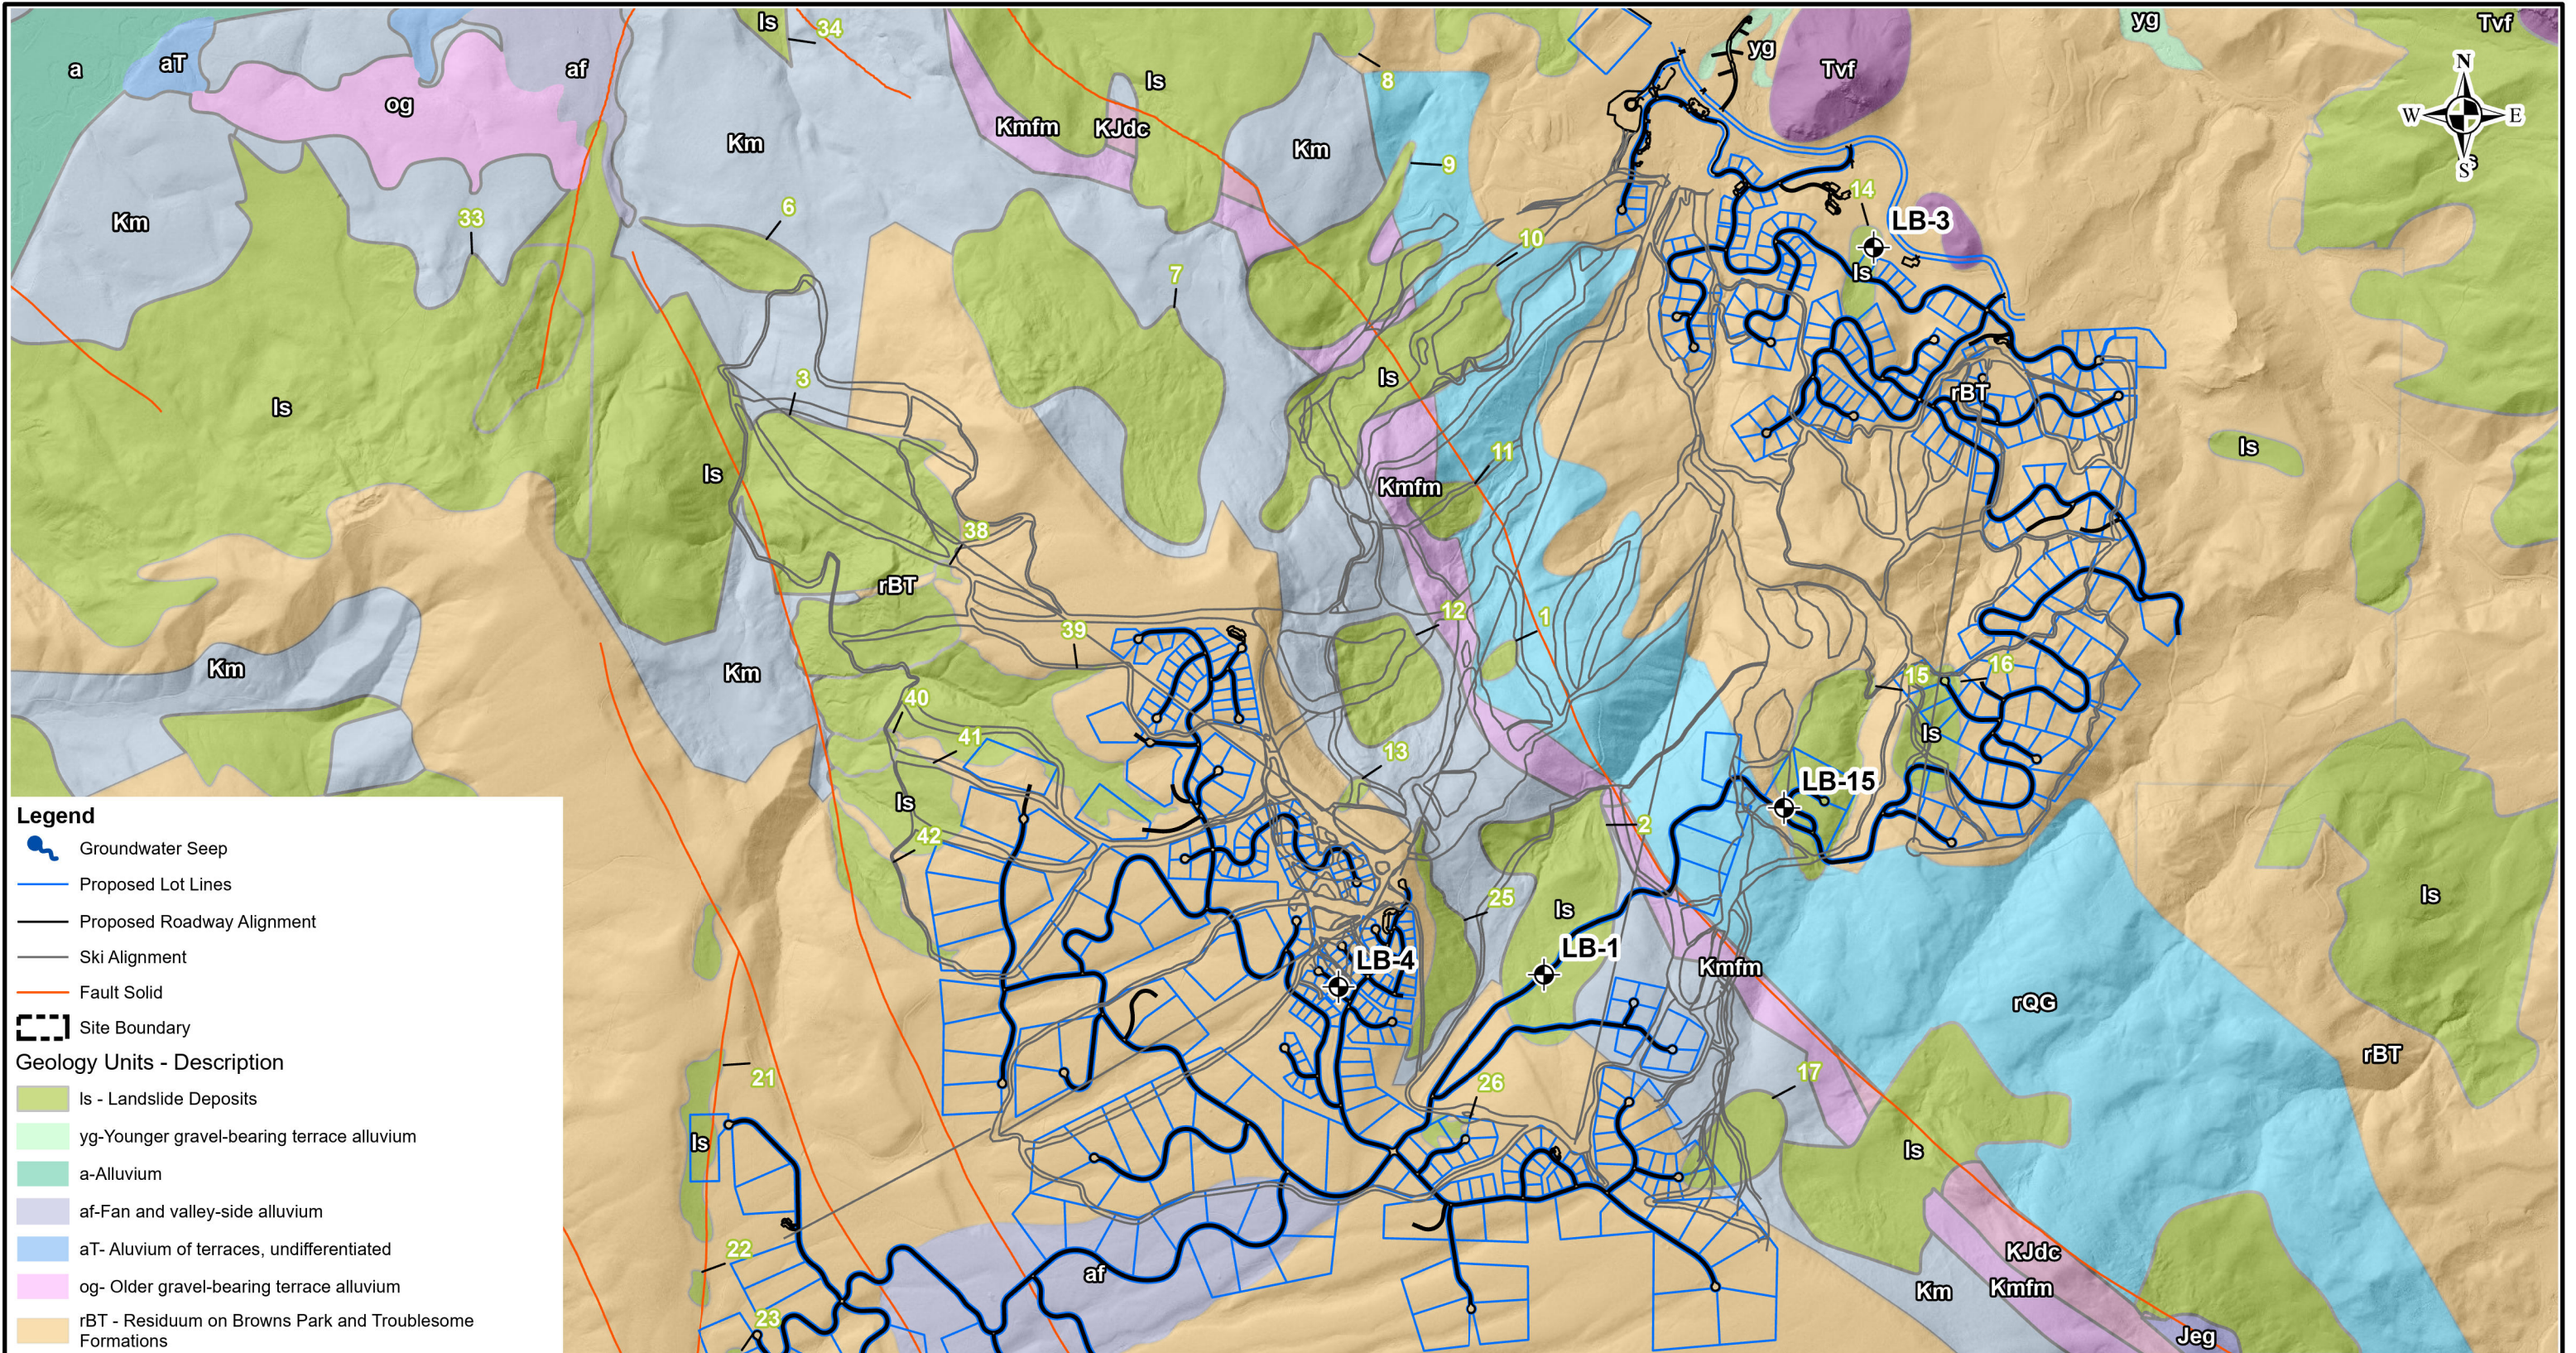
BORING LOCATION PLAN AND GEOLOGIC MAP

Hereafter, borings are indicated with LB-# designations. The boring locations are depicted on Figure 2.

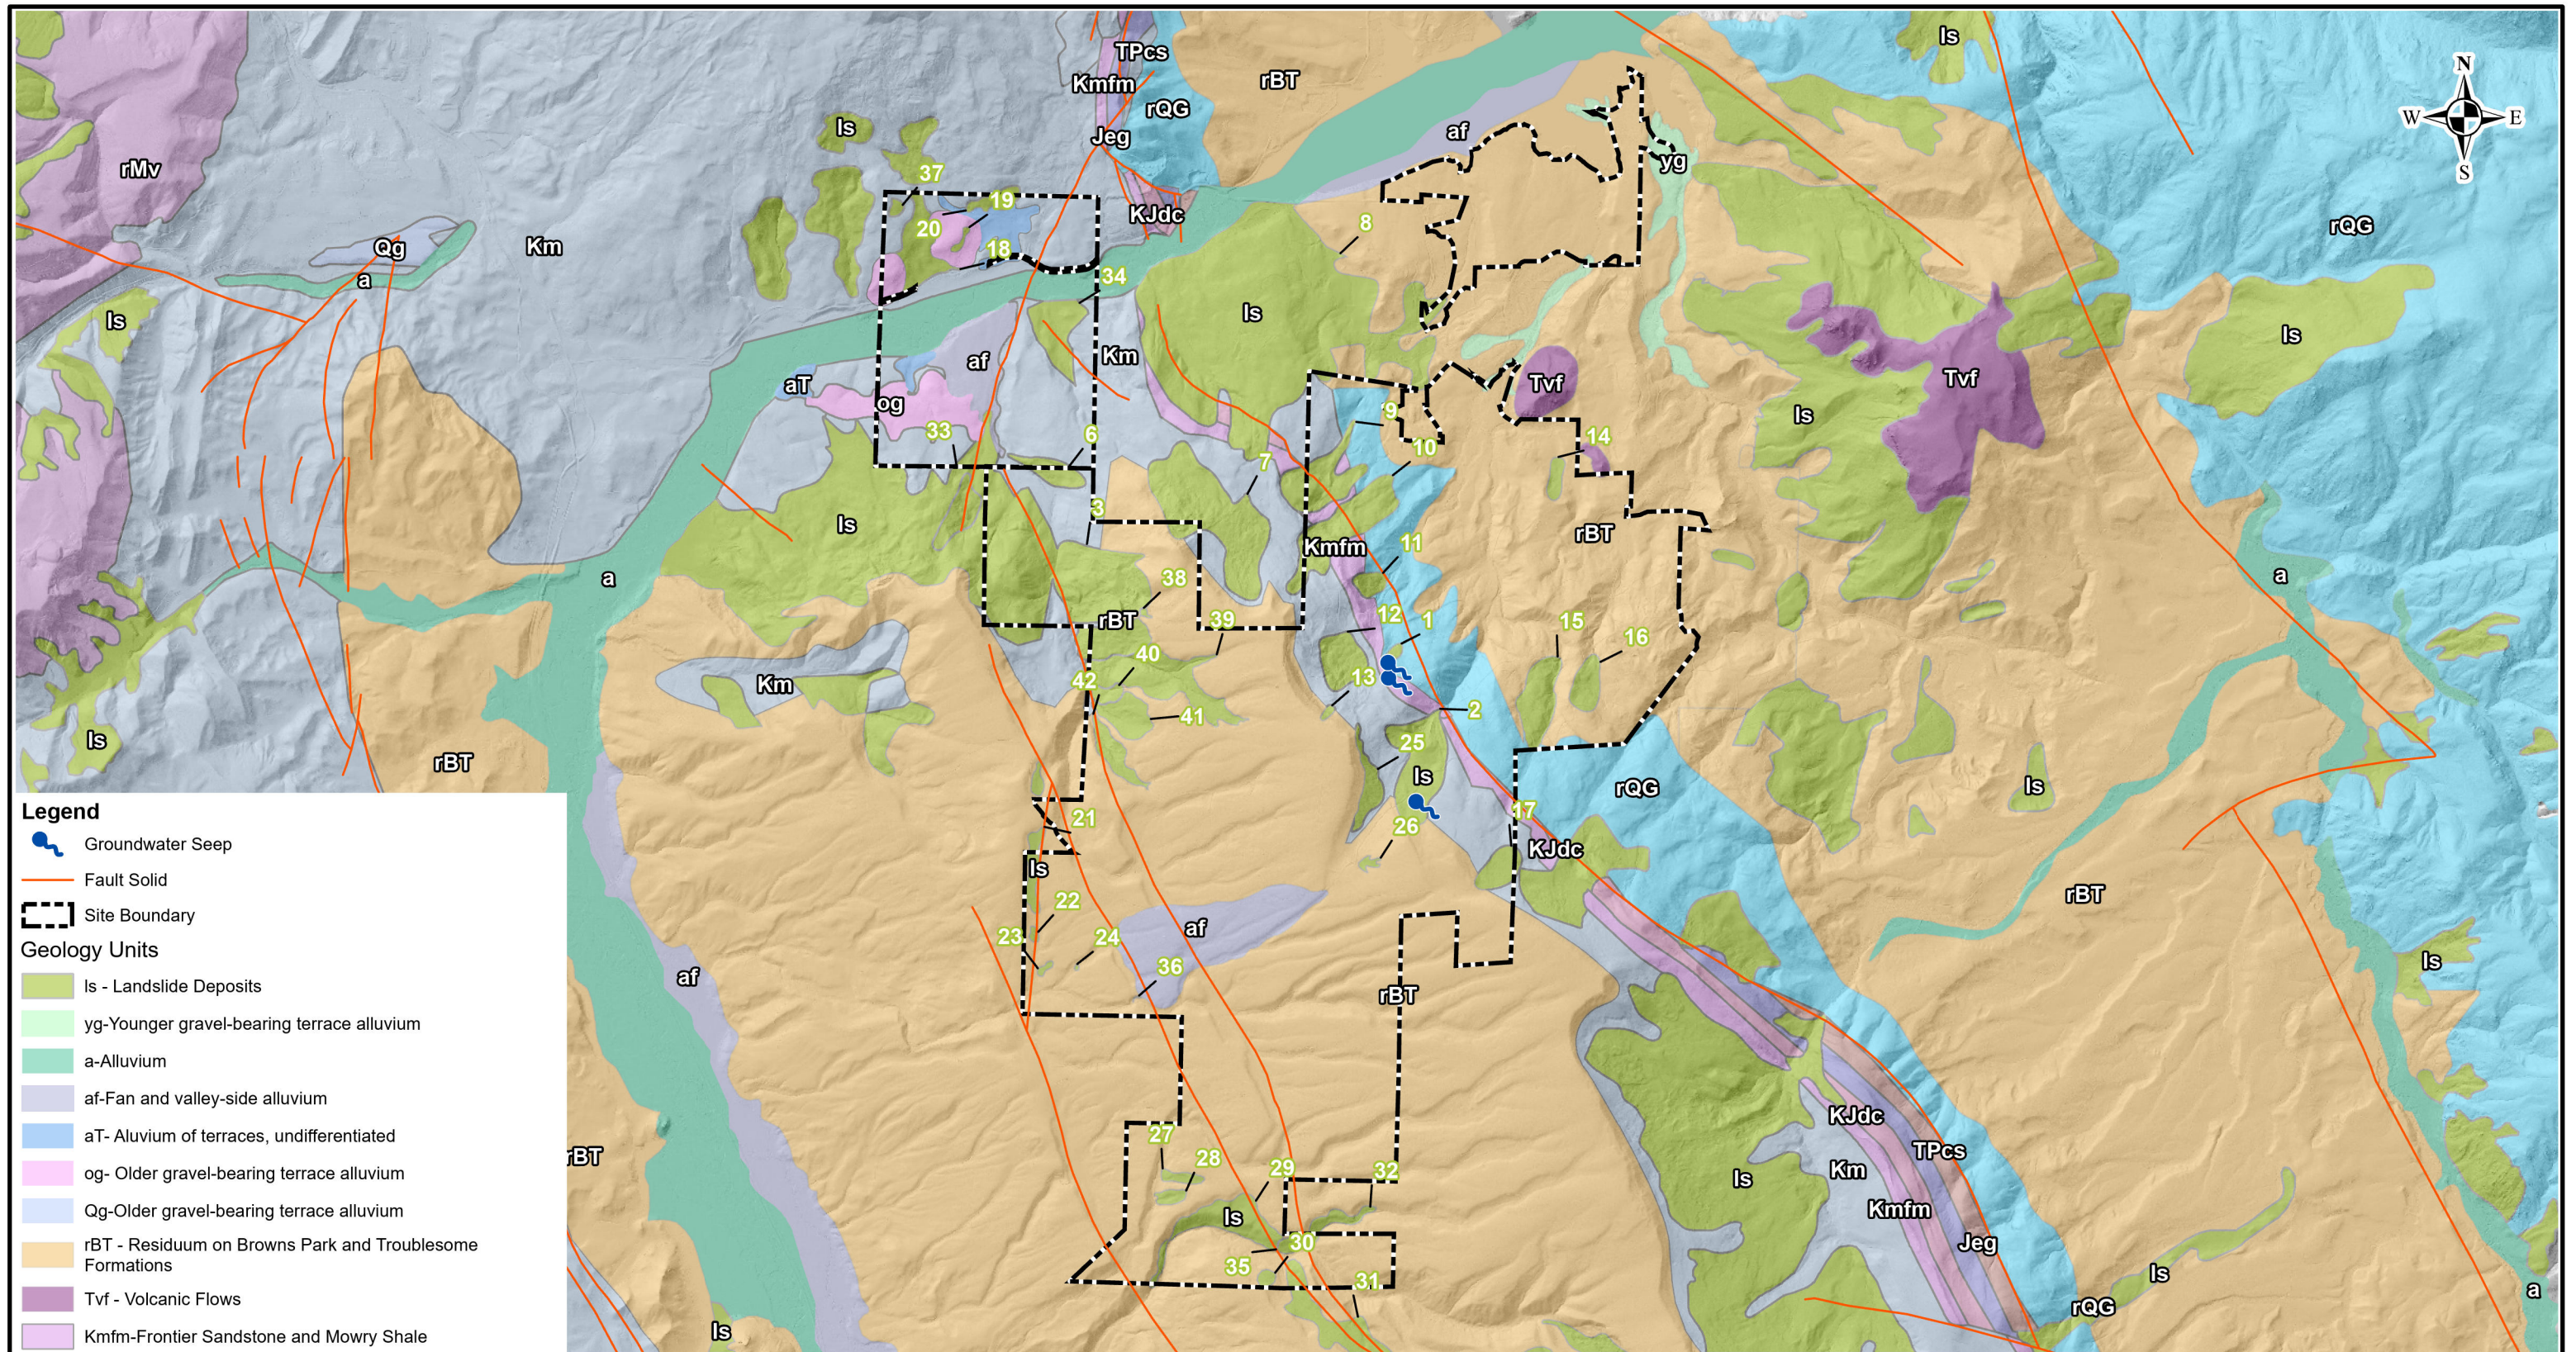
**21 NOVEMBER 2024
PROGRESS
GEOLOGIC MAP**

We performed field geologic mapping of the site to identify geologic hazards potentially affecting the proposed development. Mapping was performed to delineate bedrock and surficial deposits, and identify previous slope movements, faults, and other geologic features where accessible. A summary of identified geologic units is provided below, and our site-specific geologic map incorporating our findings is presented in Figures 3a and 3b.

Areas with steep slopes (grades 30% or greater) are delineated and shown on Figures 4a and 4b. Detailed slope stability analyses will be necessary where development will encroach upon the steep slope areas. We observed 33 landslides (both shallow and potentially deep-seated) derived from unconsolidated residuum on steep slopes; see Figures 3a and 3b.
