TAILWATERS

STAGECOACH

Water Quality Study

November 27, 2023

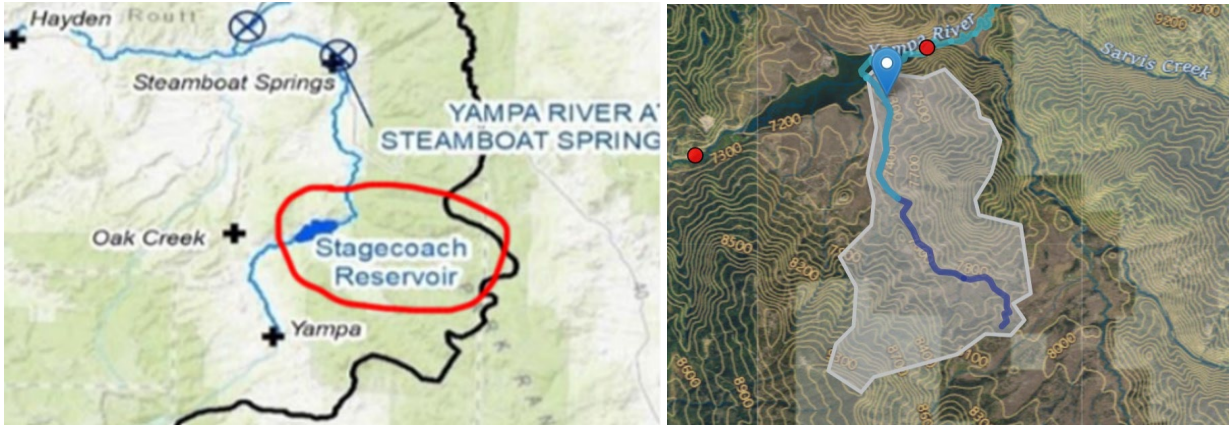
Figure 3 - Upper Yampa River and Little Morrison Creek Hydrology

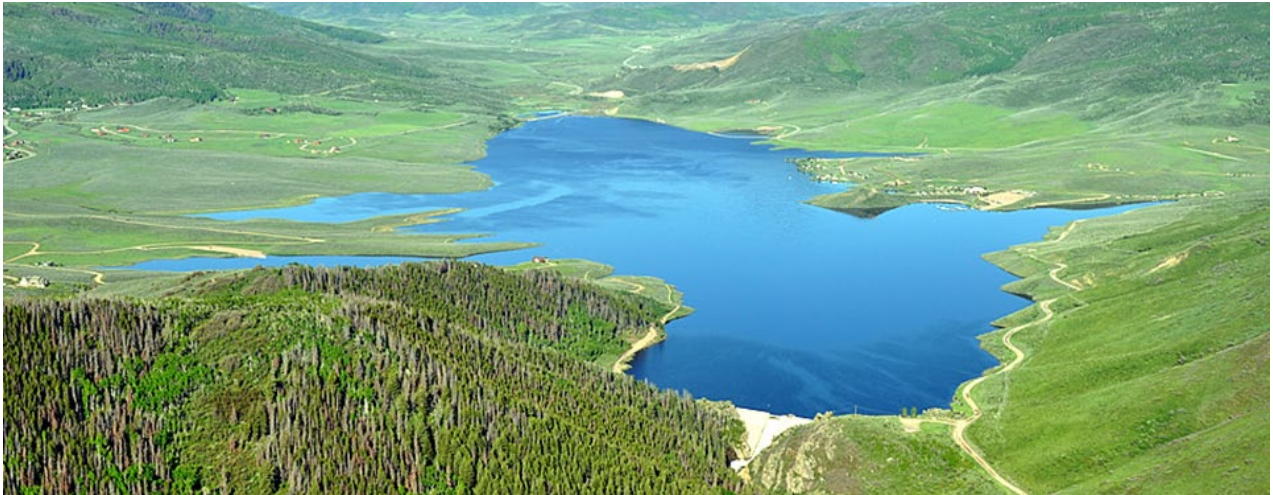
Figure 6 - Stagecoach Reservoir

The main point source of nutrients to the reservoir include the Yampa River, Little Morrison Creek and the Morrison Creek Wastewater Plant which discharges treated effluent directly into the reservoir. The plant, which is currently being upgraded has a January 2016 discharge permit from CDPHE which has specific effluent limits and reporting requirements for nutrients discharged from the plant.

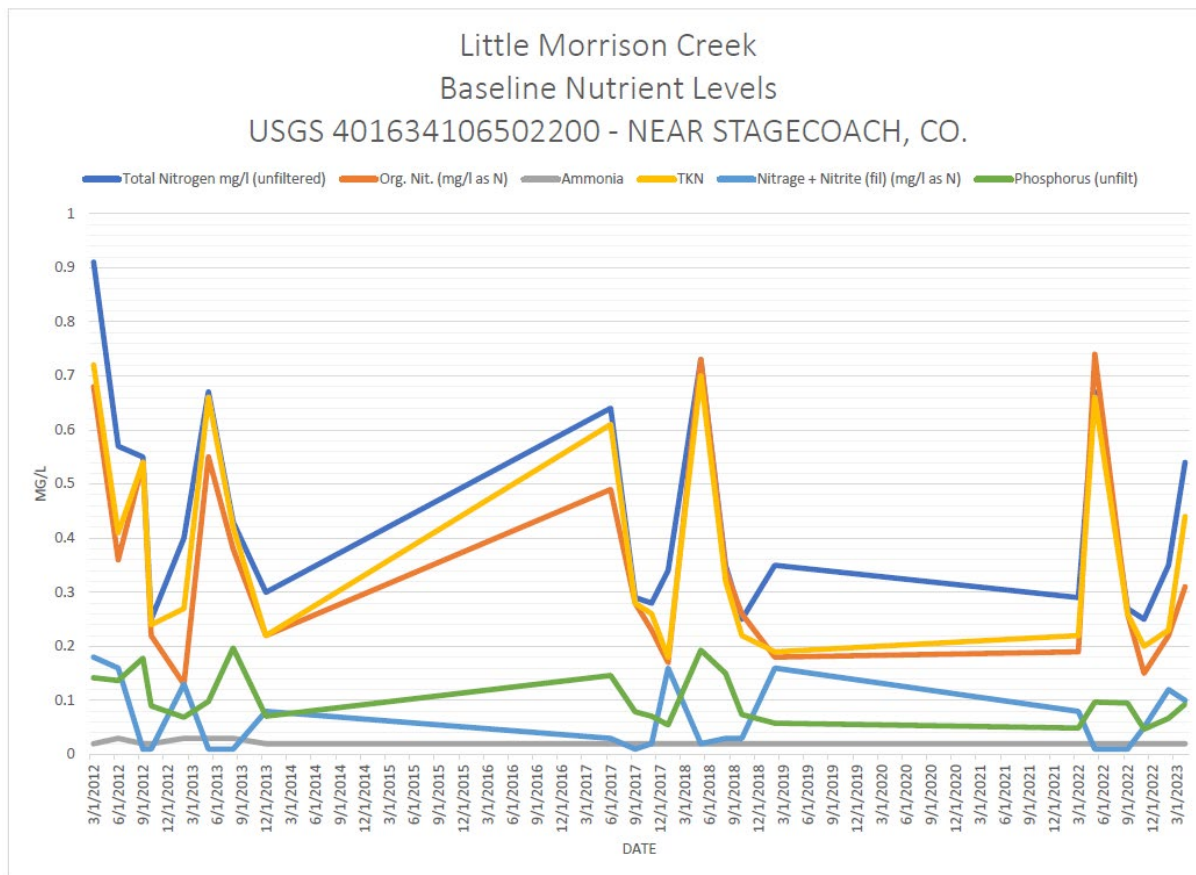
Table 3 - Nutrients Loading from Little Morrison Creek

It should be noted that the overall effect of nutrient loading from Little Morrison Creek is a fraction of what comes from the Upper Yampa. The average annual flowrate in the creek is less than 2 cfs, whereas the average flow rate from the Yampa into Stagecoach is nearly 70 cfs. Table 3 above shows the nutrient loading coming into Stagecoach reservoir from the upstream drainage basin. Nitrogen levels tend to peak just under 0.7 mg/l while phosphorus levels are generally between 0.1-0.2 mg/l.

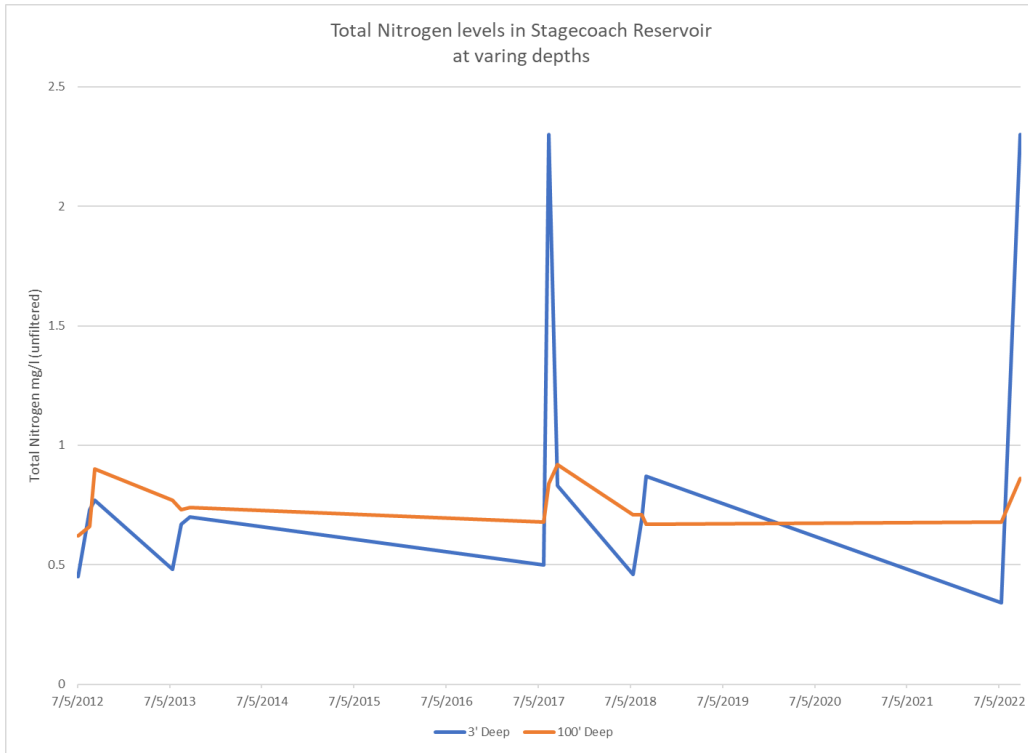
Table 7 - Nitrogen levels at varying depths of Stagecoach Reservoir

Nitrogen and phosphorus levels within the lake itself have been also monitored over the past decade. Measurements have been taken near the dam at the water surface (0-3’ deep) and at the bottom of the reservoir (100’-120’ deep). As shown in tables 7 total nitrogen levels are consistent with influent and effluent levels. Nitrogen levels tend to be lower closer to the surface although some spikes are reflected in graph, these surface spikes do appear to influence nitrogen levels at depth, but to a much smaller degree. Phosphorus levels shown in table 8 also show nutrient levels at varying depths of the reservoir. Unlike nitrogen, the phosphorus levels are consistently higher at depth (over double the concentrations). These elevated concentrations appear to be higher than influent levels which may support the theory of phosphorus production in the reservoir bed due to decomposing native reservoir bed material which is consistent with historic land uses and was anticipated during reservoir construction.
