Landfill Inspection

11/18/2024

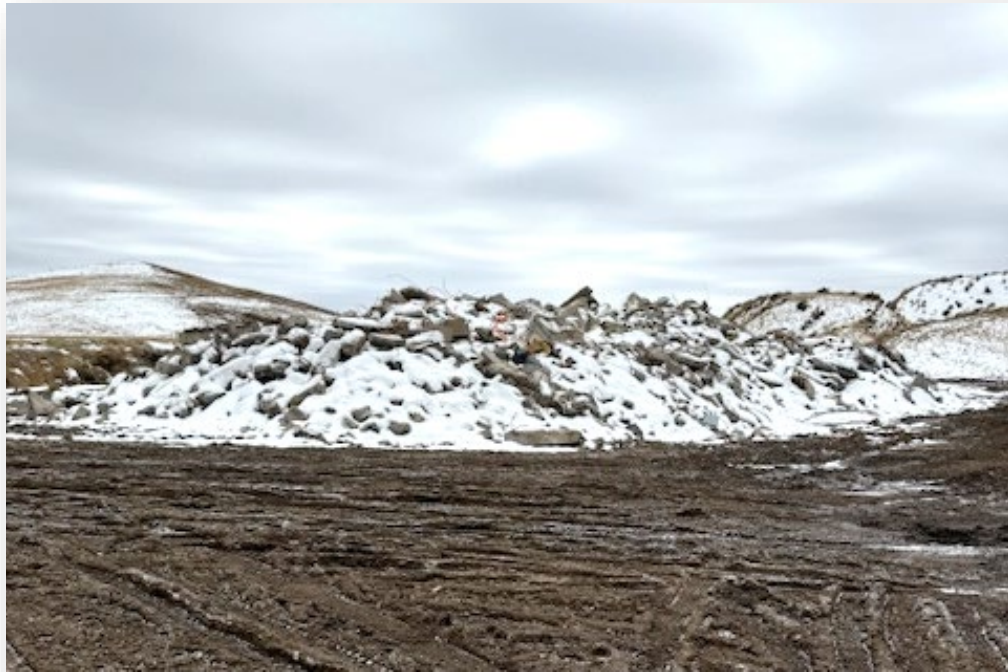
Ditch Adjacent to MRF – some waste present but ditch not inhibited

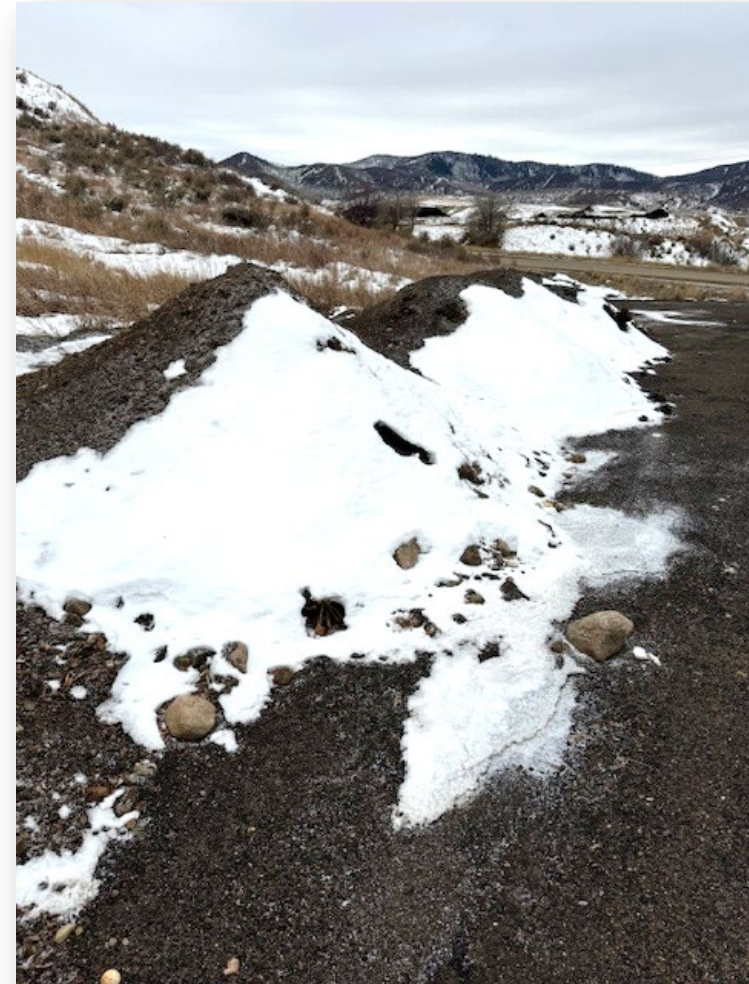
Stored concrete – 3rd party to process.
Aggregate to be used for operations/roads

- Should confirm composting requirements are being fulfilled based on past inspections and Compliance Advisory
- Stored concrete to be processed by 3rd party. Leftover aggregate to be used on roads/operations

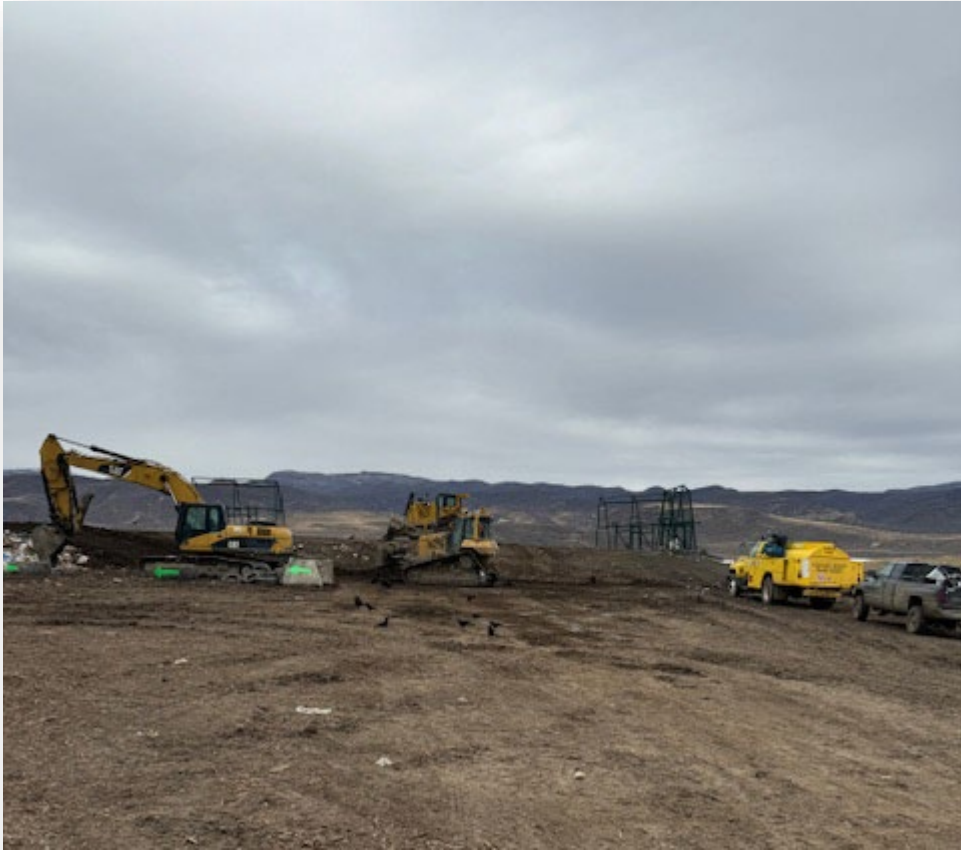
Working Face

Note waste “catchers” in background to help prevent wind-blown trash. An additional “catcher” to be ordered according to Landfill Rep

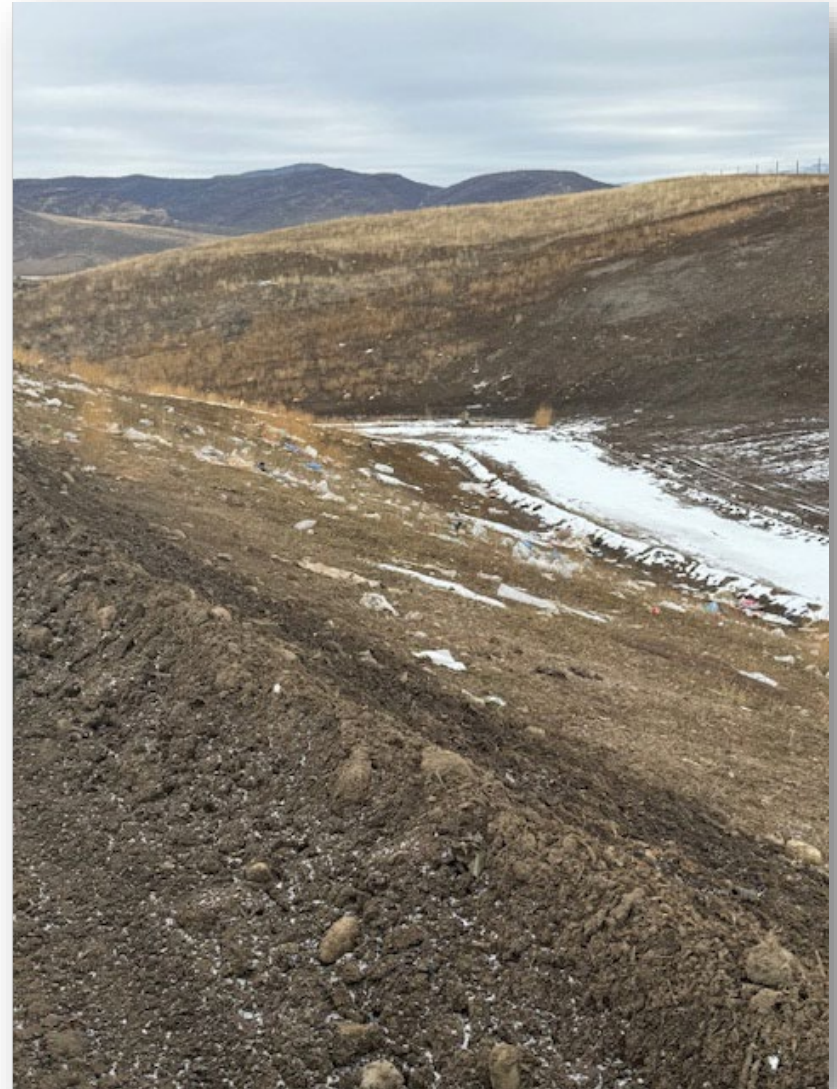
Wind deposited waste along hillside
