To: Madeline Song / Discovery Land Company

Date: 15 November 2023
Revised 20 September 2024, 11 October 2024, and 21 November 2024

Re: Desktop Review and Geologic Study
Stagecoach Mountain Resort
Routt County, Colorado
Langan Project No.: 620044701

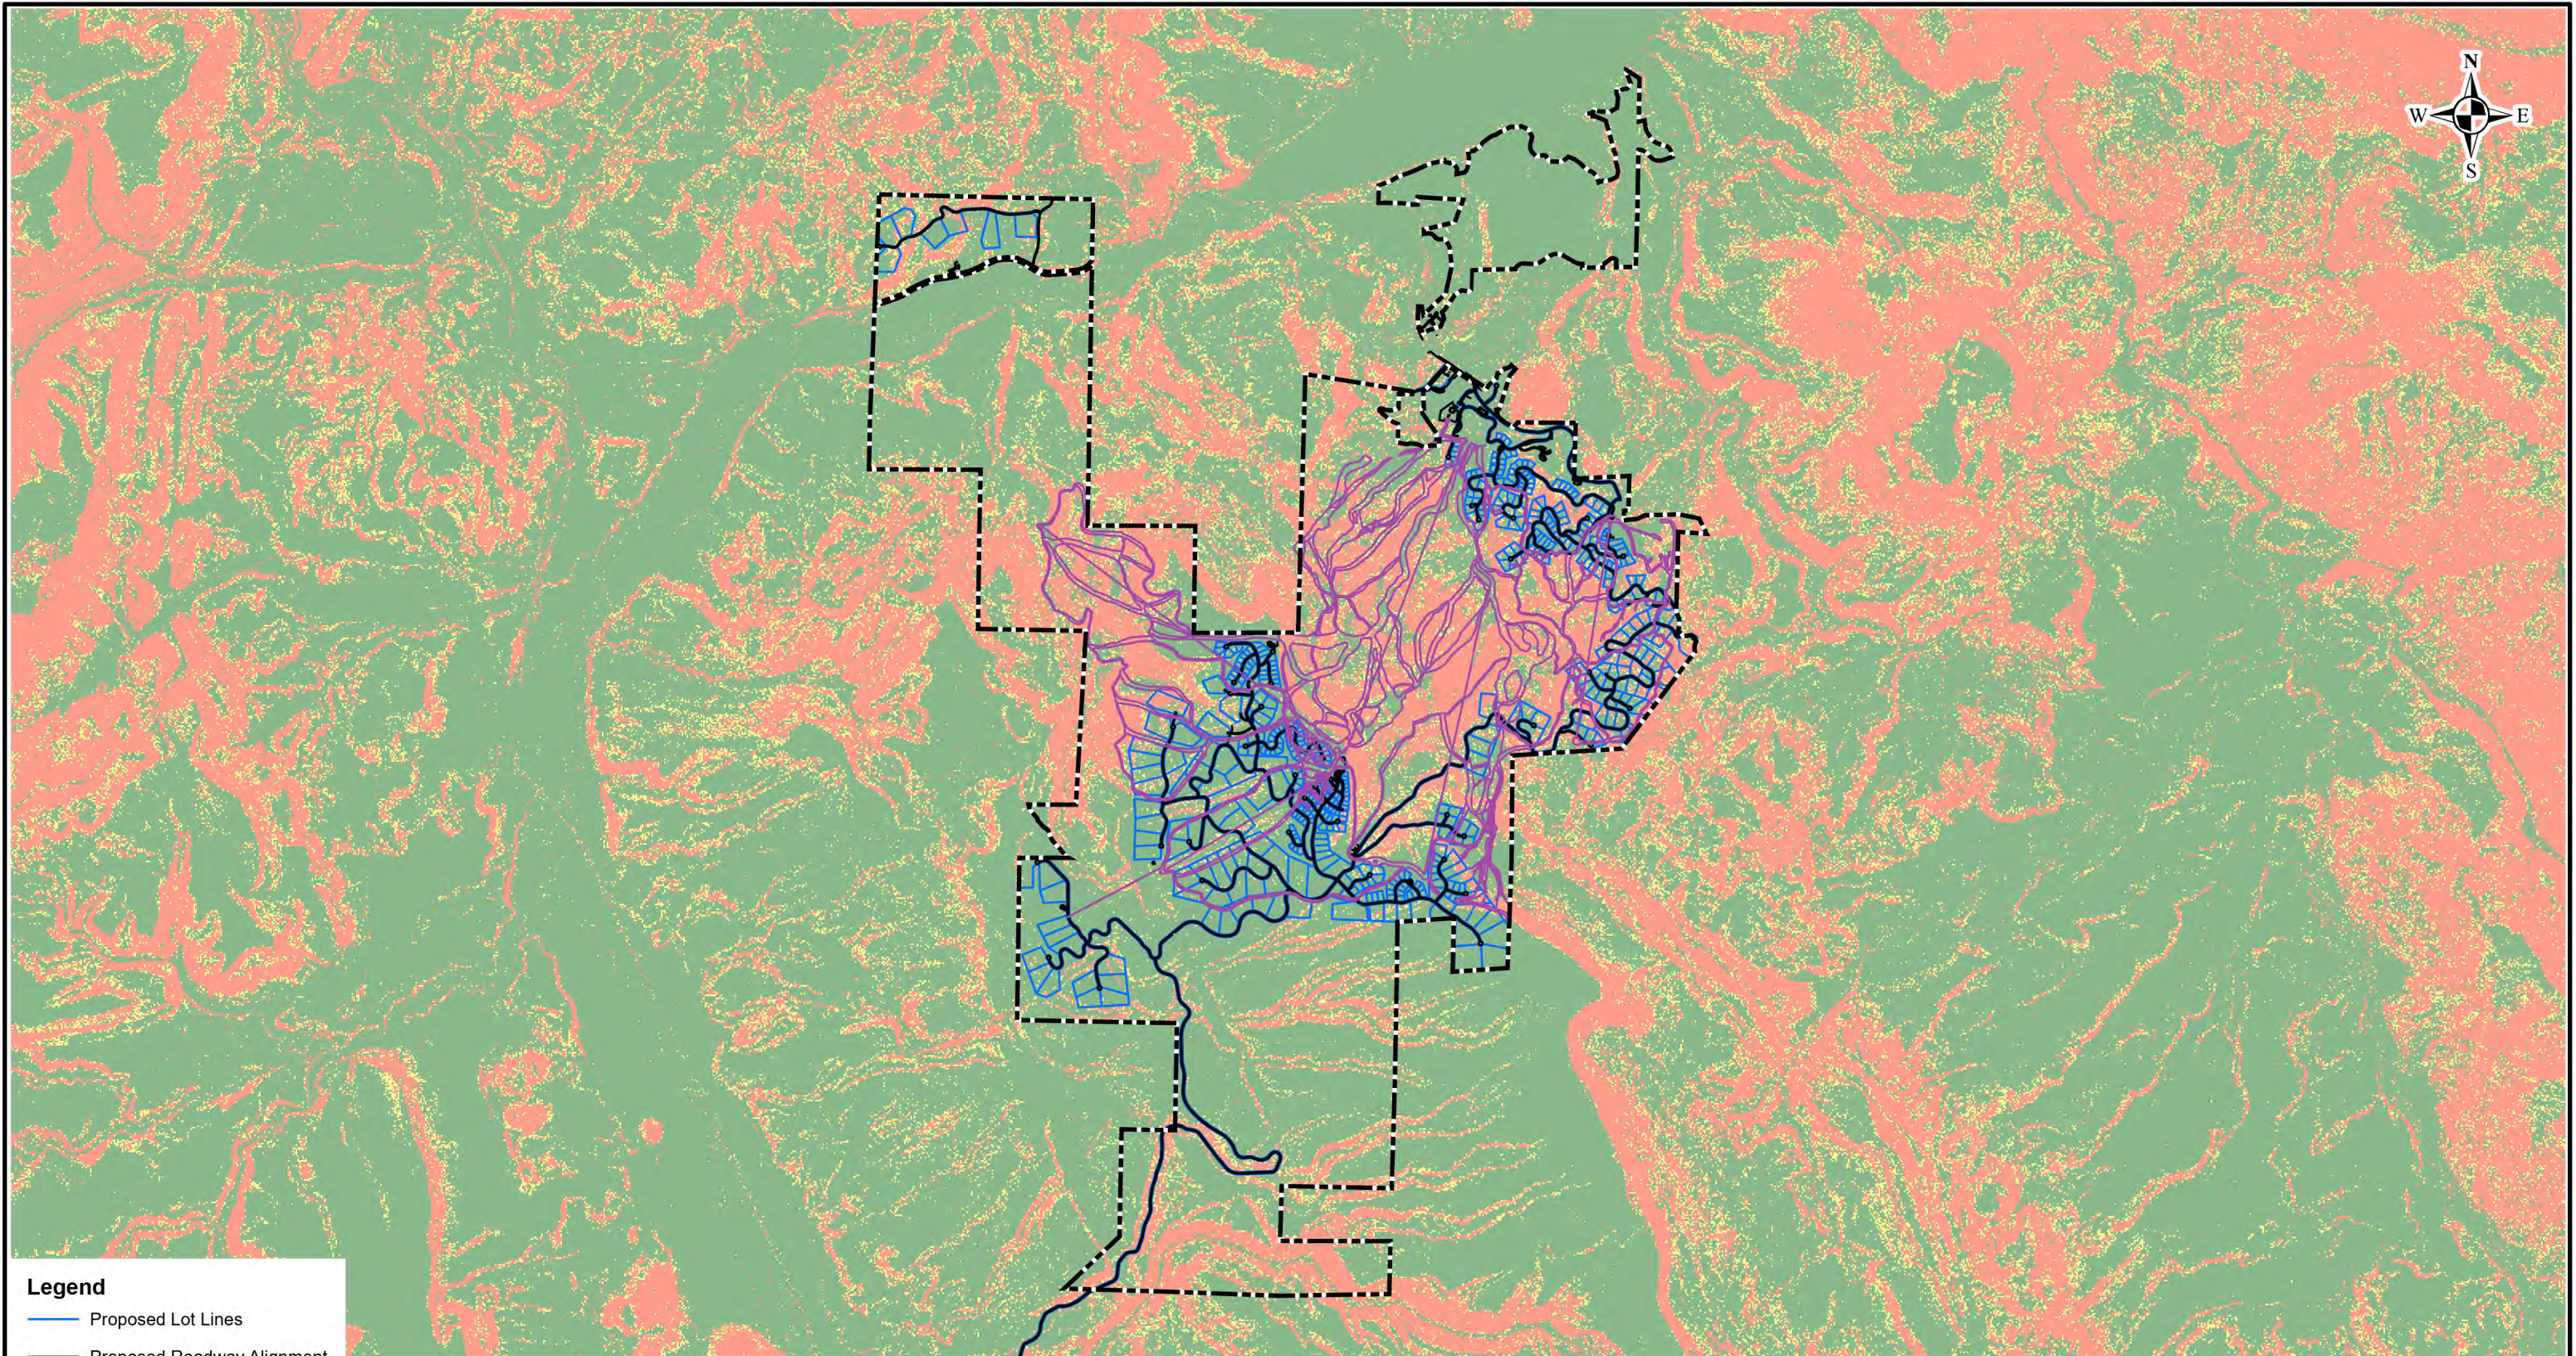
<table><tr> <td>Project No.</td> <td>620044701</td> <td rowspan="4">Figure</td> </tr><tr> <td colspan="2" style="text-align: center;">4a</td> <td></td> </tr></table>

Areas with steep slopes (grades 30% or greater) are delineated and shown on Figures 4a and 4b. Detailed slope stability analyses will be necessary where development will encroach upon the steep slope areas. We observed 33 landslides (both shallow and potentially deep-seated) derived from unconsolidated residuum on steep slopes; see Figures 3a and 3b.
