July 13, 2017

Re: Compliance Advisory for Phantom Landfill  
2500 County Road 67, Penrose, CO 81240  
Fremont County  
SW/FRM/PH3 1.6

**Attachment A - Photo Log**  
**Phantom Landfill, June 8, 2017 Inspection**

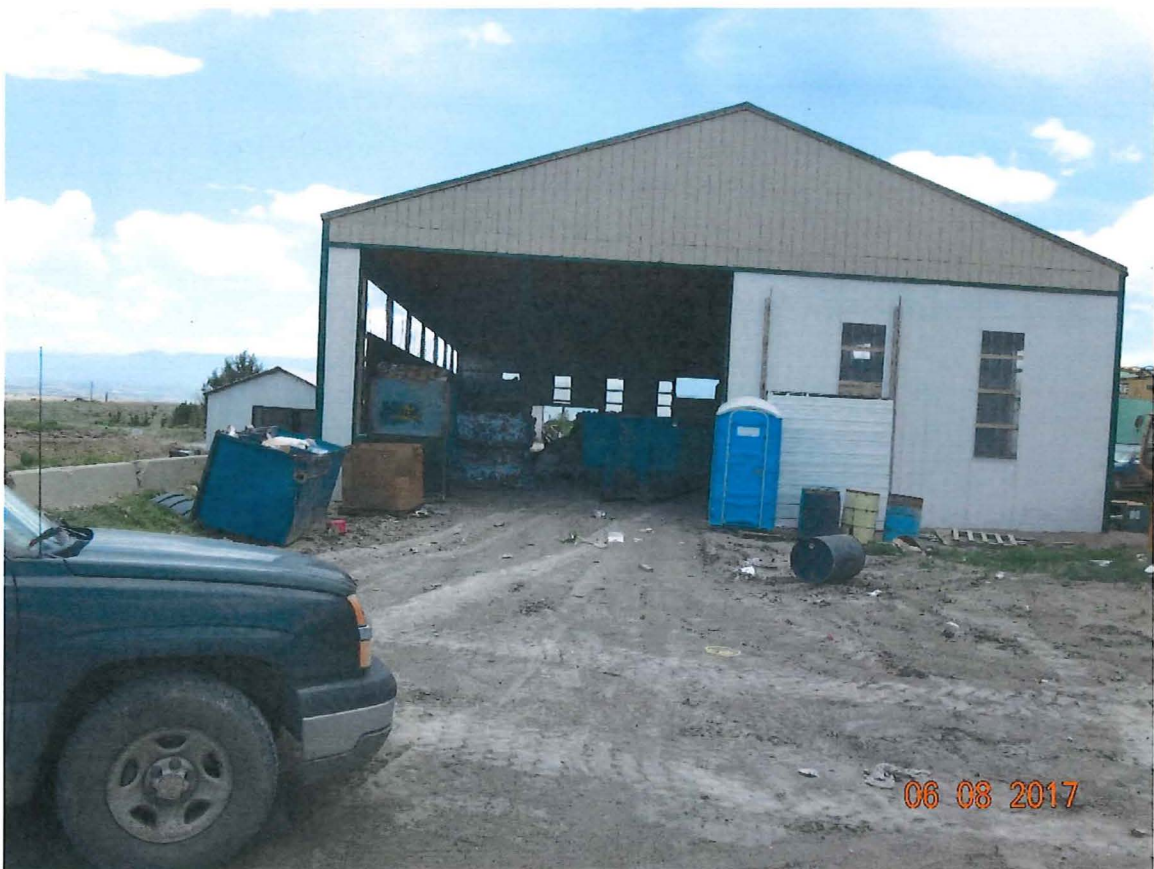
Two buildings are located north of the office area, including the recycling building which is used to store recyclable materials, and the equipment maintenance building. An area for collecting e-waste is located outside and to the east of the recycling building. Much of the e-waste was contained in plastic bins; however, several waste televisions were sitting directly on the ground surface, a violation of Section 16.5.5 of the Regulations. See Photos 4, 5 and 6.

Photo 4: Looking southwest at the recycled materials storage building at the west portion of the Facility.

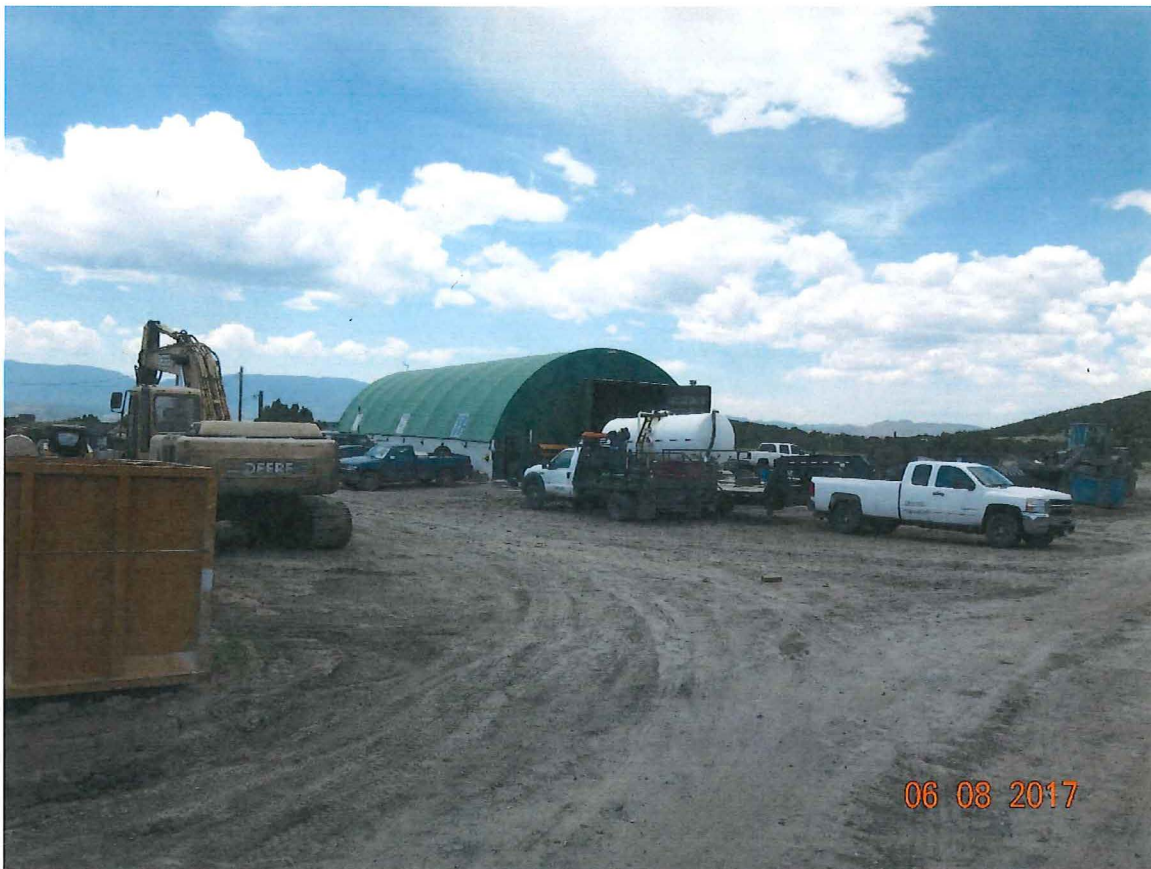
Photo 5: The equipment maintenance building with some Facility equipment. Looking southwest.

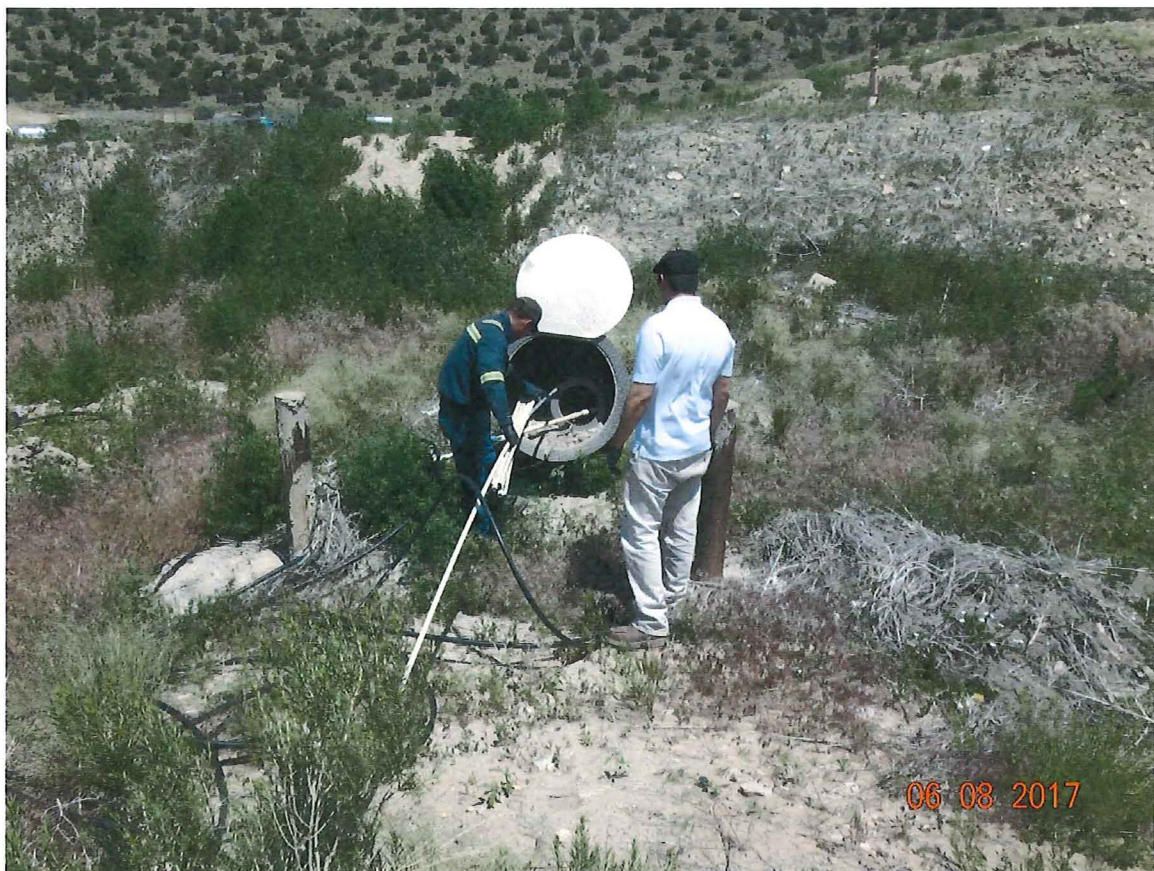
Determining accurate leachate levels using this method with an uncalibrated measuring pipe appeared ineffective and confusing. This apparently results in inaccurate operating records related to leachate levels. In addition, determining where the base of the leachate sump was for maximum pipe insertion seemed to be subjective based on the presence of the pump near the base and other potential obstructions. The protective cover at the top of the leachate pipe casing was not locked and was pried open by another PVC pipe used for leachate extraction pumping. This could allow wind-blown waste into the leachate access pipe or provide access by animals which could compromise system by allowing debris to accumulate at the base of the sump. Leachate from the collection system is periodically pumped and temporarily stored in two nearby tanks west of the leachate pipe casing. See Photos 7 and 8.

Photo 7: Looking north at the leachate access pipe and casing as the PVC measuring pipe is assembled.

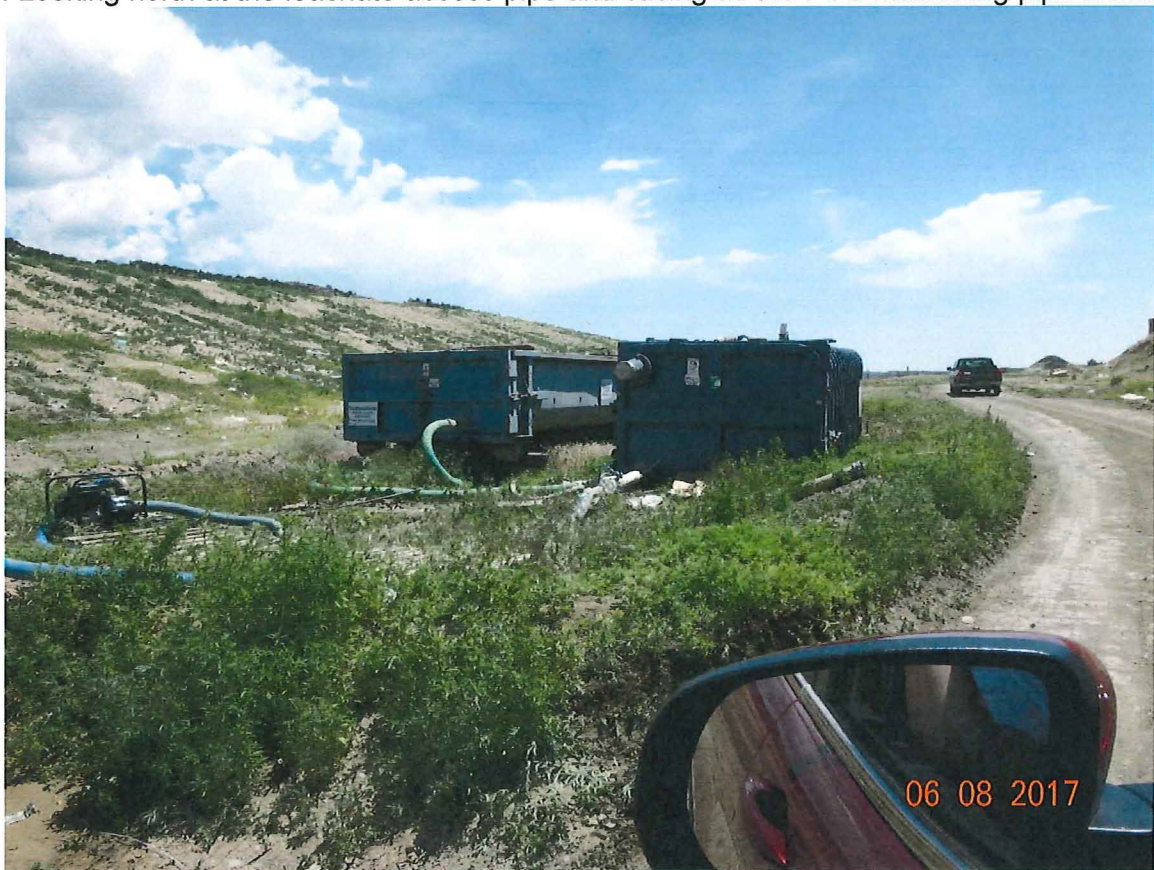
Photo 8: The leachate collection tanks south of the disposal cell. Looking east-northeast.

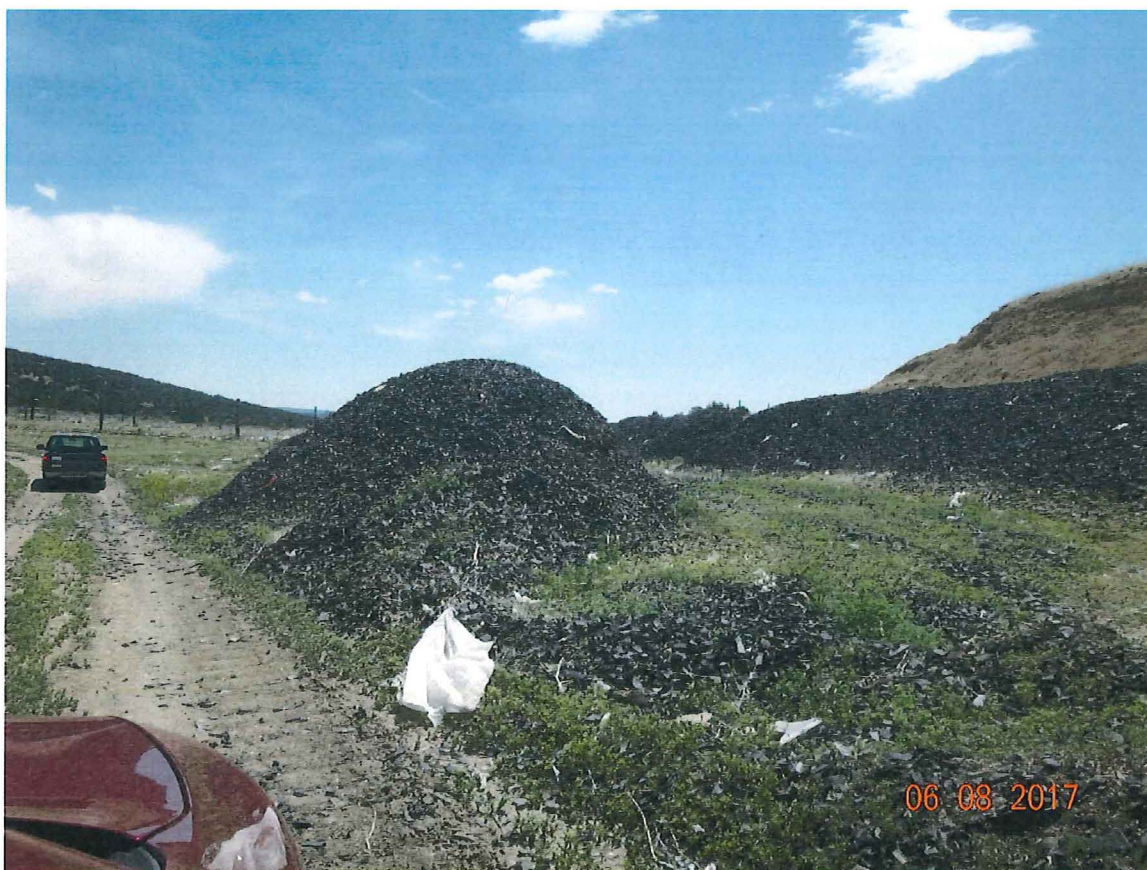
Near the southeast portion of the Facility, several piles of waste tire shreds were present. These are to be used for a leachate drainage layer in the area at the east portion of the Facility where cell expansion construction is underway. See Photos 10 and 11.

Photo 10: Looking east at stockpiled tire shreds for a leachate drainage layer in the cell under construction.

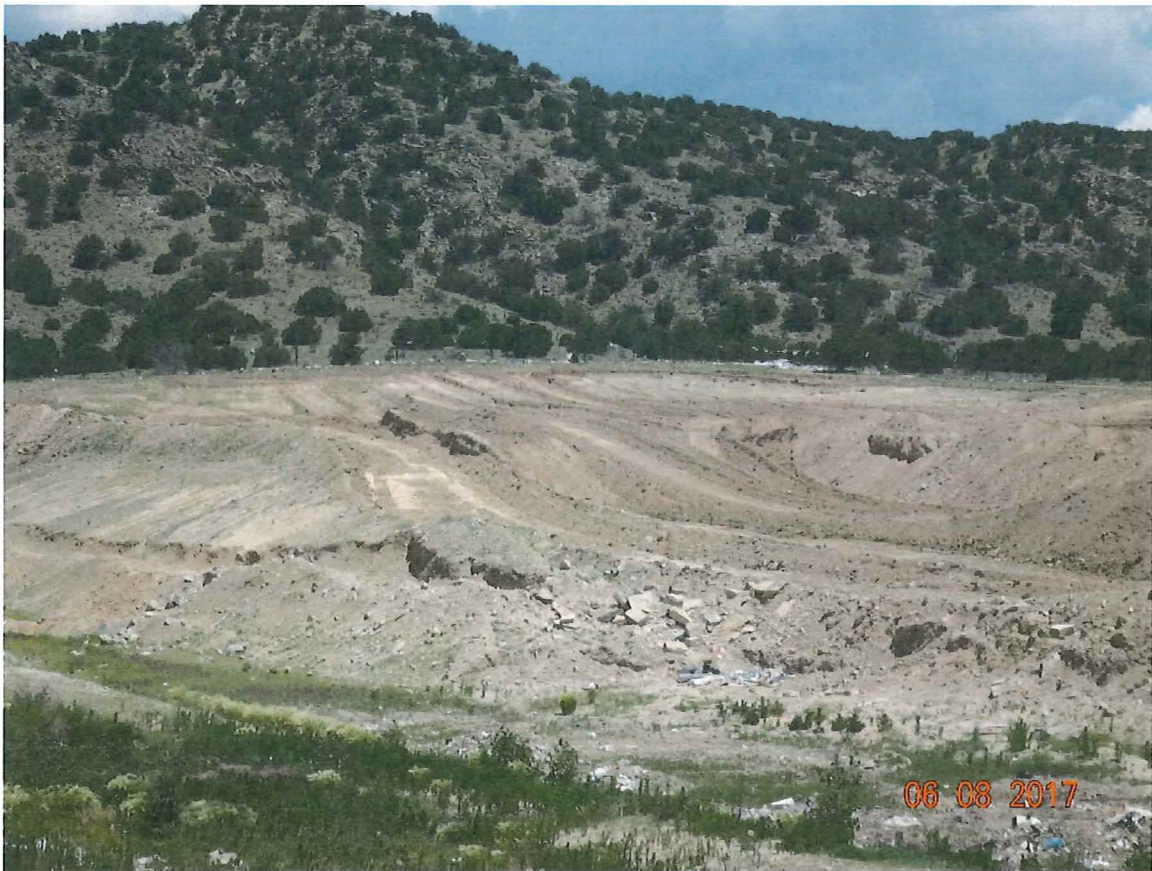
Photo 11: Looking northeast at the cell construction area at the east portion of the Facility.

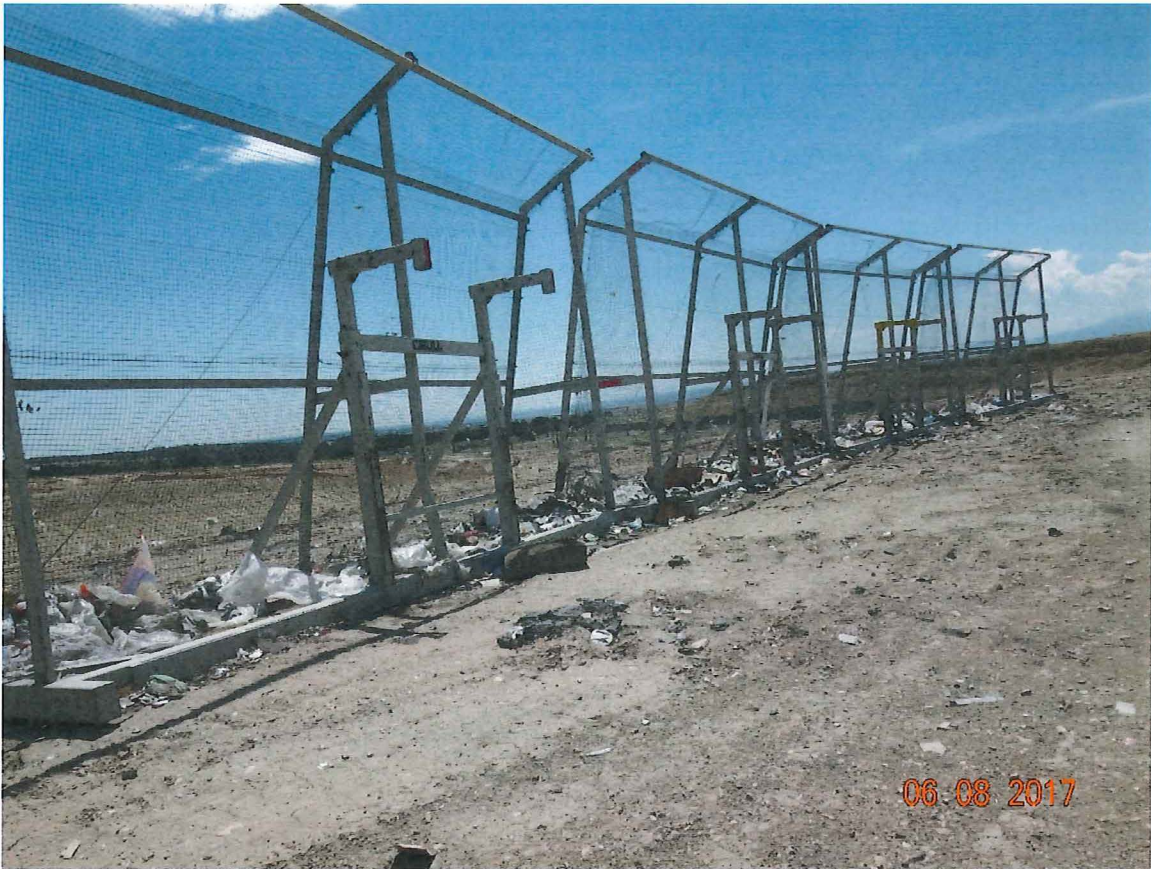
From the northeast corner of the property, the inspection proceeded to the active working face near the north-central portion of the Facility. A movable wind fence was located east of the working face to help control wind-blown waste as seen on Photo 17. A compactor and dozer were operating at the working face which occupied the east portion of a relatively large depression. At the west side of this large depression, the fly ash removal wall was present. A high percentage of mixed municipal waste materials were combined with the fly ash at the removal area. Mr. Riesburg stated that the fly ash is removed and hauled to the solidification basin for use there.

Photo 17: Looking southeast at a movable fence near the waste disposal working face.
