Re: OWTS Observations
Janes Residence
Lot 9, Murphy Larson Ranch
Routt County, Colorado
Western Slope Geotech Project No. 19-1035

This report summarizes Western Slope Geotech, Inc.'s (WSG) observations of the On-site Wastewater Treatment System (OWTS) conducted for the above referenced project. WSG conducted one site visit for observation of the OWTS installation on October 23, 2020.

OWTS AS-CONSTRUCTED PLAN

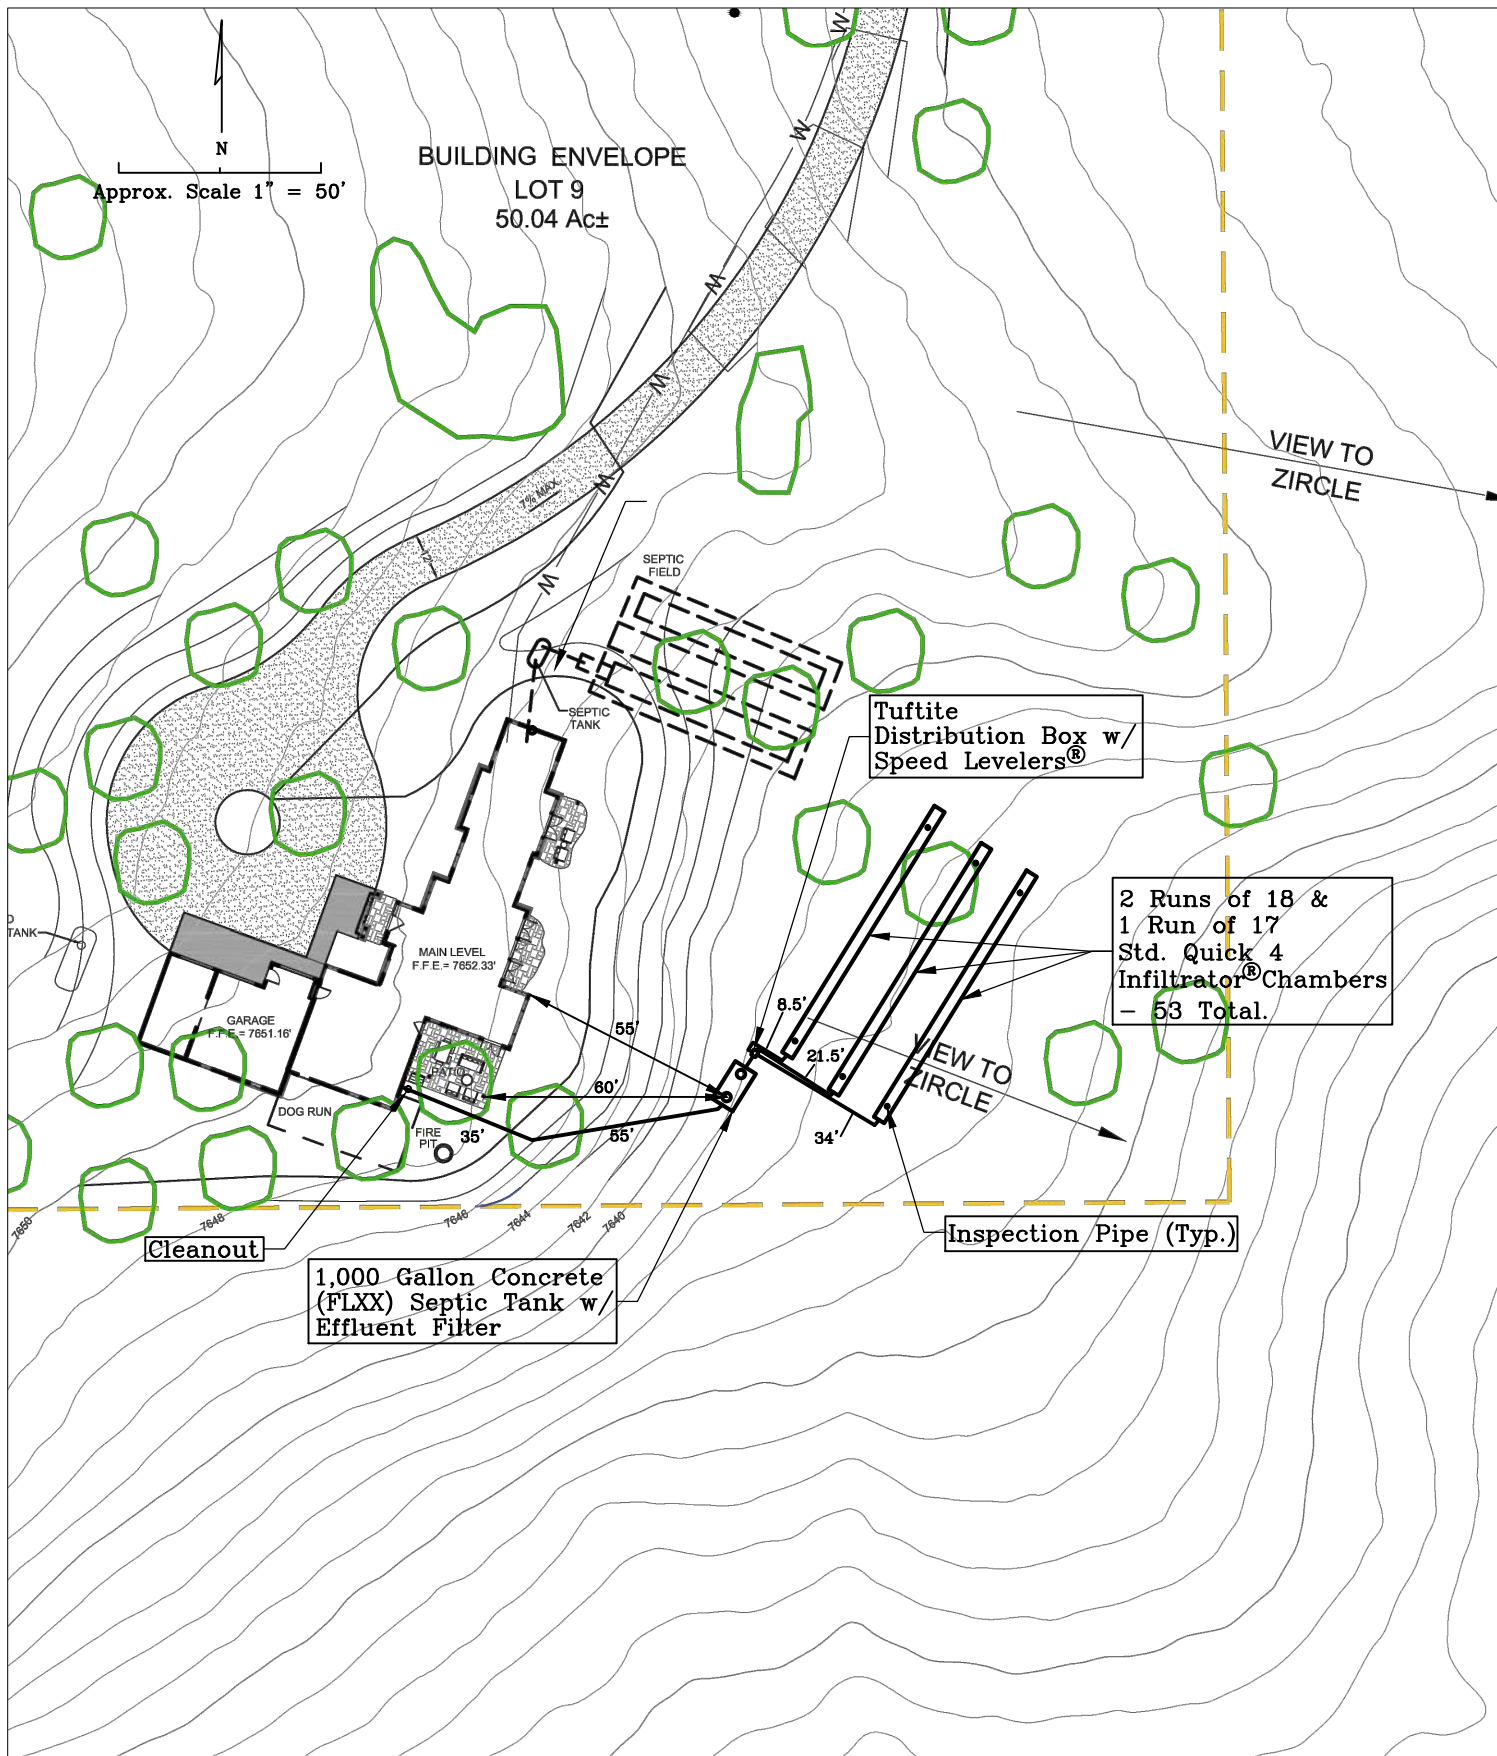
Figure No.: 1

The approximate location of OWTS components is shown on the attached Figure 1. WSG did not observe final grading at the STA. We recommend final grading meet plan requirements that includes sloping all final STA surfaces to provide positive surface drainage and revegetation. The owner should observe the STA for signs of final cover settlement and poor drainage conditions and correct, as necessary.
